# Empire Home Inspection

## Confidential Inspection Report

Escondido, CA 92025

October 1, 2014

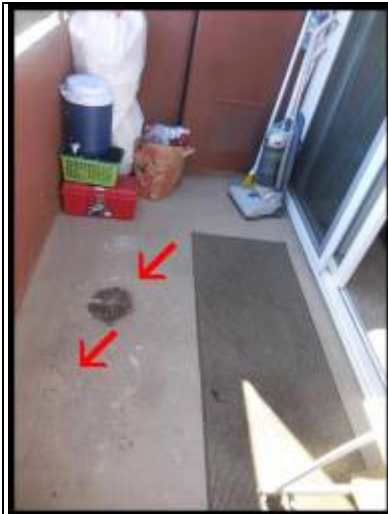
Small patio/deck with no cover. Cool deck floor finish needs repair and new finish coat to maintain waterproof conditions and existing stain removal.

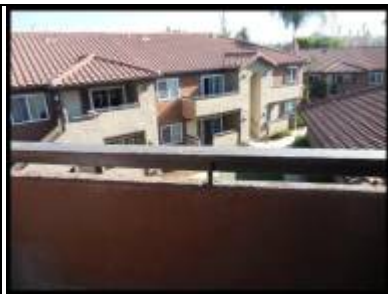
**2.11 Patio Enclosure Condition:**

The patio enclosure is functional. Plastered framed walls provide enclosure. **Top railing cap needs refinishing for wood preservation.**

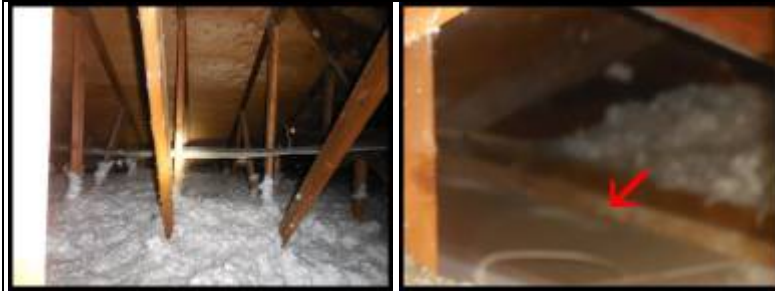
**4.21 Insulation Noted:** The attic insulation appears to be adequate and properly installed. The following type of insulation was noted in the attic: Cellulose. Blown in place.

Area over hall bathroom has no insulation. repairs are needed.

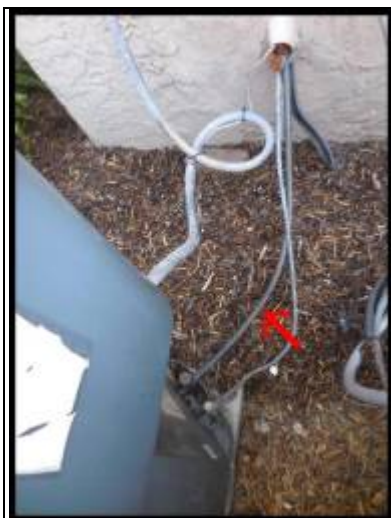
Attention Needed - The insulation wrap on the suction line to the condenser/compressor is in need of attention due to missing insulation.

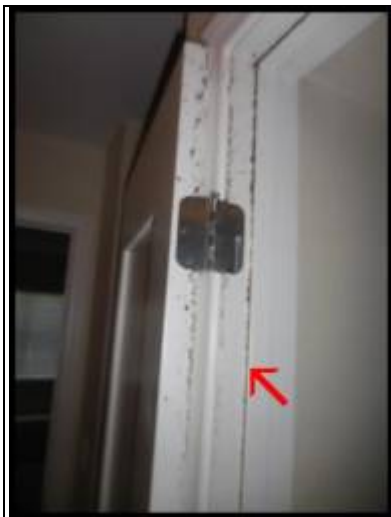
Availability of secondary air for combustion and flue draft appears to be inadequate. Services of a qualified licensed professional are required. Lack of a secondary air source is a serious condition, and immediate action is needed. This lack of secondary air can increase the creation of carbon monoxide and/or the spillage of flue gases into the living area of the house. Dust noted at perimeter of door indicates lack of combustion air. Have all air and venting systems serviced by licensed HVAC contractor.

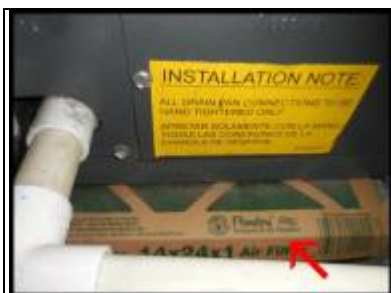
**7.25 Filter Type/Size:**

Disposable fiber filter with 30 to 45 day service life. Filter is stuck in bottom of furnace and needs proper size to be secured in place to operate correctly.

Replace all with Clean Air filters.

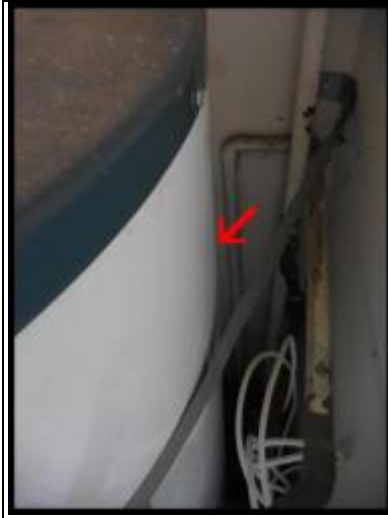
The water heater is gas-fired. Non Approved Earthquake Strapping is present. Straps need to surround tank and then be bolted to structure.

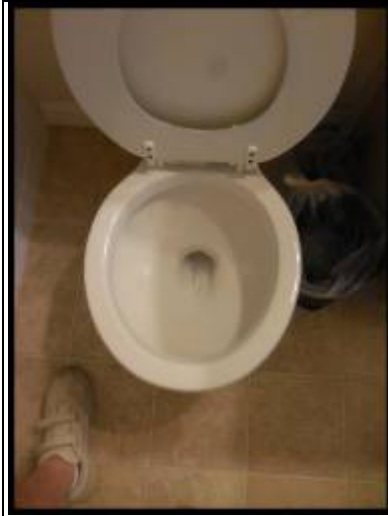
#### 11.4 Toilet Condition

The toilet in this bathroom needs repair. The toilet is not secure to the floor, allowing it to wobble and possibly leak. Action should be taken to re-secure it to the floor.

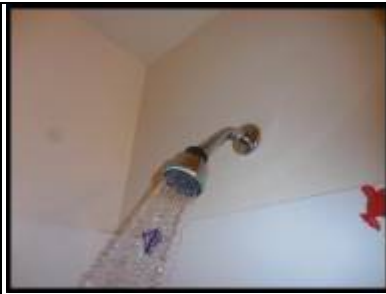
Diverted valve is frozen in shower position. Replacement is necessary.

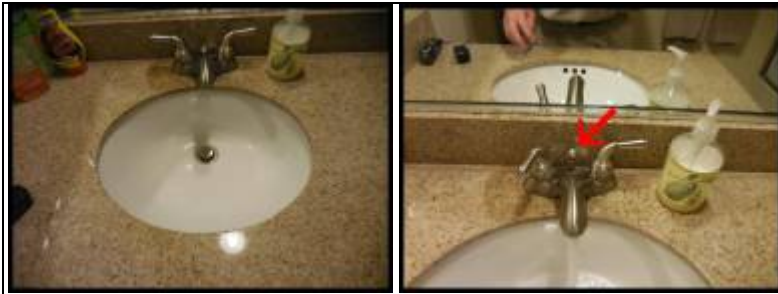
**11.22 Faucet and Basin Fixture:** The faucet and drainage fixture appear to be functional.  
**Sink stopper is not functional at time of inspection. Repairs are needed.**

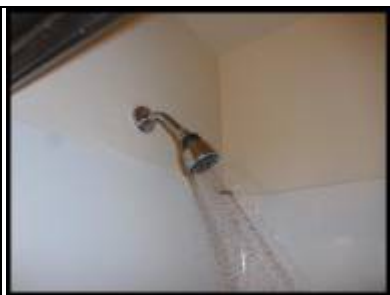
Diverter valve is frozen and replacement is needed.

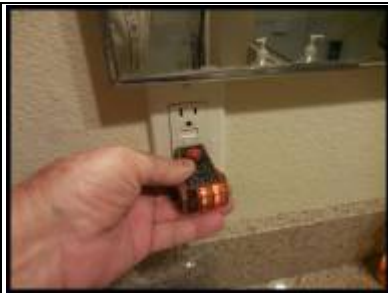
There is a functional Ground Fault Circuit Interrupt protected outlet installed in the area of the bathroom vanity. **There is intermittent contact with this receptacle and it needs to be replaced for proper performance.**

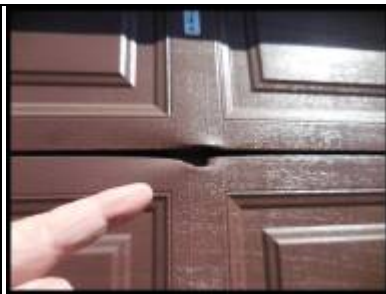
**14.4 Overhead Door and Hardware Condition:**

Damaged panels are noted at exterior of door.

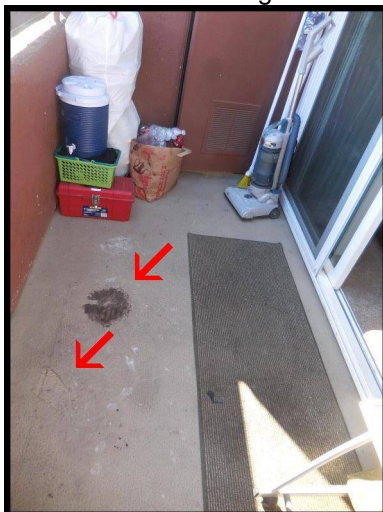
1. Small patio/deck with no cover. Cool deck floor finish needs repair and new finish coat to maintain waterproof conditions and existing stain removal.

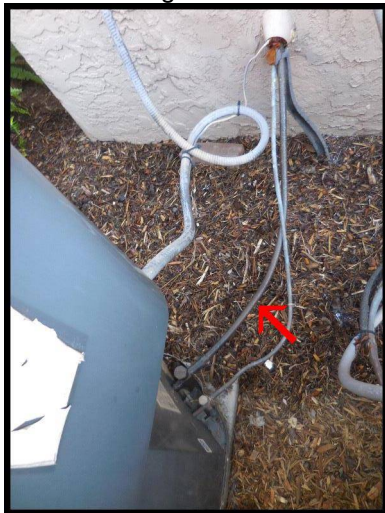
4. Attention Needed - The insulation wrap on the suction line to the condenser/compressor is in need of attention due to missing insulation.

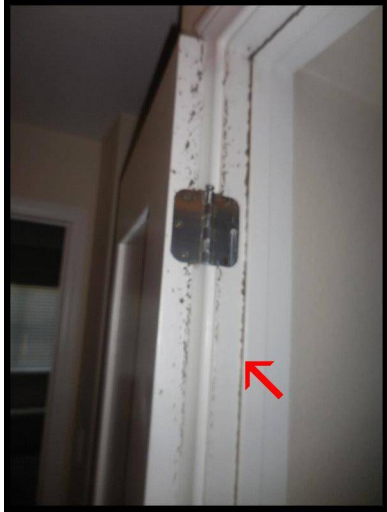
5. Availability of secondary air for combustion and flue draft appears to be inadequate. Services of a qualified licensed professional are required. Lack of a secondary air source is a serious condition, and immediate action is needed. This lack of secondary air can increase the creation of carbon monoxide and/or the spillage of flue gases into the living area of the house. Dust noted at perimeter of door indicates lack of combustion air. Have all air and venting systems serviced by licensed HVAC contractor.

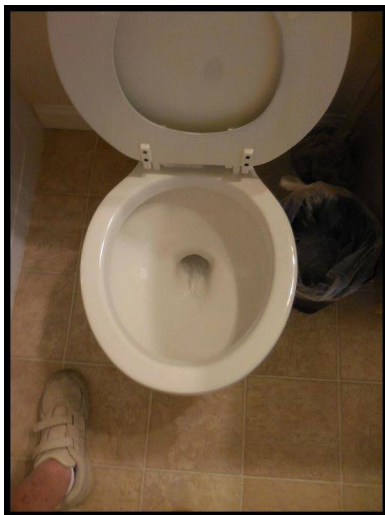
11. The toilet in this bathroom needs repair. The toilet is not secure to the floor, allowing it to wobble and possibly leak. Action should be taken to re-secure it to the floor.

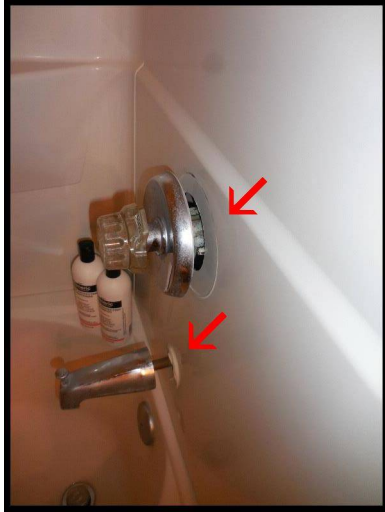
#### *11.6 Tub Mixing Valve*

12. Mixing valve assembly needs to be secured to framing behind tub wall. Services of a licensed plumbing contractor are required in both bath tub assemblies.
