Empire Home Inspection

Confidential Inspection Report

Alpine, CA 91901

August 25, 2014

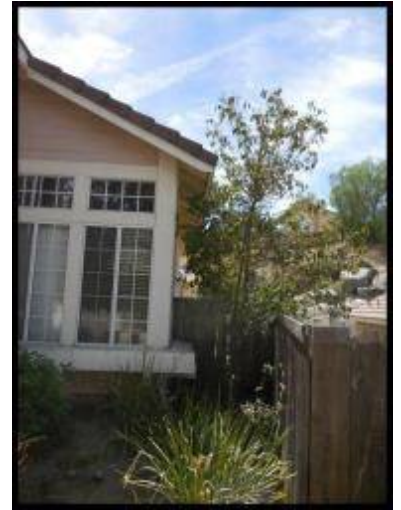
2.3 Bushes and Shrubs Condition:

Functional - The shrubs and/or bushes need maintenance and scheduled watering.

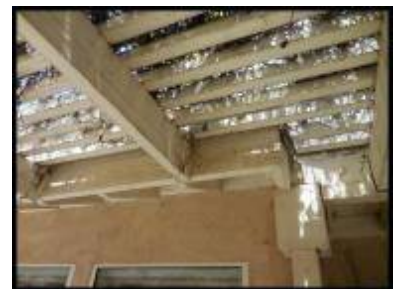
2.14 Patio Cover Condition:

The patio cover is functional. Pressure wash and repaint.

Patio cover and deck need to be cleared of growth. Post and beams are structurally acceptable.

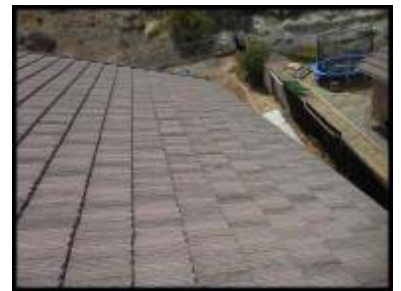
4.5 Condition of Roof Covering Material:

Broken roof tiles were observed and underlayment is deteriorated so that sheathing is exposed. Have licensed roofing contractor make necessary repairs to rotted starter board and sheathing before water intrudes into living area.

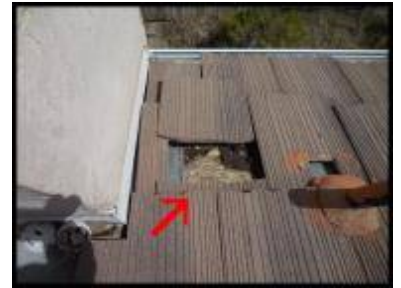
Broken roof tile was observed and repairs are needed.

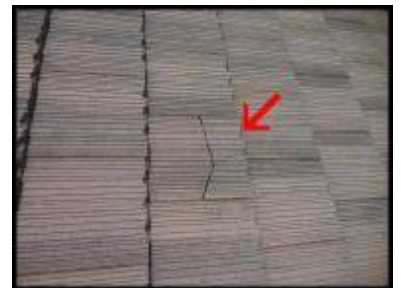
Sub-standard roof repair is seen and needs to be addressed.

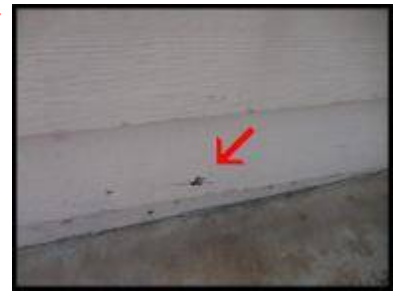
6.3 Siding Condition:

Lower pieces of the exterior siding is in a deteriorated condition that requires repair or replacement.

Have strip siding and trim checked for integrity and replaced as needed.

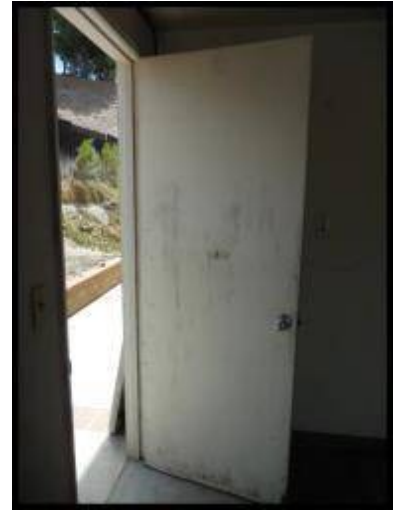
6.8 Outside Entry Doors:

Garage man door is aged and worn. Delamination has started and replacement is recommended.

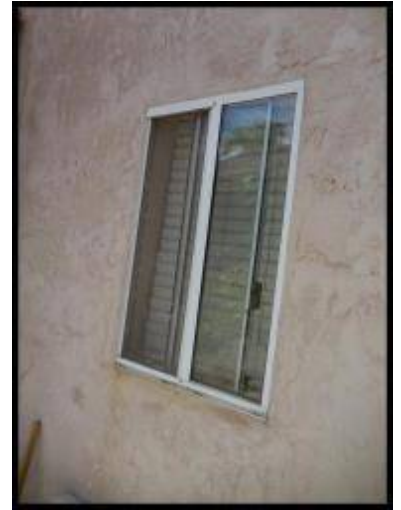
6.10 Window Condition:

Aluminum windows are aged and worn consistent with age of structure. Window screens are in need of re-screen at most locations windows and doors.

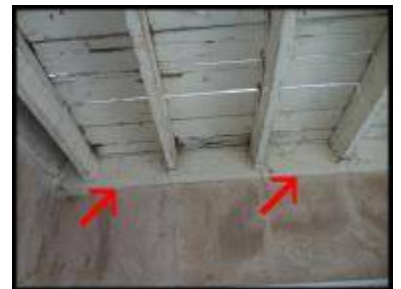
Douglas Fir. Lag bolting is recommended to attach ledger to structure.

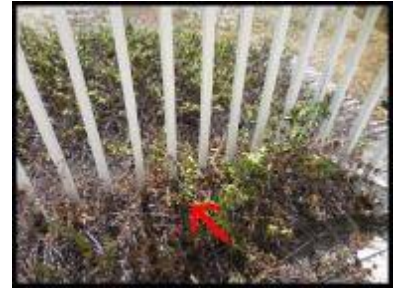
6.17 Condition of Wood Materials:

Attention Needed - The wood materials used in the deck need some repair or replacement. Have deck sheathing and railing checked for integrity and replace as needed.

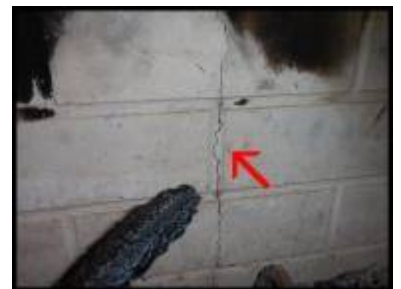
6.25 Firebox Condition:

Rear refractory panel has crack replacement is recommended.

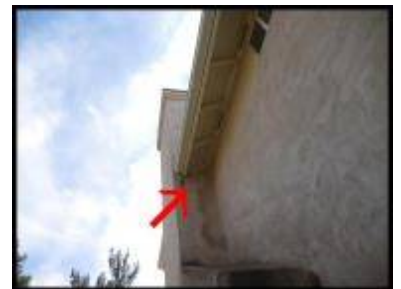
Have flashing checked at fireplace. Staining is noted under overhang.

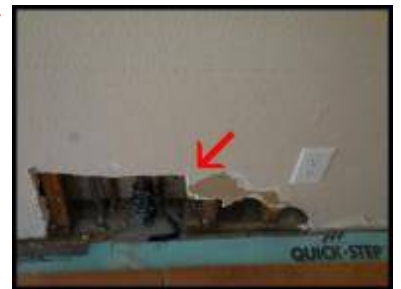
Plumbing repairs are seen at sink wall. No elevated moisture levels were recorded. Monitor concealed area under cabinets for signs of growth or smell. Drywall repairs are needed. Check disclosures for more information.

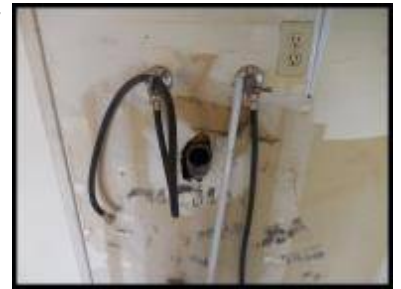
Yes, drain and supply lines are present. Drywall repair to fire wall is needed behind washer location.

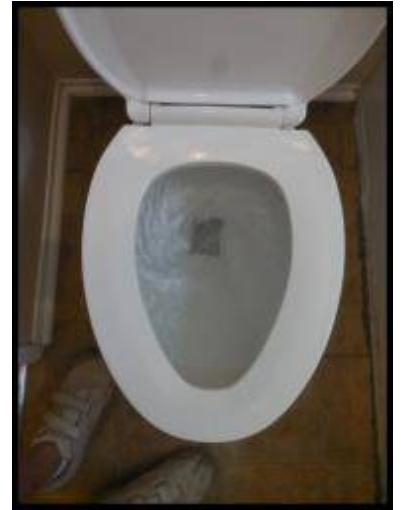
The toilet operates as designed no leaks were detected. The toilet is not secure to the floor, allowing it to wobble and possibly leak. Action should be taken to re-secure it to the floor.

20. The toilet is not secure to the floor, allowing it to wobble and possibly leak. Action should be taken to re-secure it to the floor.

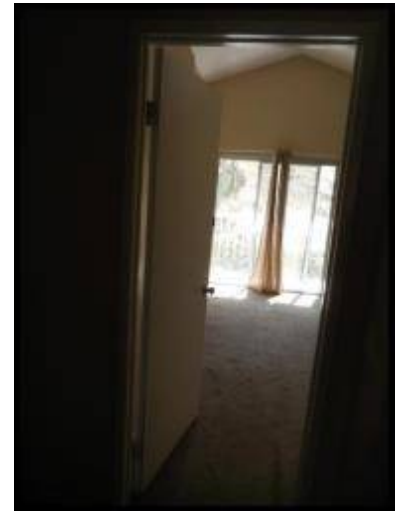
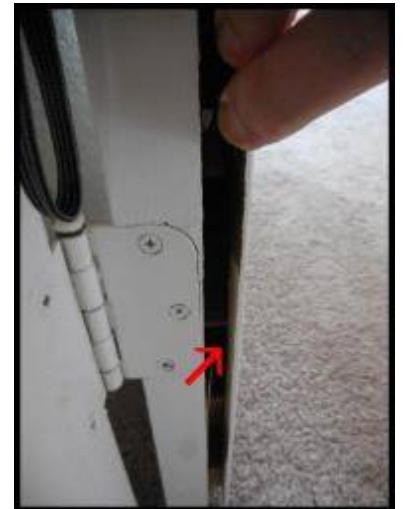
Skin has separated.

Because of impaction on inside of door.

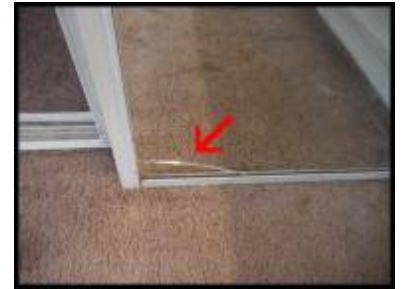
Door is broken and track needs to be replaced.

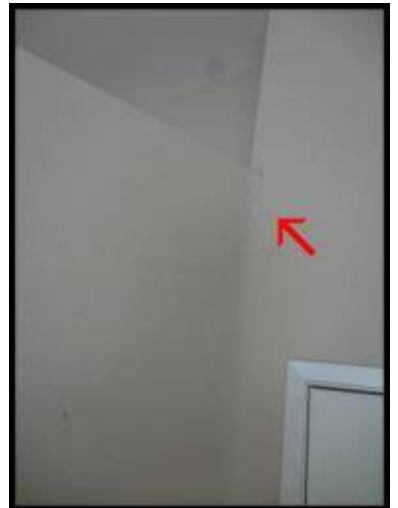
Cracks are noted at bedroom door wall and ceiling. Issues are non structural, drywall repairs are needed.
