Empire Home Inspection

Report: [Sample]

Confidential Inspection Report

Poway, CA 92064

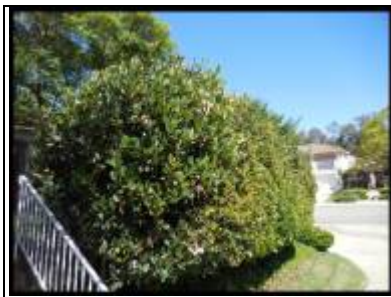
2.3 Bushes and Shrubs Condition:

Attention Needed - The shrubs and/or bushes need to be trimmed or maintained. Over grown condition provides privacy.

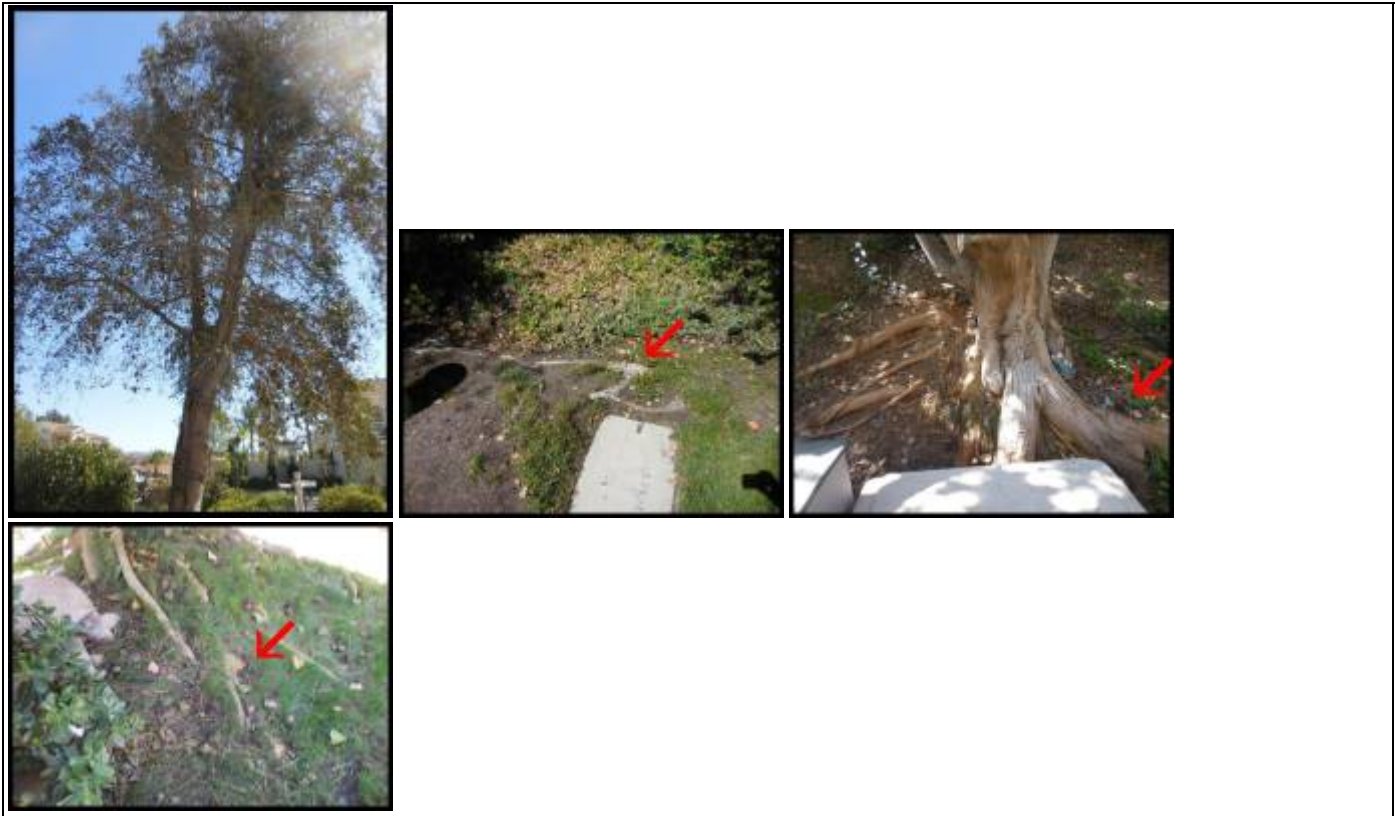
2.4 Trees Condition:

Mature Landscape is noted with aggressive root systems that may damage flatwork and structure.

Roots can cause expensive damage. Have tree specialist advise as to root pruning or tree removal.

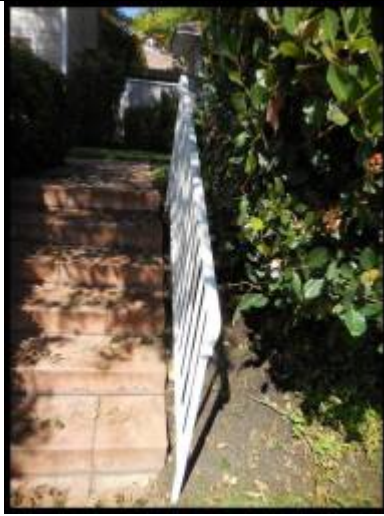
2.7 Walkways and Stoop Materials: Stair railing is loose and wobbly. Repairs are needed.

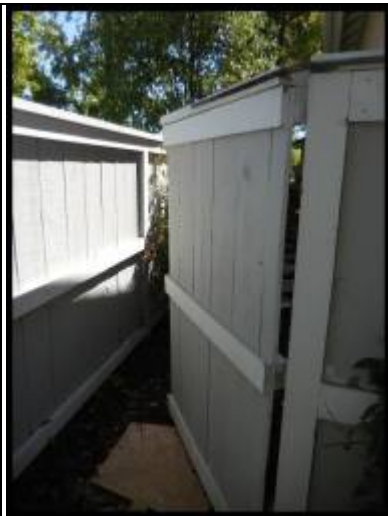
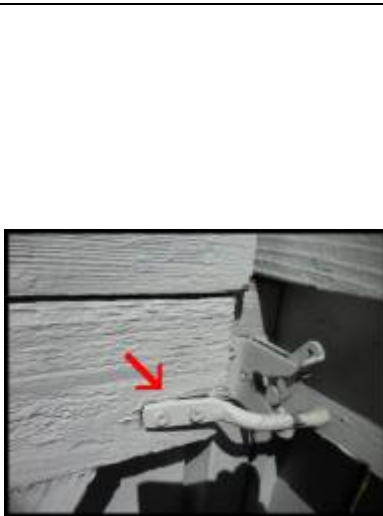
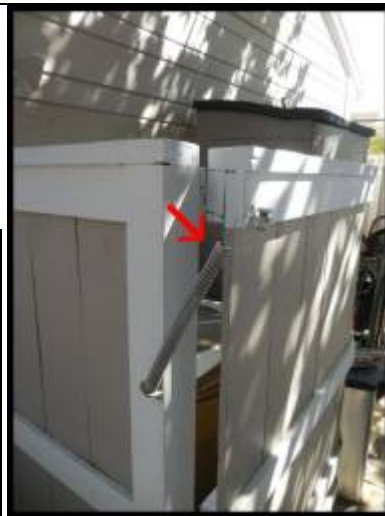
The gate or latch hardware needs repair to function as intended.

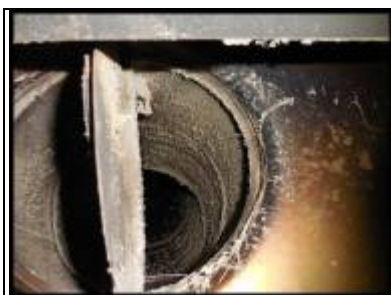
There is a damper clip installed.

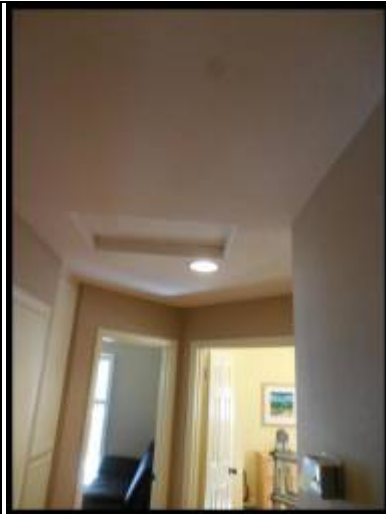
13.9 Upper Level Smoke Detector:

Recommend hardwired combination CO/ smoke detection monitors be installed in hallway.

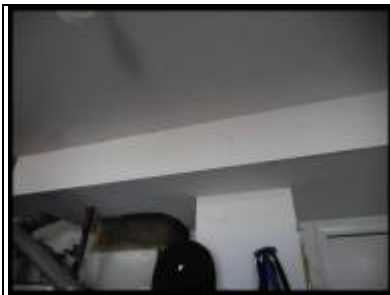
Cat door through fire wall is violation of separation garage and living area. Repairs are needed.

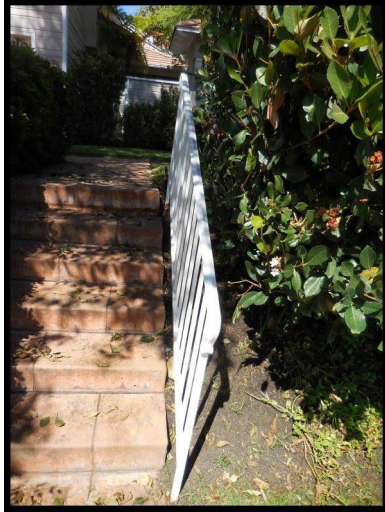
2. Stair railing is loose and wobbly. Repairs are needed.

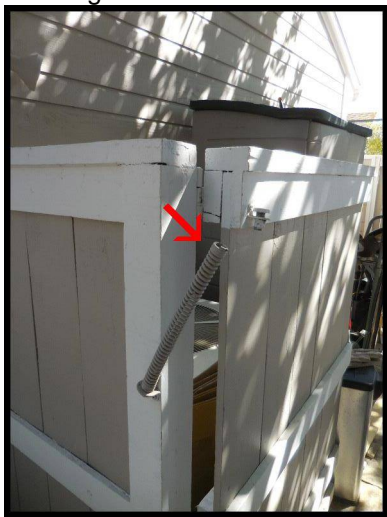
9. The gate or latch hardware needs repair to function as intended.

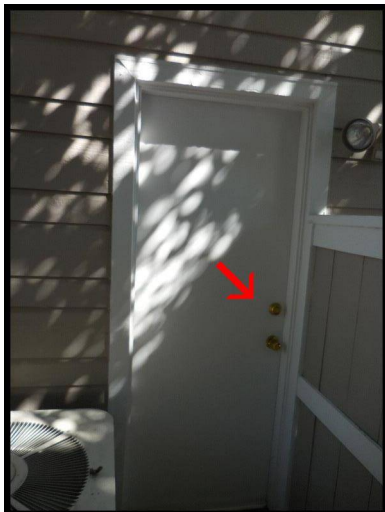
18. Exterior doors should have thumb latch unlock on inside of door for emergency egress.
