# Empire Home Inspection

## Confidential Inspection Report

Escondido, CA 92025

October 1, 2014

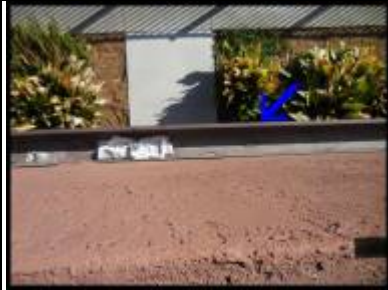
**2.11 Patio Enclosure Condition:**

The patio enclosure is functional. Plastered framed walls provide enclosure. **Top railing cap needs refinishing for wood preservation.**

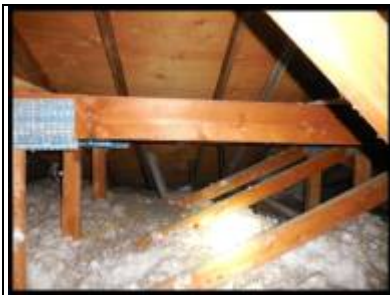
**4.21 Insulation Noted:** The attic insulation appears to be adequate and properly installed. The following type of insulation was noted in the attic: Cellulose. Blown in place.

Area over hall bathroom has no insulation. repairs are needed.

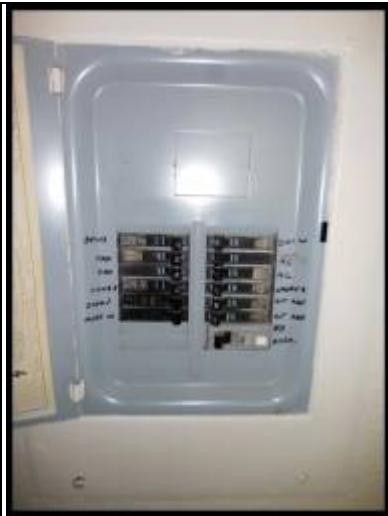
**5.8 Disconnect:**

No main disconnect on sub panel.

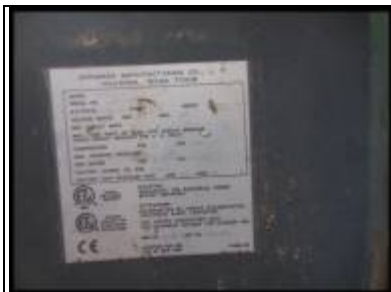
### 7.1 Model/ Serial Number/ Size:

System is Goodman Manufacturing brand. Serial number is 050819335. MFG date August 2005.

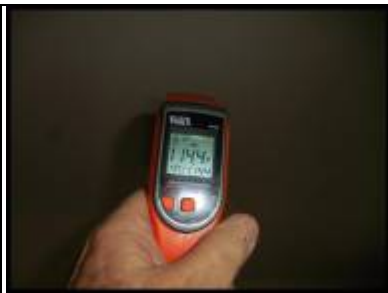
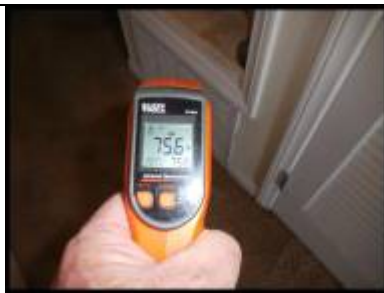
**7.21 Furnace Temperature Output:**

39 F temperature rise. Good heating.

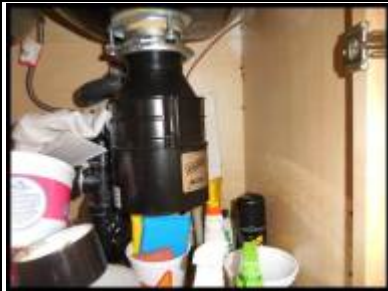
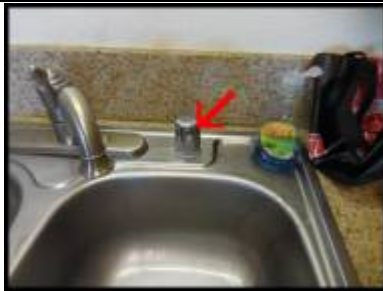
Air Gap is present but is obstructed between air gap and disposal discharge is seen, repairs are needed.

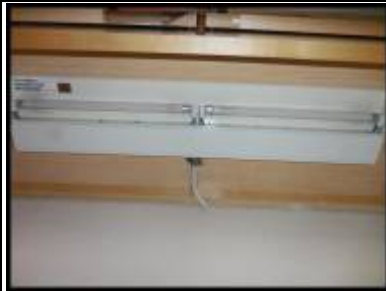
Kitchen Light fixtures were operable. **Down light over sink needs cover.**

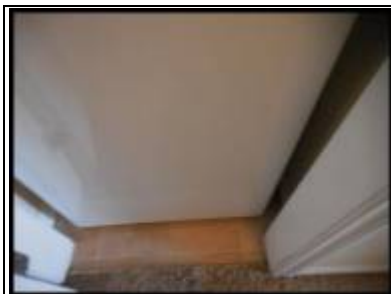
**10.5 Floor:** The floor coverings are functional. The floor covering material is vinyl.

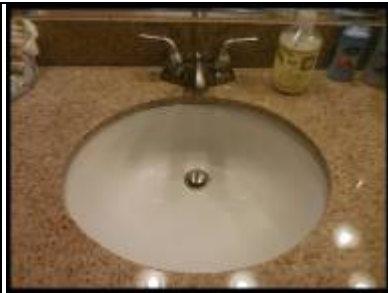
#### 11.2 Faucet and Basin Fixture:

The faucet and drainage fixture appear to be functional.

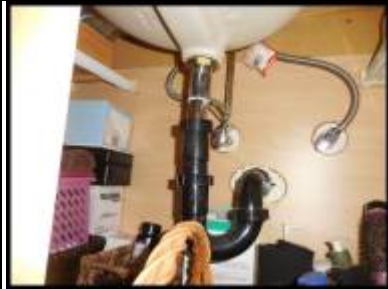
#### 11.3 Supply and Drain Lines:

Faucets and supply lines are functional. No leaks were detected. There are shutoffs installed for both hot and cold water pipes under the basin.

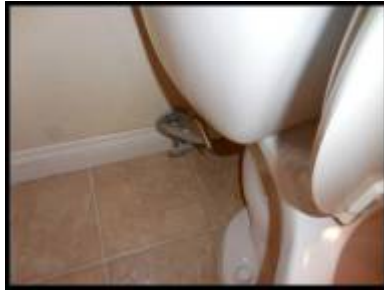
#### 11.4 Toilet Condition

The toilet in this bathroom needs repair. The toilet is not secure to the floor, allowing it to wobble and possibly leak. Action should be taken to re-secure it to the floor.

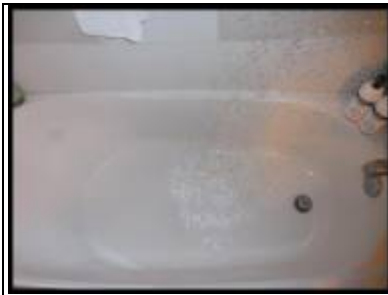
#### 11.5 Tub:

-FG Tub/Shower Combo-OK The bathtub is a fiberglass reinforced plastic material, and it appears to be in functional condition.

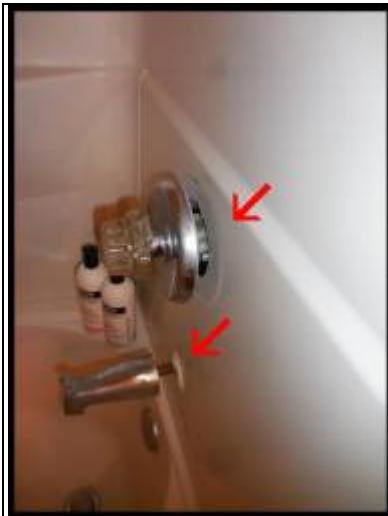
#### 11.6 Tub Mixing Valve

Mixing valve assembly needs to be secured to framing behind tub wall. Services of a licensed plumbing contractor are required in both bath tub assemblies.

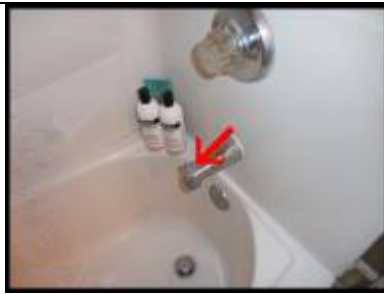
#### 11.7 Shower/Shower Head and Mixing Valves:

Functional - The shower, shower head, and mixing valves are all performing as required.

Diverted valve is frozen in shower position. Replacement is necessary.

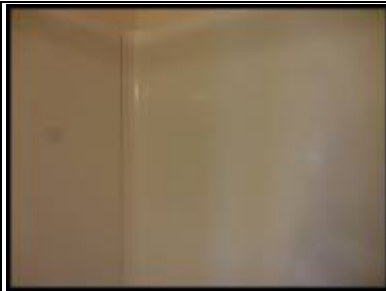
**11.8 Tub & Shower Walls:**

The walls appear to be in functional condition.

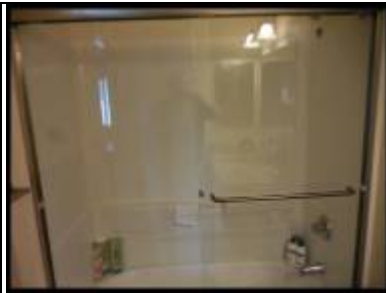
**11.10 Glass Tub/Shower Door:**

Shower Yes - The shower stall has a glass door installed. The glass appears to be safety glass.

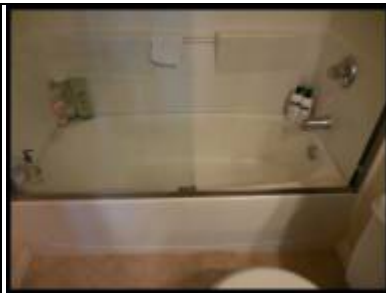
**11.11 Caulking/Water Contact Areas:** The caulking in the water contact areas appears to be functional.

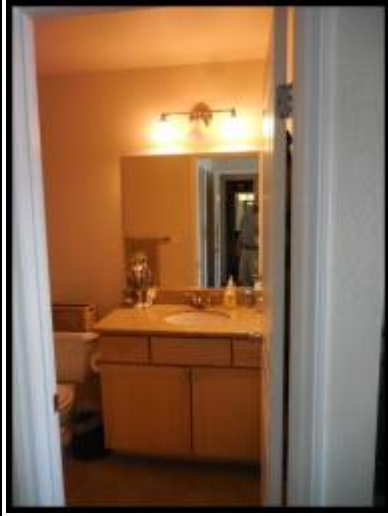
**11.12 Entry Door:**

The entry door to the bathroom is functional.

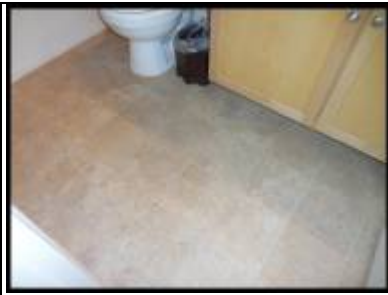
**11.16 Floor:**

The flooring in this bathroom is functional. The floor covering material is vinyl.

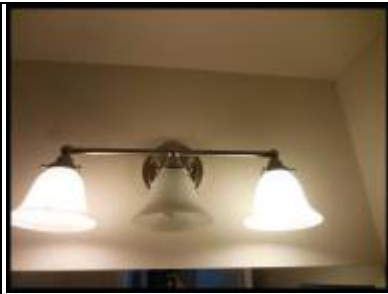
**11.17 Lighting:**

Vanity Light OK - The lighting around the vanity mirror is functional. Bulb needs replacement.

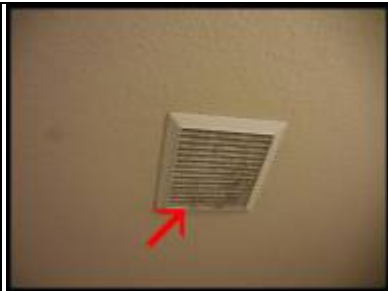
**11.18 Ventilation Fans:**

There is an exhaust fan installed in this bathroom, and it is functional. **Cleaning is needed for proper operation.**

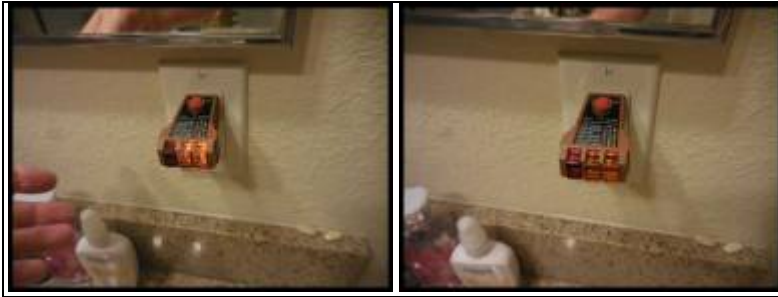
**11.19 Ground Fault Interrupt Outlets:** There is a functional Ground Fault Circuit Interrupt protected outlet installed in the area of the bathroom vanity.

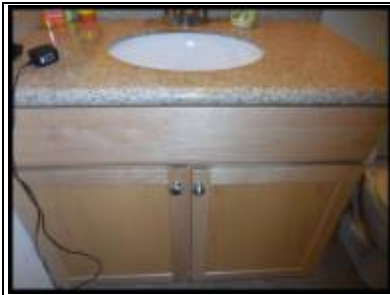
**11.21 Vanity Cabinet:** The vanity cabinet and top in this bathroom are functional.

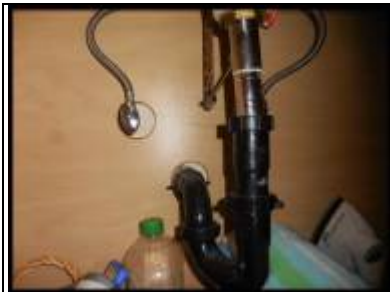
**11.23 Supply and Drain Lines:** Faucets and supply lines are functional. No leaks were detected. There are shutoffs installed for both hot and cold water pipes under the basin.

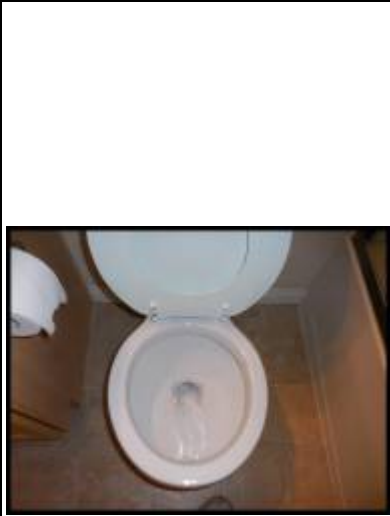
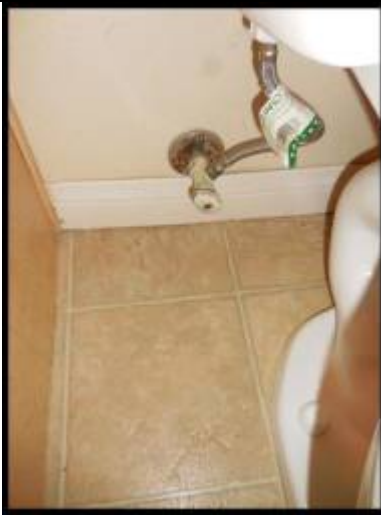
**11.24 Toilet Condition** The toilet operates as designed no leaks were detected.

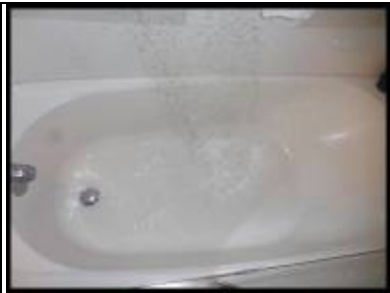
**11.25 Tub:**

-FG Tub/Shower Combo-OK The bathtub is a fiberglass reinforced plastic material, and it appears to be in functional condition.

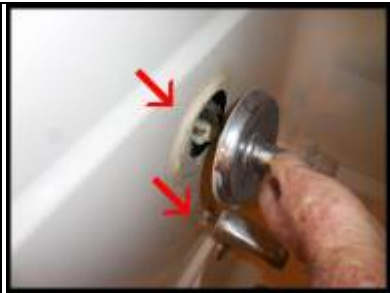
**11.26 Tub Mixing Valve**

Securing the mixing valve assembly is needed.

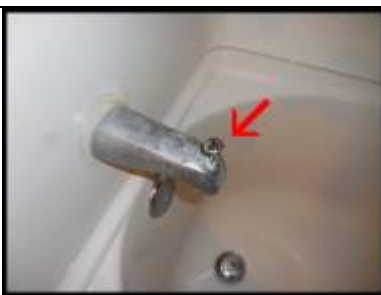
**11.27 Shower/Shower Head and Mixing Valves:**

Functional - The shower, shower head, and mixing valves are all performing as required.

Diverter valve is frozen and replacement is needed.

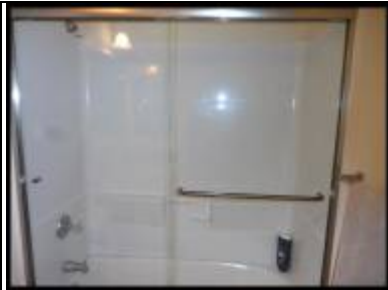
**11.30 Glass Tub/Shower Door:**

Tub Yes - The bathtub has sliding glass doors installed. The glass appears to be safety glass.

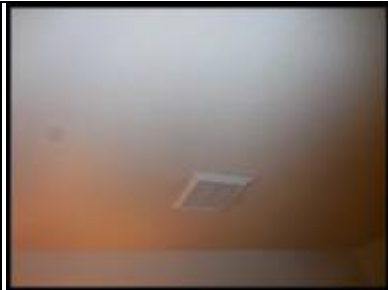
**11.34 Ceiling:**

The ceiling in this bathroom is functional.

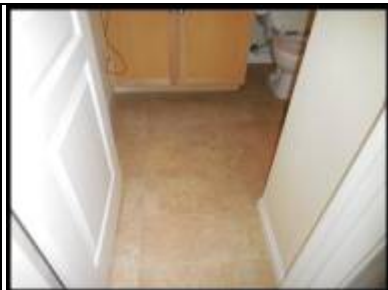
**11.35 Floor:**

The flooring in this bathroom is functional. The floor covering material is vinyl.

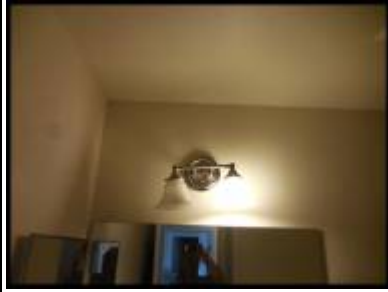
**11.36 Lighting:**

Vanity Light OK - The lighting around the vanity mirror is functional. Bulb is needed.

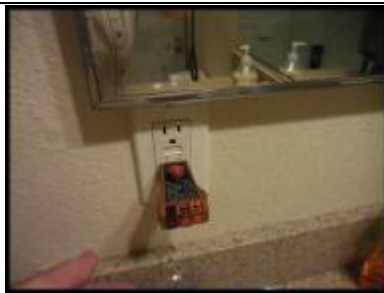
**11.38 Ground Fault Interrupt Outlets:**

There is a functional Ground Fault Circuit Interrupt protected outlet installed in the area of the bathroom vanity. **There is intermittent contact with this receptacle and it needs to be replaced for proper performance.**

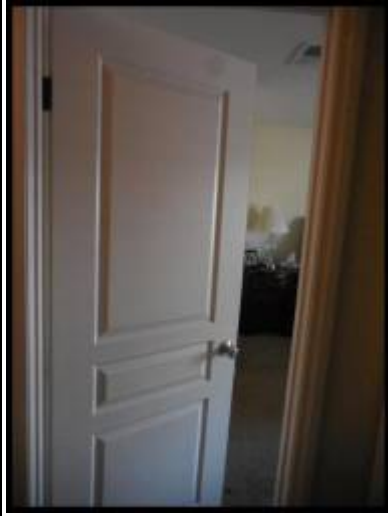
**12.1 Entry Door:**

The entry door to this room is functional.

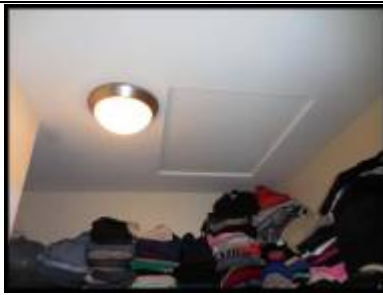
#### 12.2 Closet:

The closet is functional and of average size.  
The closet is lighted.

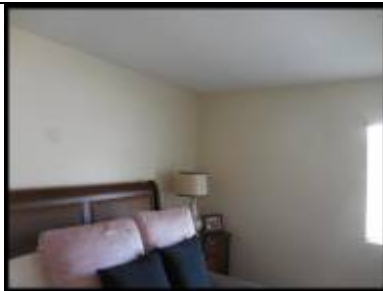
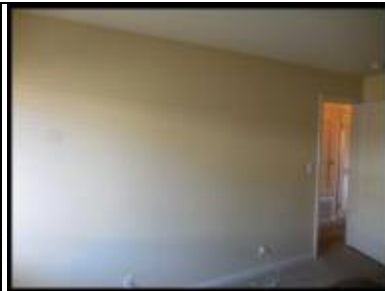
#### 12.3 Walls:

The walls in the room appear to be functional.  
Uniform insulation noted in exterior walls.

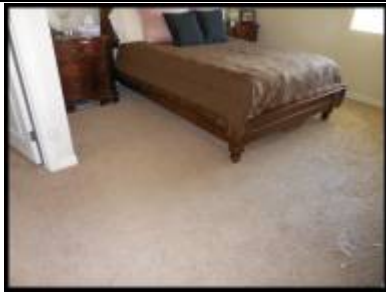
**12.6 Floor:**

The floors are in functional condition. The floor covering material is carpet.

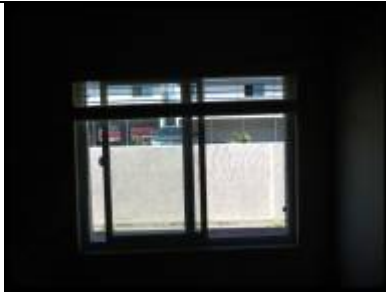
**12.7 Windows:**

The windows and associated hardware in this room are all functional.

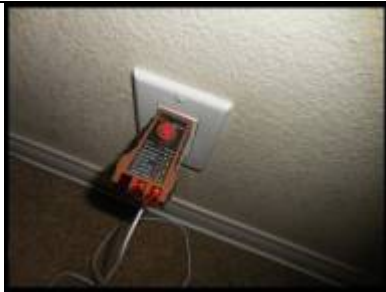
**12.8 Electrical Outlets:**

Functional - The outlets tested in this room are correctly wired and grounded.

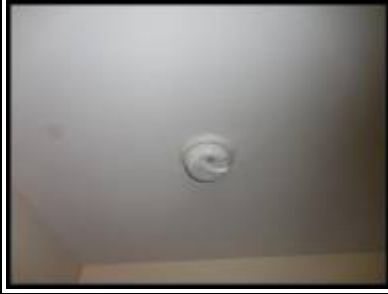
**12.10 Smoke Detector:**

There is a smoke detector installed in the room. It is undetermined if the unit is hardwired or is battery operated.

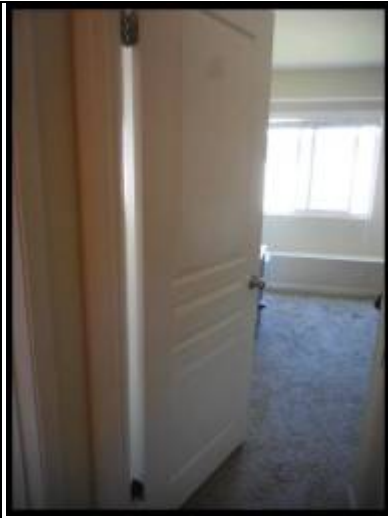
### 12.11 Entry Door:

The entry door to this room is functional.

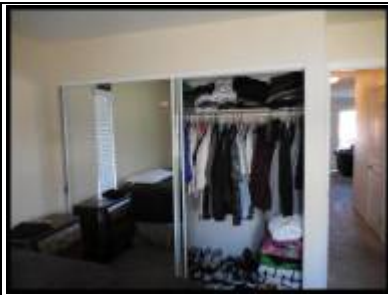
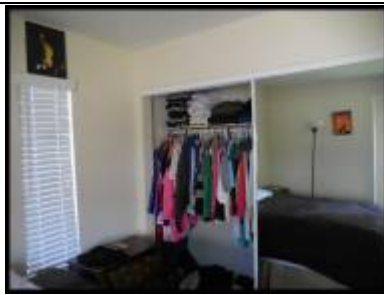
Doors are functional, Due to stored items in the closet, it is not possible to determine the condition of the walls and ceiling that are not visible.

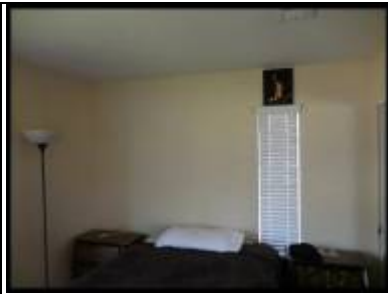
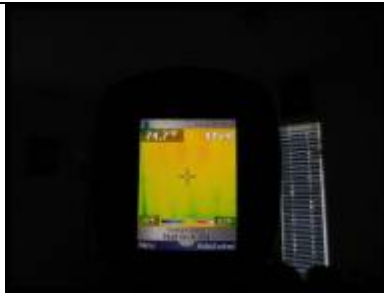
### 12.13 Walls:

The walls in the room appear to be functional.

Consistent insulation noted in exterior walls.

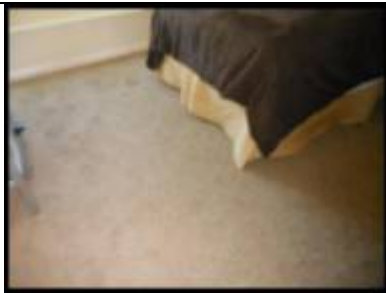
**12.16 Floor:**

The floors are in functional condition. The floor covering material is carpet.

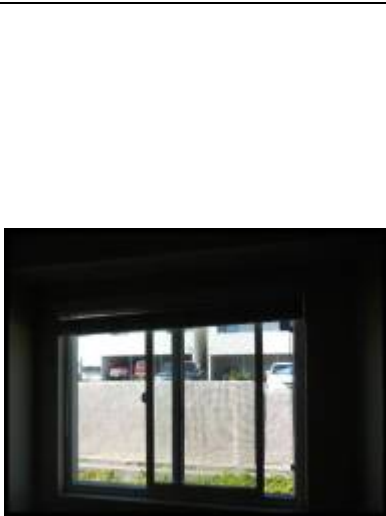
**12.17 Windows:**

The windows and associated hardware in this room are all functional.

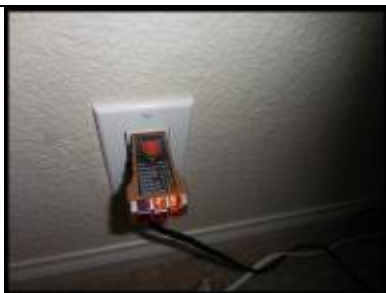
**12.18 Electrical Outlets:**

Functional - The outlets tested in this room are correctly wired and grounded.

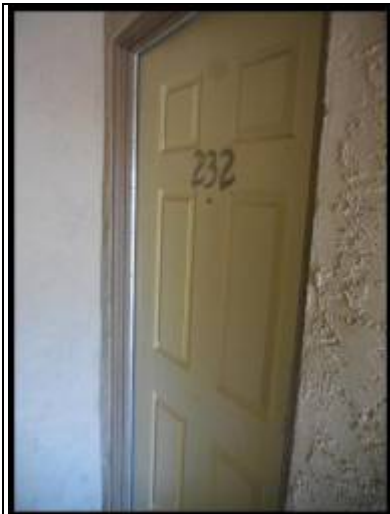
**13.2 Front Entry Door:**

The main entry door to the structure is in functional condition.

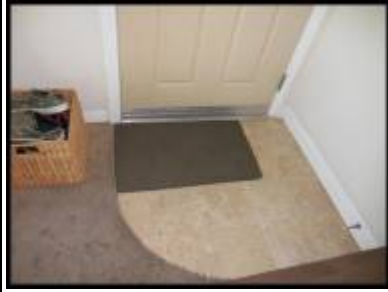
**13.3 Entry Floor:**

The entry floor material appearance is good and material is functional. The floor covering material is vinyl.

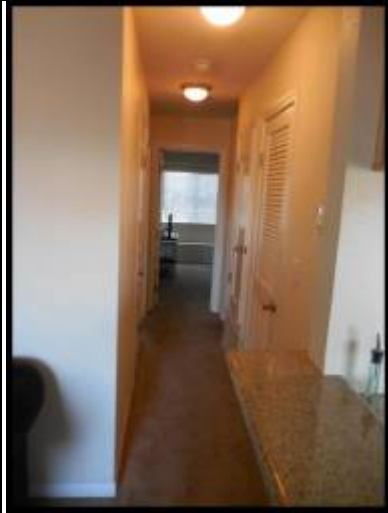
**13.4 Main Hallway:**

The main hallway walls and floor are without significant issues.

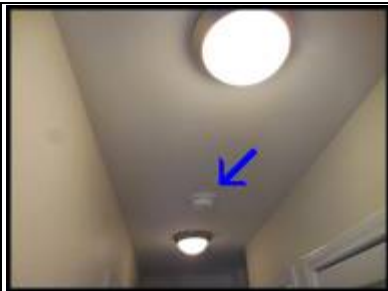
**13.5 Smoke Detector:**

There is a functional smoke detector installed in the hallway. It was undetermined if the unit is hardwired or battery operated. Smoke detectors have a product life cycle of about 6 to 7 years. It is highly recommended that these devices be tested on a regular basis and replaced when necessary to provide the highest safety protection.

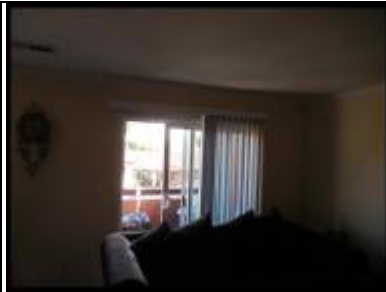
### 13.7 Entry Door:

Glass Doors and hardware in this room are operable and in good condition.

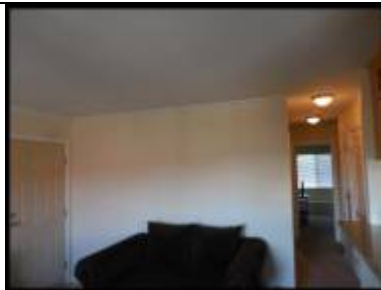
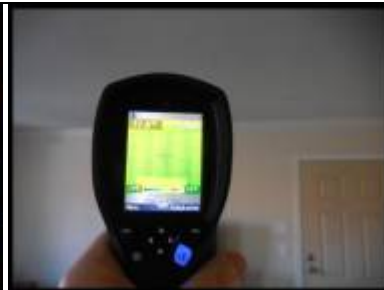
### 13.8 Walls:

The walls in the room appear to be functional.  
Uniform insulation noted in exterior walls.

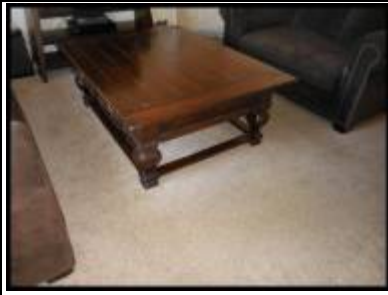
**13.11 Floor:**

The floors are in functional condition. The floor covering material is carpet.

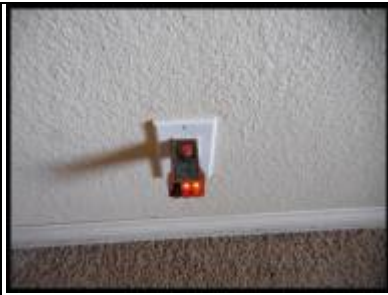
**13.12 Electrical Outlets:**

Functional - The outlets tested in this room are correctly wired and grounded.

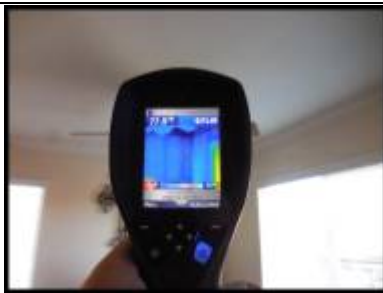
**13.14 Walls:**

The walls in the room appear to be functional.  
Uniform insulation noted in exterior walls.

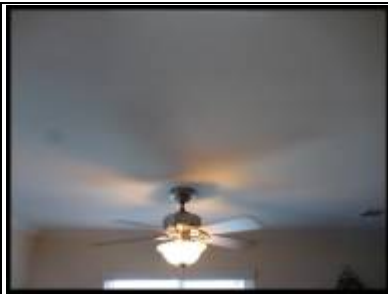
**13.15 Ceiling:**

The ceiling is functional.

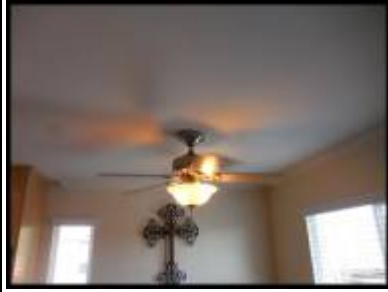
**13.17 Light Fixture**

There is a ceiling fan installed in this room. It appears to be functional.

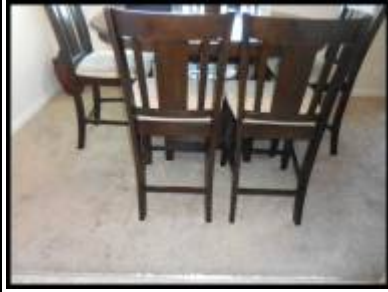
**13.18 Floor:**

The floors are in functional condition. The floor covering material is carpet.

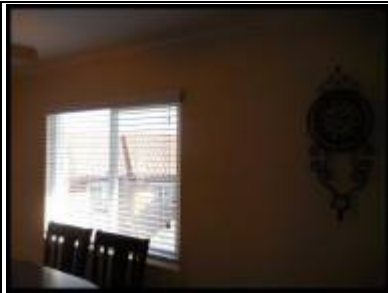
**13.19 Windows:**

The windows and associated hardware in this room are all functional.

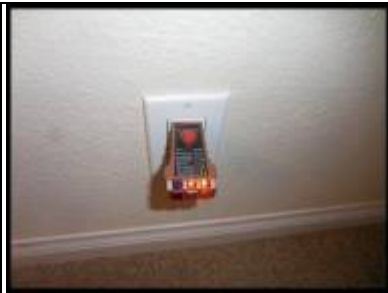
**13.20 Electrical Outlets:**

Functional - The outlets tested in this room are correctly wired and grounded.

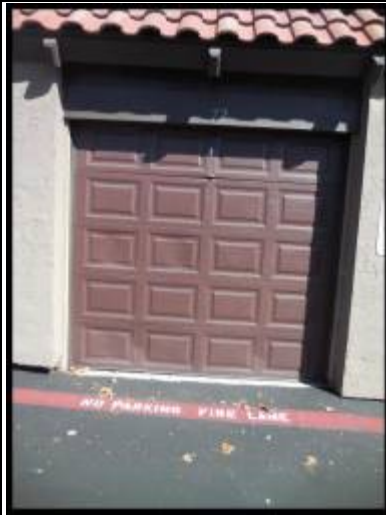
**14.3 Number of Overhead Doors**

There is a single overhead door.

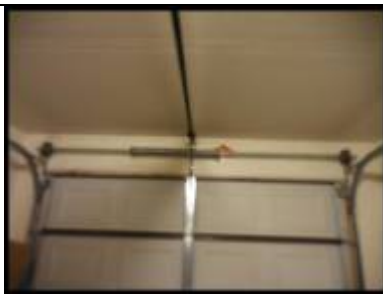
**14.4 Overhead Door and Hardware Condition:**

Damaged panels are noted at exterior of door.

The overhead door track and spring assembly are in satisfactory condition, and it is functional.

20. Damaged panels are noted at exterior of door.

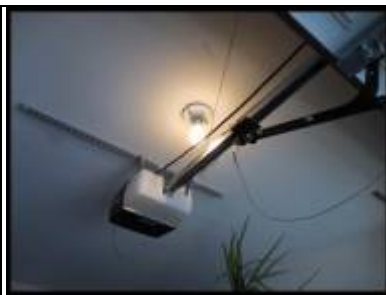
**14.5 Automatic Overhead Door Opener:**

The overhead door opener appears to function appropriately.

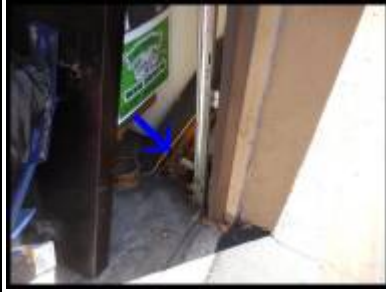
**14.6 Safety Reverse Switch on the Automatic Opener:**

Yes - The door opener is equipped with an automatic pressure reverse safety switch. The safety reverse switch worked when it met resistance. There is an electronic beam safety reverse system installed. It appears to be functional.

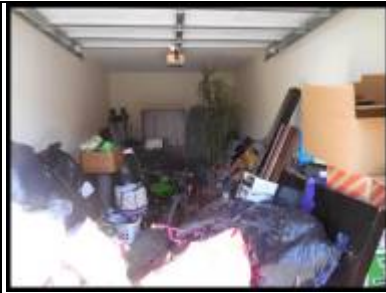
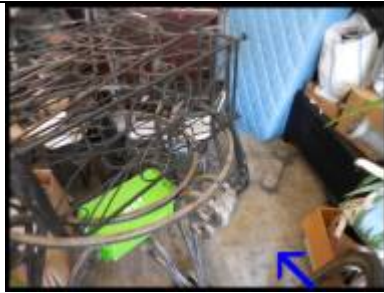
#### 14.7 Floor Condition:

Due to stored items on the garage floor, I was unable to determine the condition of the portions of the floor that are not visible.

The garage floor is functional and has a satisfactory appearance.

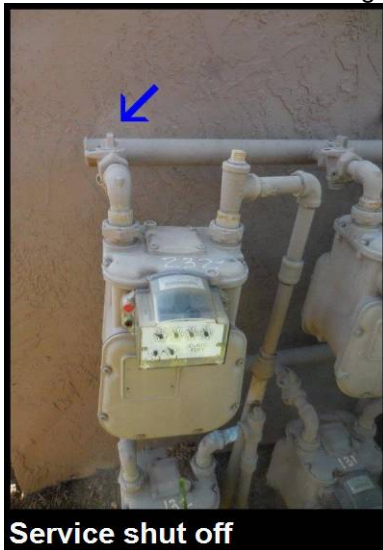
##### *2.19 Location of Meter:*

1. Meter bank at end of building.

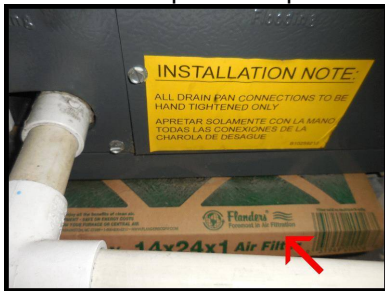
#### 7.25 Filter Type/Size:

6. Disposable fiber filter with 30 to 45 day service life. Filter is stuck in bottom of furnace and needs proper size to be secured in place to operate correctly.

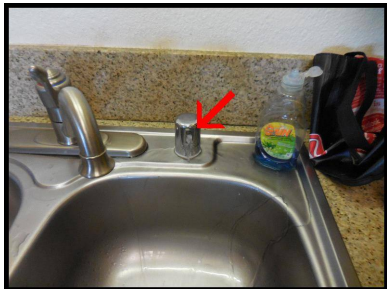
#### 8.4 Food Waste Disposal:

7. Air Gap is present but is obstructed between air gap and disposal discharge is seen, repairs are needed.

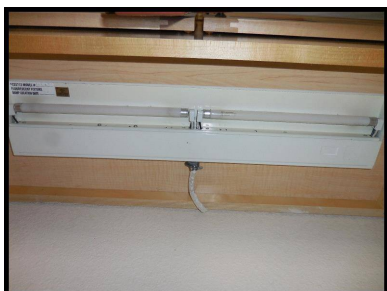
#### 8.16 Ceiling Fans:

8. Down light over sink needs cover.

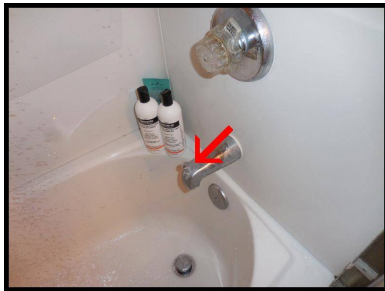
*11.7 Shower/Shower Head and Mixing Valves:*

13. Diverted valve is frozen in shower position. Replacement is necessary.

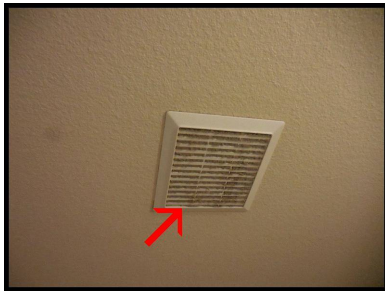
*11.18 Ventilation Fans:*

14. Cleaning is needed for proper operation.

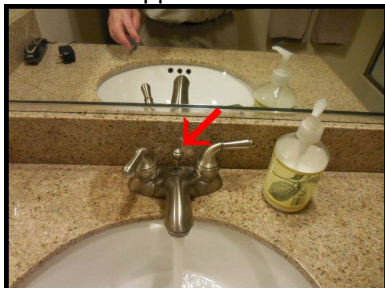
*11.22 Faucet and Basin Fixture:*

15. Sink stopper is not functional at time of inspection. Repairs are needed.

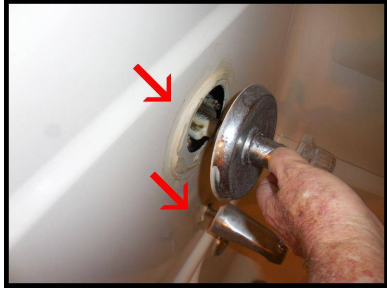
*11.26 Tub Mixing Valve*

16. Securing the mixing valve assemble is needed.

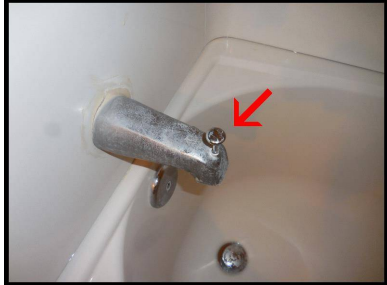
*11.27 Shower/Shower Head and Mixing Valves:*

17. Diverter valve is frozen and replacement is needed.

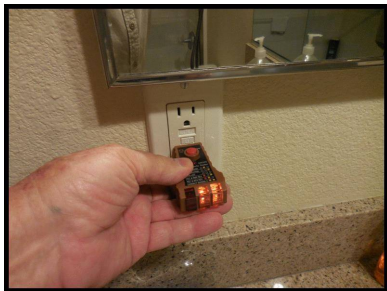
*11.38 Ground Fault Interrupt Outlets:*

19. There is intermittent contact with this receptacle and it needs to be replaced for proper performance.
