Empire Home Inspection

Confidential Inspection Report

Alpine, CA 91901

August 25, 2014

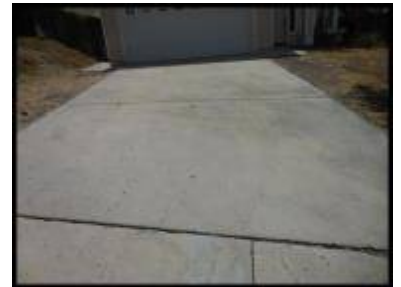
2.6 Driveway Condition:

The driveway surface material is in functional condition with only normal deterioration noted. Stress relief cracks noted.

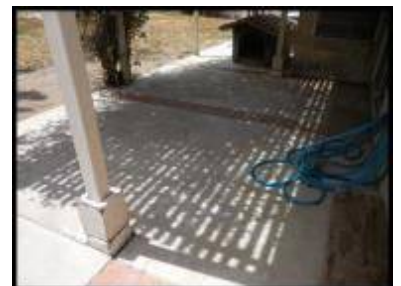
2.11 Slab Condition:

Stress relief cracking is noted.

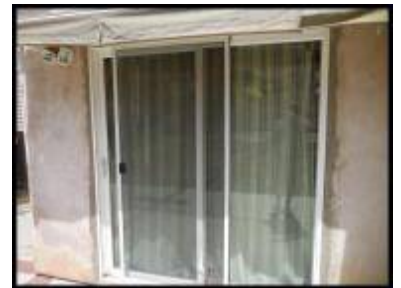
2.14 Patio Cover Condition:

The patio cover is functional. Pressure wash and repaint.

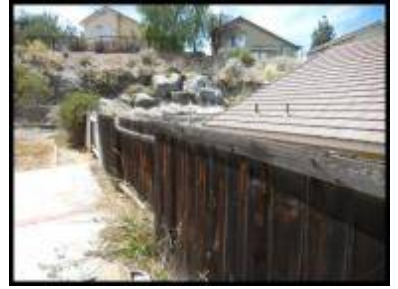
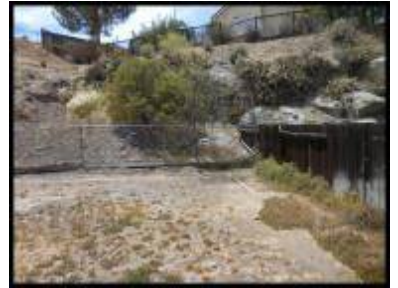
2.16 Fence Materials Condition:

Wood fencing is aged and worn. Repairs will need to be made often.

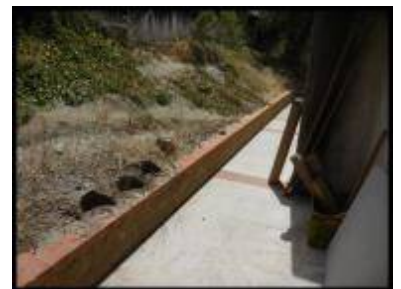
**2.21 Water Drainage:**

Attention Needed - bank needs to be planted to keep dirt from washing over wall.

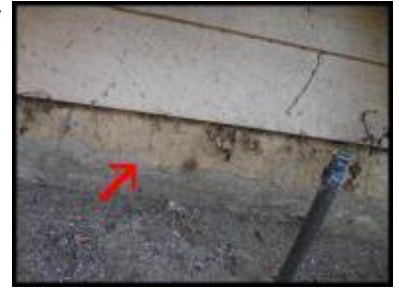
3.4 Visible Foundation Wall Cracks at Exterior:

No visible cracking in the vertical foundation walls was noted during the exterior examination. Plaster brush coat is worn by irrigation. Irrigation over spray should be controlled not wetting structure.

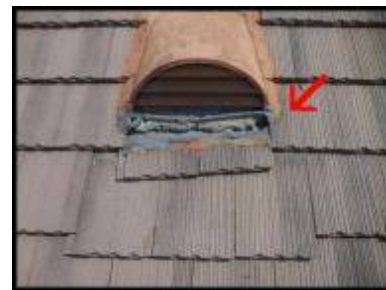
Sub-standard roof repair is seen and needs to be addressed.

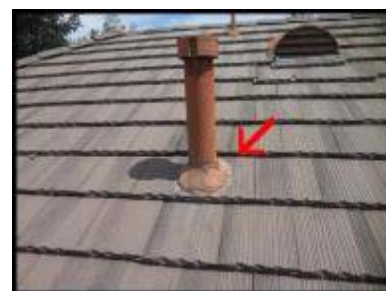
4.8 Flashing:

Flashings are mudded in and jacks are not visible. Storm collars are installed on vent pipes.

Regular maintenance of roof jacks, flashings and slipping tiles annually will prevent water infiltration problems.

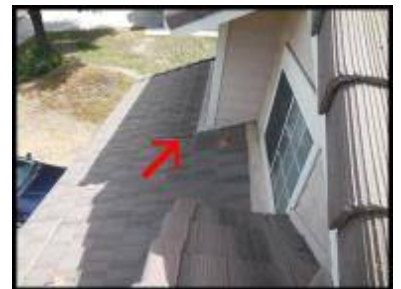
4.14 Garage Roof

Tile slip needs to be addressed at roof to wall location.

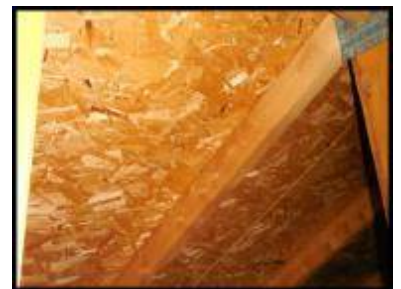
4.22 Roof Decking:

The roof decking material is oriented strand board sheeting.

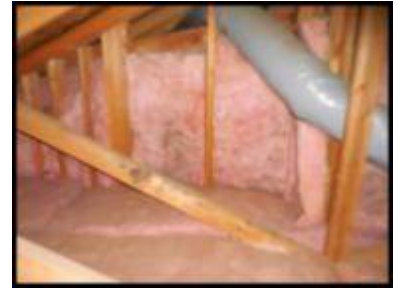
4.25 Vapor Barrier Installed:

There was no vapor barrier noted in the attic cavity.

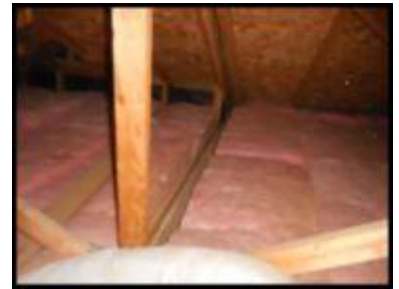
4.26 Insulation Clear of Sheathing:

There is at least 1 1/2 inches of clearance between the roof sheathing and the insulation.

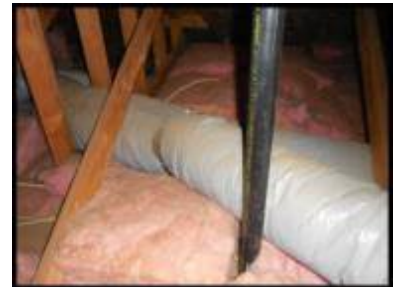
4.27 Insulation Noted:

The attic insulation appears to be adequate and properly installed.

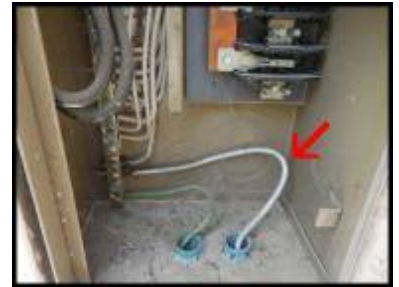
5.2 Main Service Ground Verified:

Yes - The main service ground wire was located by the inspector. UFER and copper pipe grounding.

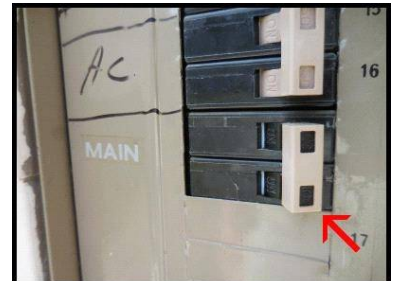
Service shut off

Bottom of panel.

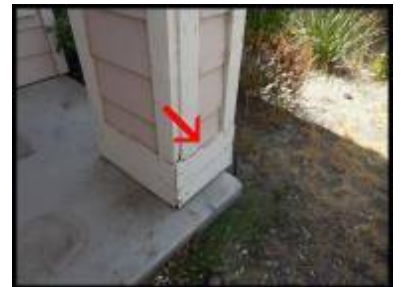
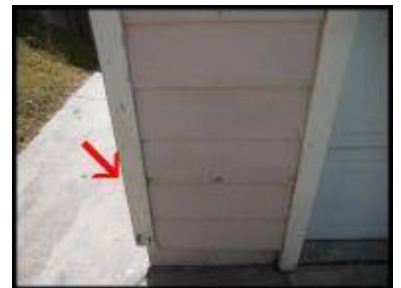
6.3 Siding Condition:

Lower pieces of the exterior siding is in a deteriorated condition that requires repair or replacement.

Have strip siding and trim checked for integrity and replaced as needed.

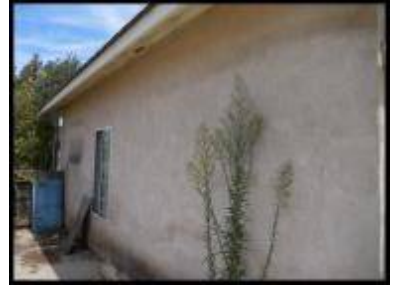
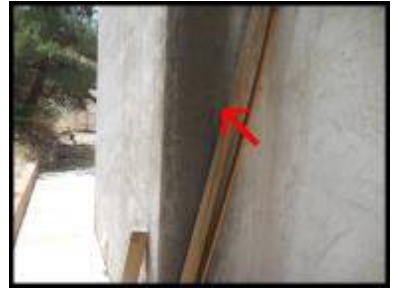
The stucco is in serviceable condition. Staining of finish coat can be restored to original color with fog coat from original manufacture Expo Stucco.

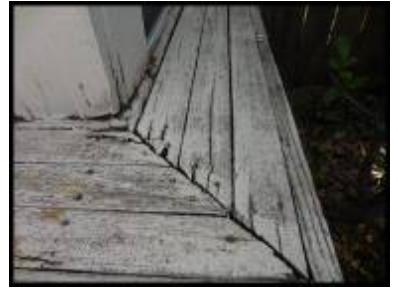
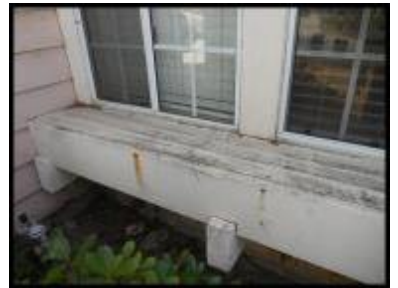
6.4 Trim Condition:

Pot shelf is deteriorated to the point that it needs repair or replacement.

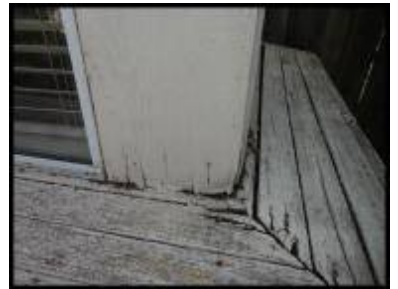
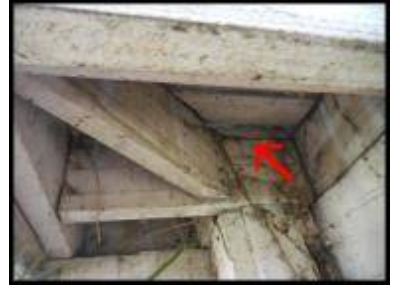
Water damage is noted at wood members.

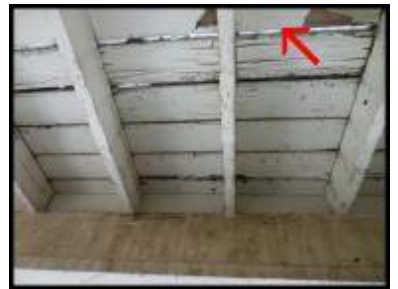
6.7 Condition of Painted Surfaces:

Portions of the exterior finish or painted surfaces are in a condition that calls for refinishing. Peeling paint is noted. Delay will cause further deterioration of the siding material. Regular painting maintenance will provide exposed wood protection from sun and elements.

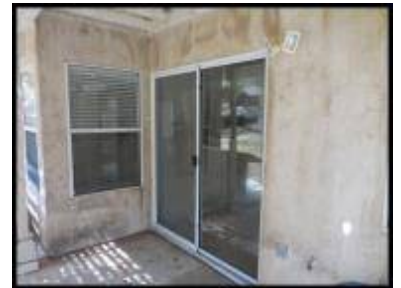
Aluminum sliding glass door is aged but functional.

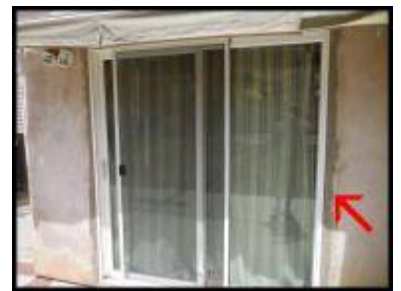
Vinyl slider is newer and in good condition.

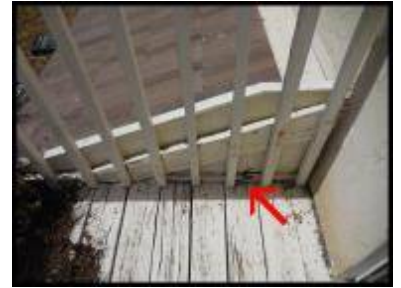
6.17 Condition of Wood Materials:

Attention Needed - The wood materials used in the deck need some repair or replacement. Have deck sheathing and railing checked for integrity and replace as needed.

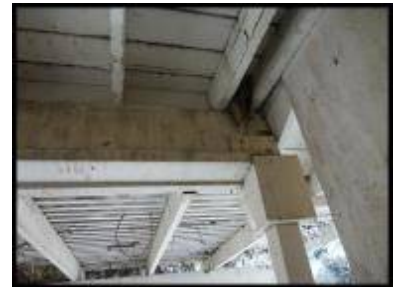
6.18 Framing of Deck/Porch:

The framing of the deck or porch was done in an acceptable manner. Have all joist hangers completely nailed at attachments.

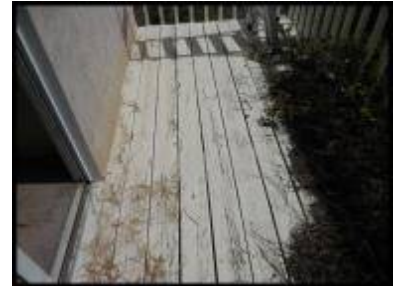
6.19 Deck, Porch, or Balcony Flooring Material:

Decking is aged and worn, replacement of concealed and deteriorated pieces may be needed. Refinish wood to provide protection from elements.

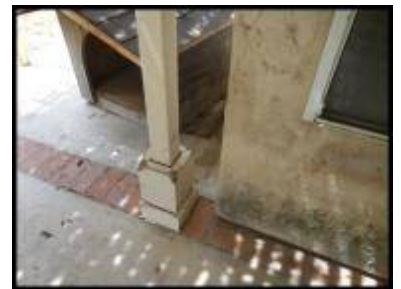
6.20 Supporting Posts:

The supporting posts appear to be functional.

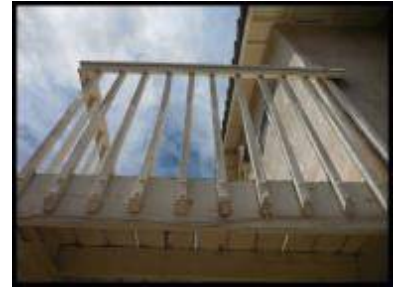
6.21 Deck or Porch Railings:

Railing is aged and worn, replacement is recommended with new balusters and top cap.

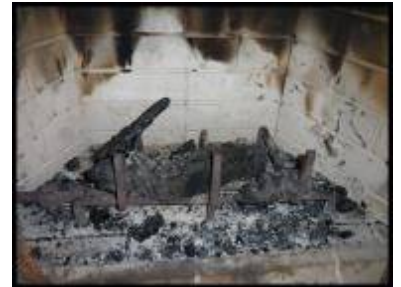
6.25 Firebox Condition:

Rear refractory panel has crack replacement is recommended.

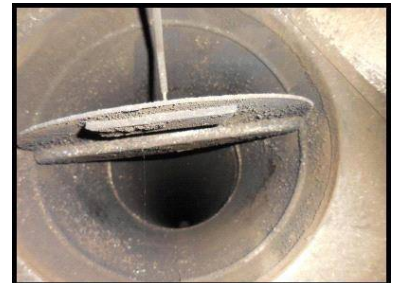
Open

There is no damper clip installed. All fireplaces with a gas connection should have a clip installed that will allow a small airflow up the chimney.

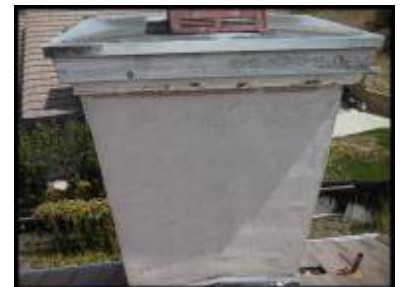
**6.31 Exterior Stack Condition:**

The exterior stack appears functional. Paint is needed on wood band.

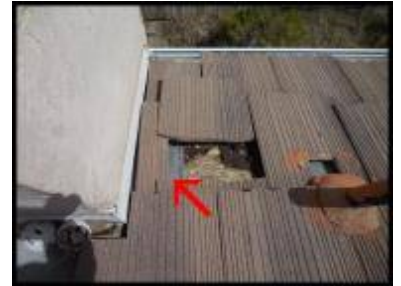
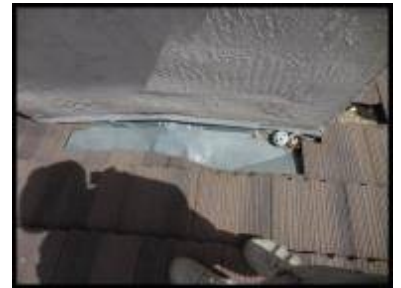
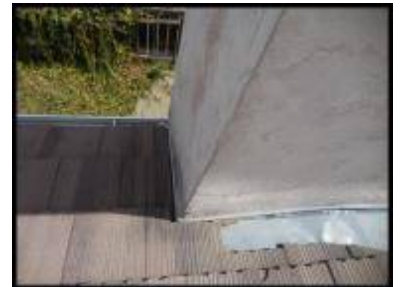
6.37 Flashing:

Have flashing checked at fireplace. Staining is noted under overhang.

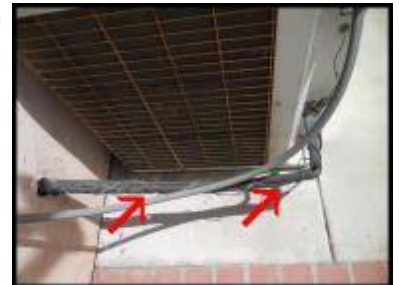
7.4 Insulation Wrap on the Suction Line:

Attention Needed - The insulation wrap on the suction line to the condenser/compressor is in need of attention due to deteriorated or missing insulation.

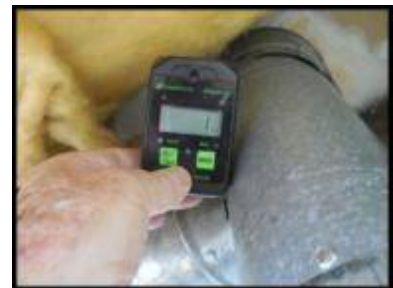
7.25 Carbon Monoxide Tested:

Yes. Action Necessary - Measurable amounts of carbon monoxide were noted. A hazardous condition may exist. Further testing and evaluation are needed. Have furnace flue checked for proper operation.

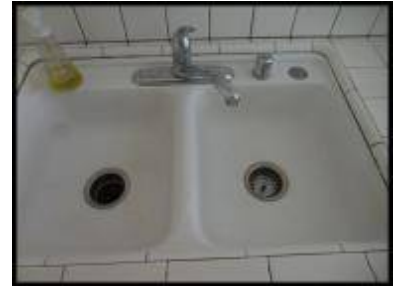
8.1 Faucet and Sink:

Sink appears functional with no leaks noted. **Faucet needs to be secured so as not to spin when spout is moved from sink to sink.**

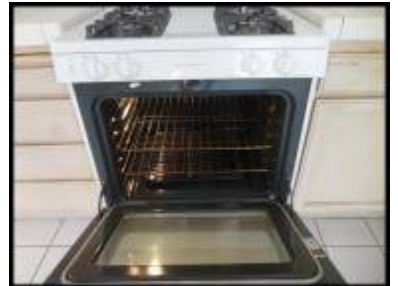
**8.9 Oven:**

Stove has not been secured as required by manufacturer's installation instructions. A tip-over hazard exists for small children. Stove should be properly secured right-away.

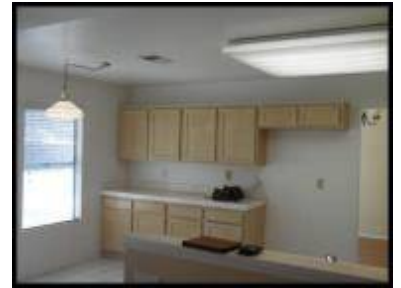
Plumbing repairs are seen at sink wall. No elevated moisture levels were recorded. Monitor concealed area under cabinets for signs of growth or smell. Drywall repairs are needed. Check disclosures for more information.

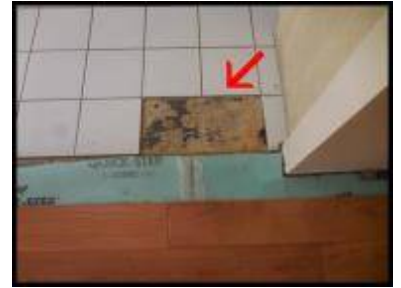
8.20 Floors:

The floor covering material is glazed ceramic tile. The floor in this room is in need of repair.

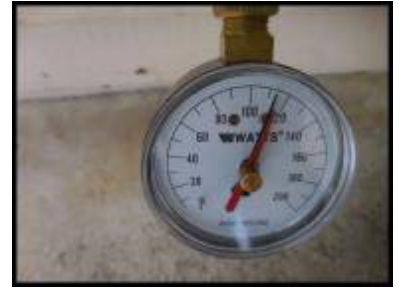
9.8 Water Pressure:

Action Necessary - High water pressure can cause damage to fill valves in toilets, dishwasher, and clothes washer. Recorded pressure is over 110 psi. Repair of regulator is needed to provide over pressure protection before leaks develop.

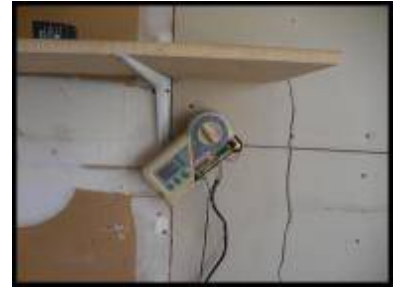
9.20 Lawn Sprinkler System:

Abandoned controller is noted. The inspection of the installed lawn sprinkler is beyond the scope of this inspection. Recommend further inspection by a licensed plumber or lawn sprinkler company.

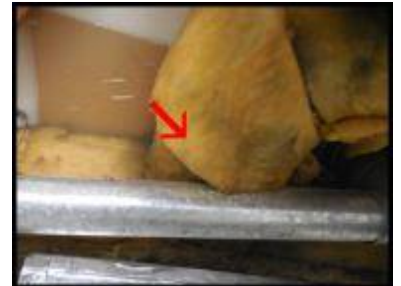
Clearance between vent pipe and combustible insulation is needed. Have condition repaired for safety.

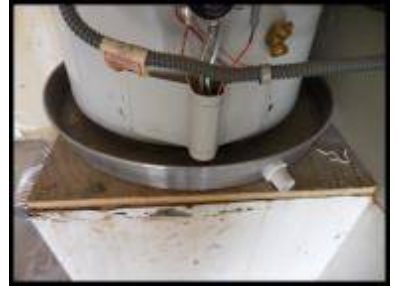
9.32 Drain Valve:

Yes - There is a drain valve installed on the lower side of the water heater. Smitty overflow drip pan needs to be plumbed to floor.

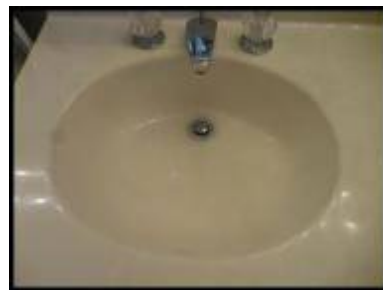
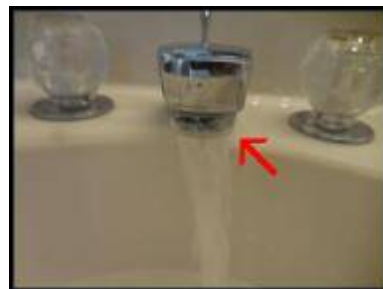
Corroded aerators are noted.

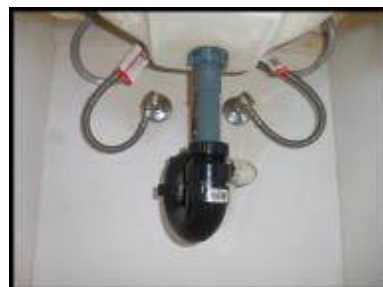
The lavatory drains slowly. There may be some blockage either in the fixtures or the drain lines.

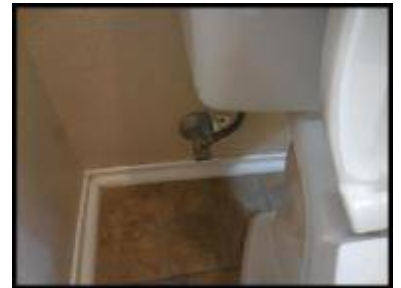
11.4 Toilet Condition

The toilet operates as designed no leaks were detected. The toilet is not secure to the floor, allowing it to wobble and possibly leak. Action should be taken to re-secure it to the floor.

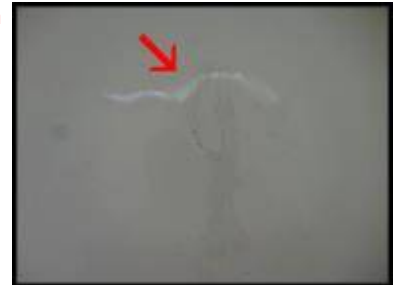
11.5 Tub:

-FG Tub/Shower Combo-OK The bathtub is a fiberglass reinforced plastic material. Bottom of tub has been compressed and repair of cracking is noted. Tub needs to be supported from below to stop this condition. Provide support for deck and have re-finish repairs made.

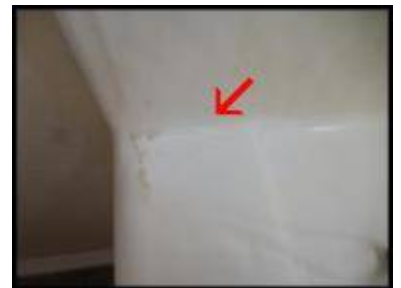
Cracking at corners is noted and repairs should be made by licensed fiberglass repair service.

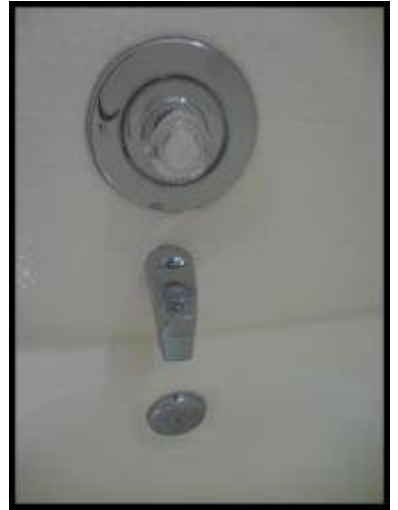
11.6 Tub Mixing Valve

The tub mixing valve and the tub unit are in functional condition.

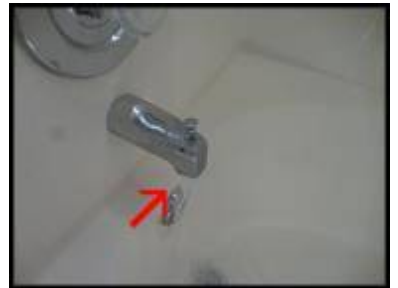
Diverter valve doesn't seat to provide flow to shower head. Repair or replace.

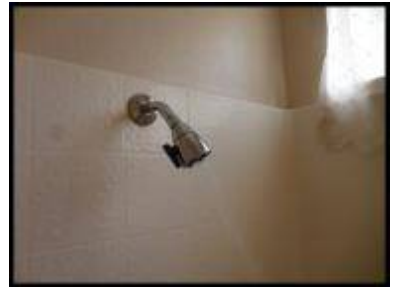
11.7 Shower/Shower Head and Mixing Valves:

Minimal flow is noted.

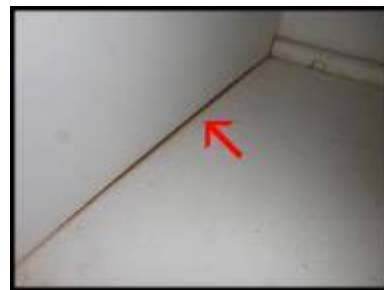
Damage to pullman lower is noted from previous water leak, no elevated moisture levels were recorded at time of inspection.

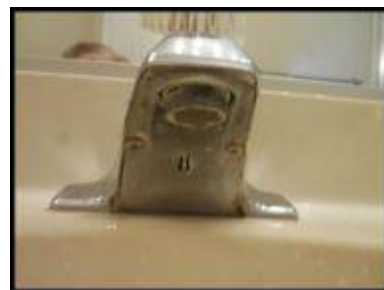
11.21 Faucet and Basin Fixture:

Faucet is aged and worn. Supply lines are backwards so that a scald hazard exists, repairs are needed.

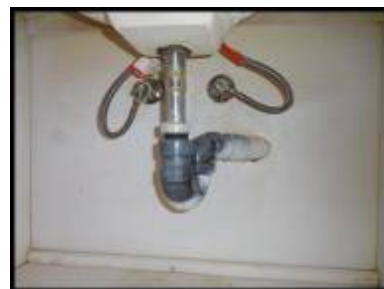
11.22 Supply and Drain Lines:

Faucets and supply lines are functional. No leaks were detected. There are shutoffs installed for both hot and cold water pipes under the basin. Sinks have slow flow condition, trap and drain cleaning is recommended.

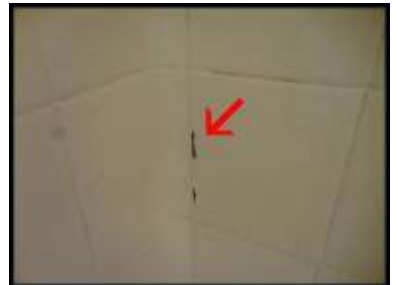
11.27 Tub & Shower Walls:

Damage is noted in corner of surround to gel coat. Repairs are needed.

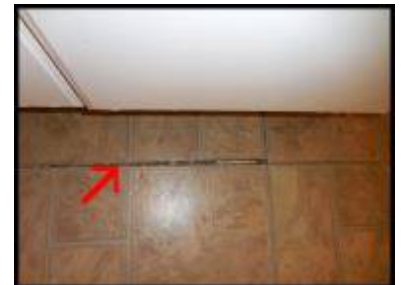
The flooring in this bathroom is in need of attention to prevent further deterioration.

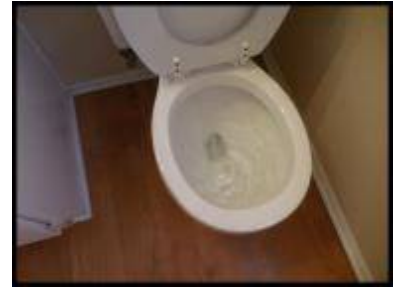
11.41 Toilet Condition

The toilet is not secure to the floor, allowing it to wobble and possibly leak. Action should be taken to re-secure it to the floor.

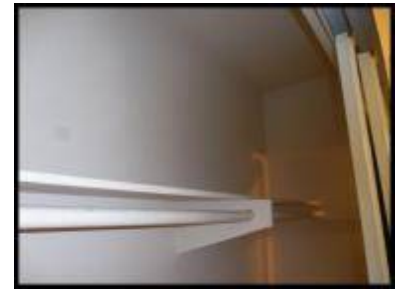
Door is broken and track needs to be replaced.

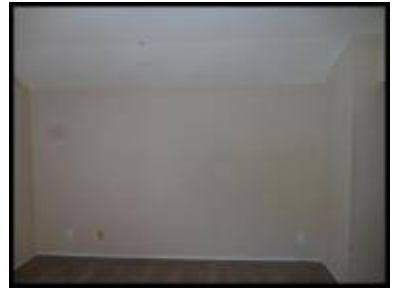
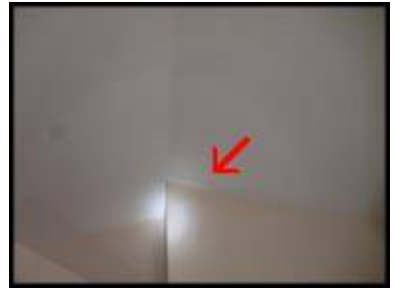
Cracks are noted at bedroom door wall and ceiling. Issues are non structural, drywall repairs are needed.

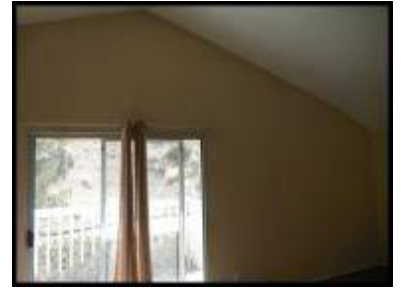
12.4 Ceiling:

The ceiling is functional. No staining is noted from water infiltration.

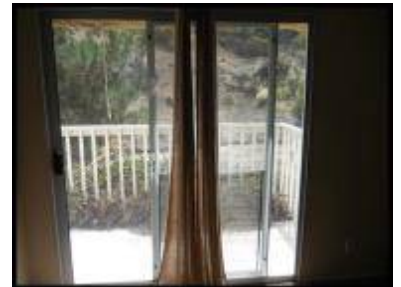
**12.7 Windows:**

Glass Doors and hardware in this room are aged and worn but operable.

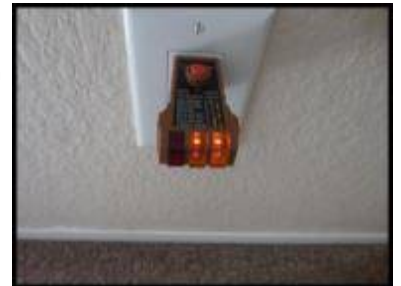
**12.8 Electrical Outlets:**

Functional - The outlets tested in this room are correctly wired and grounded. Suggest AFCI protected outlets be installed. This is a requirement in new construction but this safety upgrade is recommended for existing bedrooms. It is designed to prevent the plug from being loose enough to cause arcing which can result in a spark causing a fire.

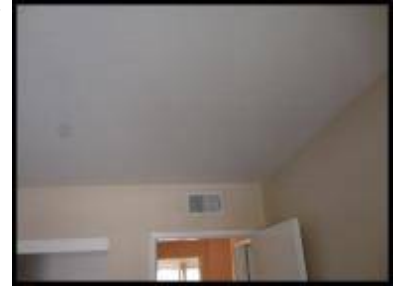
12.19 Heat Source Noted:

There is a heat source to this room. There is no comment as to the amount of air or temperature coming from the supply vent.

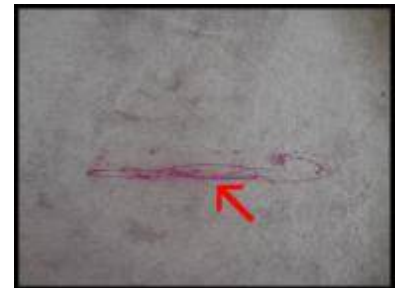
12.26 Floor:

The floor covering material is carpet. Carpeting is stained and worn.

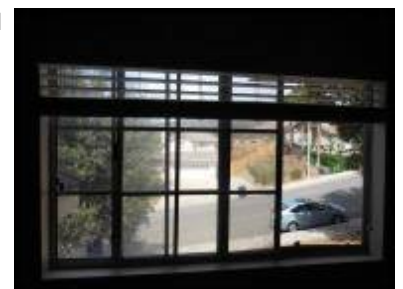
**12.27 Windows:**

Aged and worn aluminum slider. The windows and associated hardware in this room are all functional.

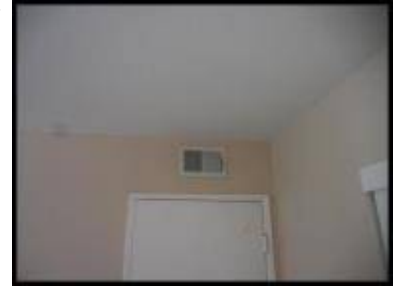
**12.29 Heat Source Noted:**

There is a heat source to this room. There is no comment as to the amount of air or temperature coming from the supply vent.

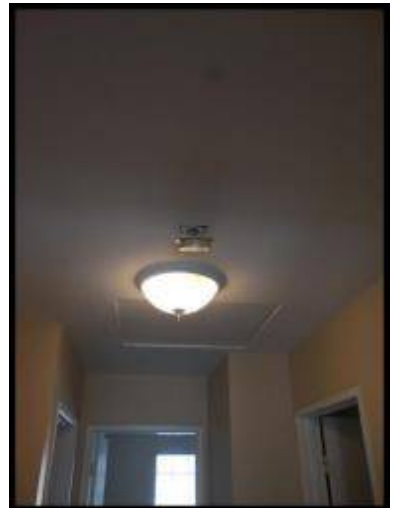
13.10 Upper Level Smoke Detector:

Smoke & Carbon Monoxide Detectors are recommended in hallways at each floor..

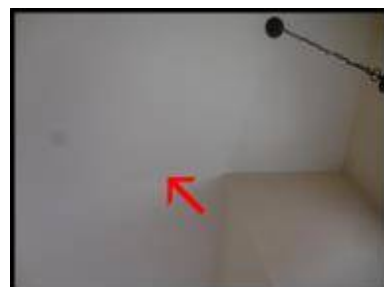
Defect is concealed in attic space above and is not visible. Suggest to have a structural specialist review further at intersection of conventional rafters and truss roof system. Destructive investigation may be necessary. If no structural issues are found then install backing at split and screw each side, tape, texture and paint.

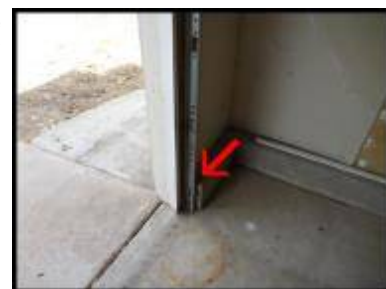
14.7 Outside Entry Door:

The outside entry door to the garage needs to be replaced.

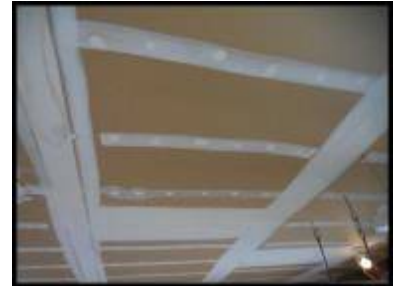
Repairs in ceiling are necessary to maintain fire separation.

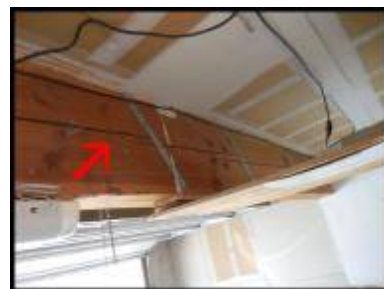
14.13 Beam Condition:

There is a post supporting an overhead beam in the garage. It appears to be adequately installed. Checking is seen in main support beam but is not no structural issues at time of inspection.

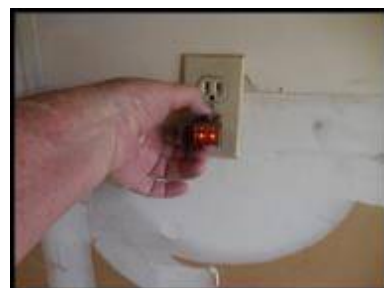
14.15 Electrical Service:

The electrical outlets in the garage tested as correctly grounded. However the GFCI receptacle didn't trip when tested or other receptacle down stream. Repair or replace receptacles as needed.

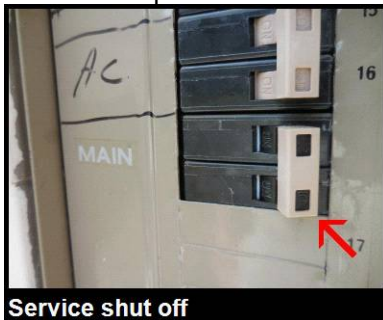
5.8 Disconnect:

2. Bottom of panel.

Service shut off

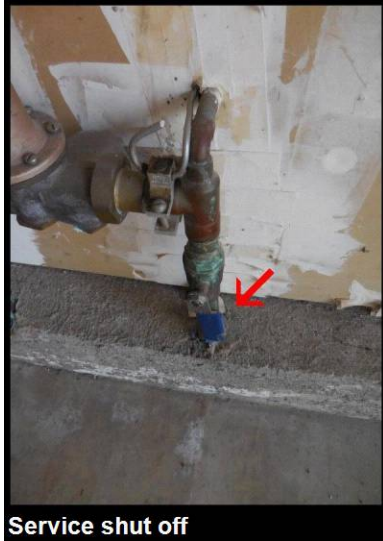
9.4 Main Water Line Cutoff Location:

3. Garage wall.

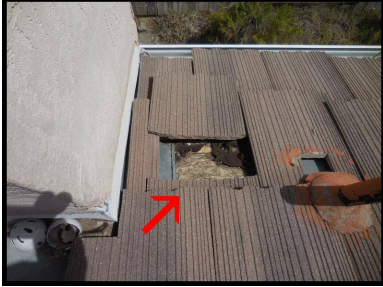
4.5 Condition of Roof Covering Material:

2. Broken roof tiles were observed and underlayment is deteriorated so that sheathing is exposed. Have licensed roofing contractor make necessary repairs to rotted starter board and sheathing before water intrudes into living area.

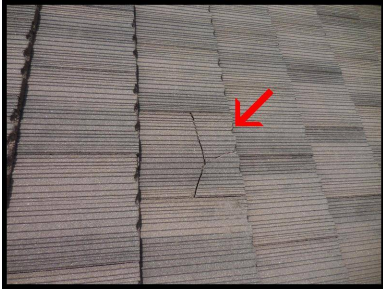
3. Broken roof tile was observed and repairs are needed.

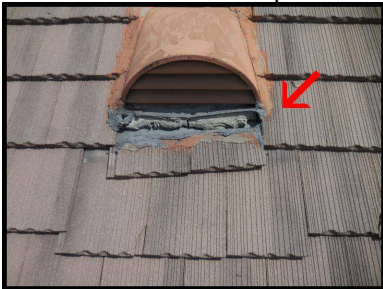
4. Sub-standard roof repair is seen and needs to be addressed.

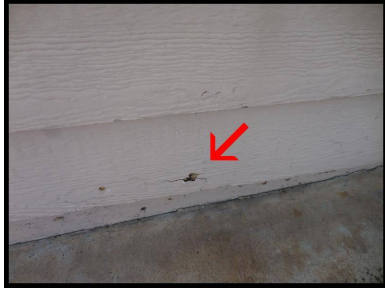
6.3 Siding Condition:

7. Lower pieces of the exterior siding is in a deteriorated condition that requires repair or replacement.

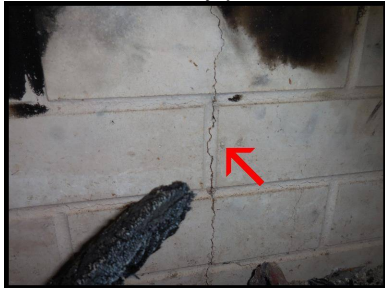
6.25 Firebox Condition:

8. Rear refractory panel has crack replacement is recommended.

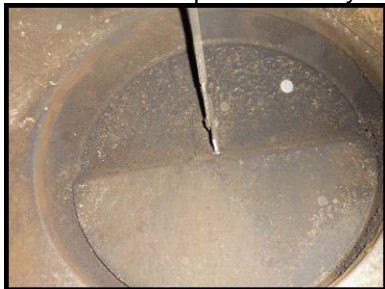
6.26 Damper Condition:

9. There is no damper clip installed. All fireplaces with a gas connection should have a clip installed that will allow a small airflow up the chimney.

Closed

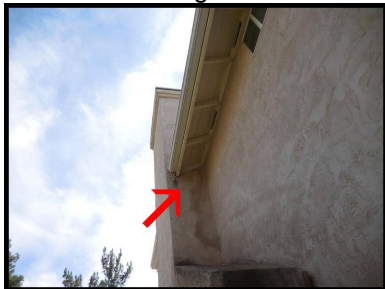
6.37 Flashing:

10. Have flashing checked at fireplace. Staining is noted under overhang.

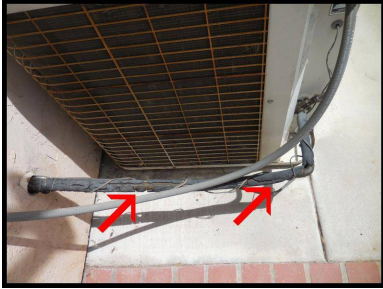
7.4 Insulation Wrap on the Suction Line:

11. Attention Needed - The insulation wrap on the suction line to the condenser/compressor is in need of attention due to deteriorated or missing insulation.

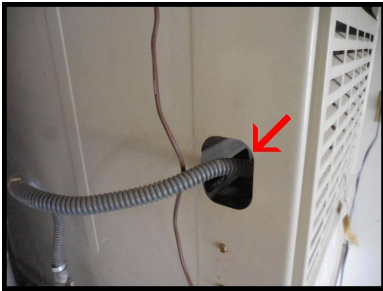
7.16 Fuel Source:

12. Recommend hard pipe be plumbed where gas line enters cabinet.

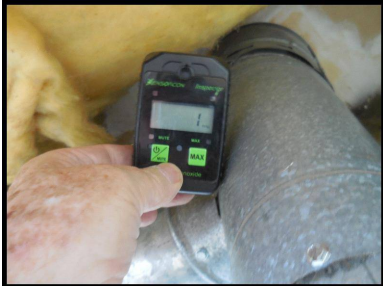
7.25 Carbon Monoxide Tested:

13. Yes. Action Necessary - Measurable amounts of carbon monoxide were noted. A hazardous condition may exist. Further testing and evaluation are needed. Have furnace flue checked for proper operation.

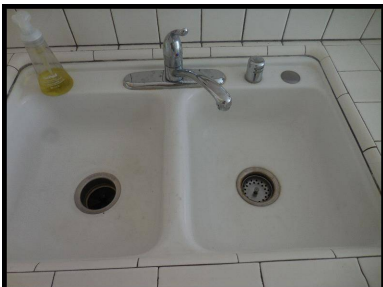
8.1 Faucet and Sink:

14. Faucet needs to be secured so as not to spin when spout is moved from sink to sink.

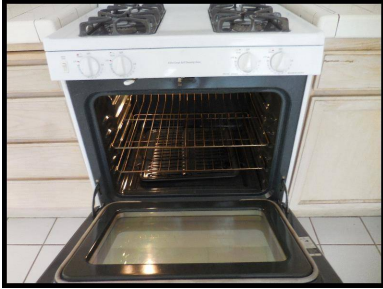
8.9 Oven:

15. Stove has not been secured as required by manufacturer's installation instructions. A tip-over hazard exists for small children. Stove should be properly secured right-away.

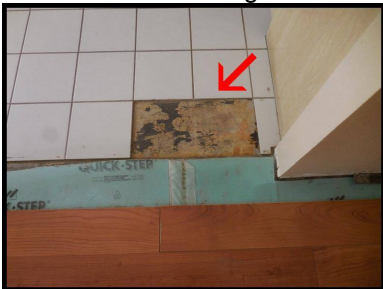
8.20 Floors:

17. The floor covering material is glazed ceramic tile. The floor in this room is in need of repair.

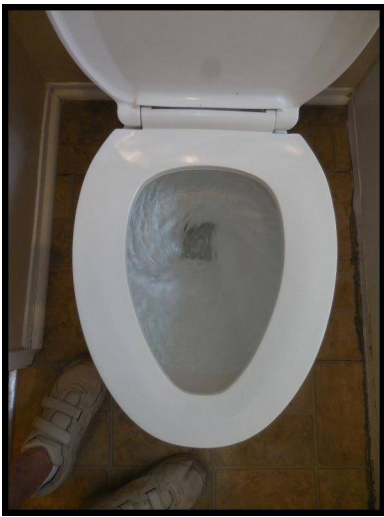
11.4 Toilet Condition

20. The toilet is not secure to the floor, allowing it to wobble and possibly leak. Action should be taken to re-secure it to the floor.

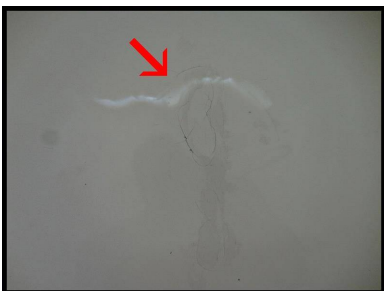
11.5 Tub:

21. Bottom of tub has been compressed and repair of cracking is noted. Tub needs to be supported from below to stop this condition. Provide support for deck and have re-finish repairs made.

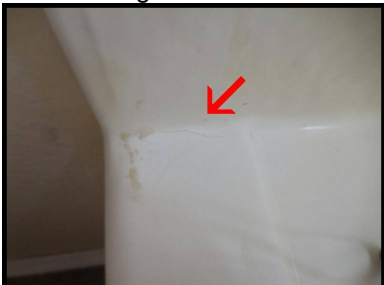
22. Cracking at corners is noted and repairs should be made by licensed fiberglass repair service.

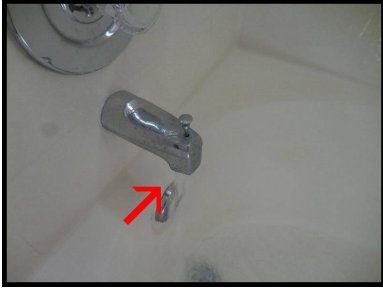
11.6 Tub Mixing Valve

23. Diverter valve doesn't seat to provide flow to shower head. Repair or replace.

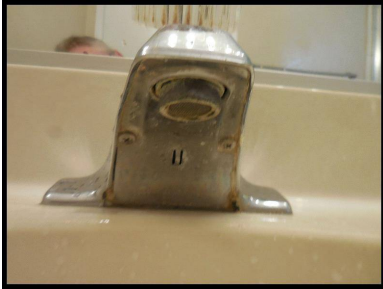
11.21 Faucet and Basin Fixture:

24. Faucet is aged and worn. Supply lines are backwards so that a scald hazard exists, repairs are needed.

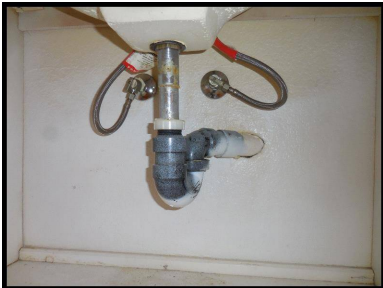
11.22 Supply and Drain Lines:

25. Sinks have slow flow condition, trap and drain cleaning is recommended.

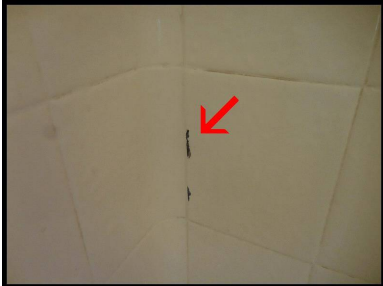
11.27 Tub & Shower Walls:

26. Damage is noted in corner of surround to gel coat. Repairs are needed.

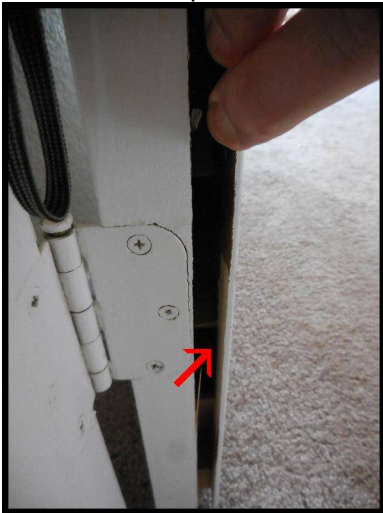
12.1 Entry Door:

The entry door to this room is damaged.

29. Skin has separated.

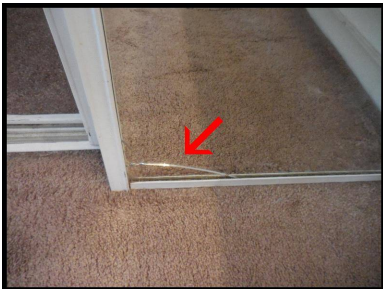
12.2 Closet:

31. Door is broken and track needs to be replaced.

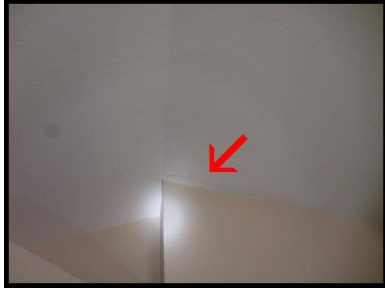
12.3 Walls:

32. Cracks are noted at bedroom door wall and ceiling. Issues are non structural, drywall repairs are needed.

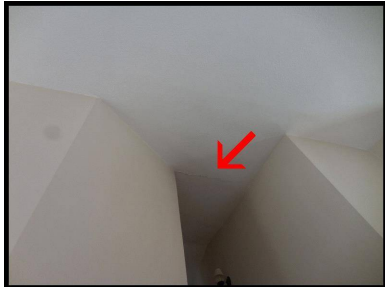
13.12 Ceiling:

Cracking in drywall is noted off entry shear wall. Cracking is cosmetic.

36. Defect is concealed in attic space above and is not visible. Suggest to have a structural specialist review further at intersection of conventional rafters and truss roof system. Destructive investigation may be necessary. If no structural issues are found then install backing at split and screw each side, tape, texture and paint.

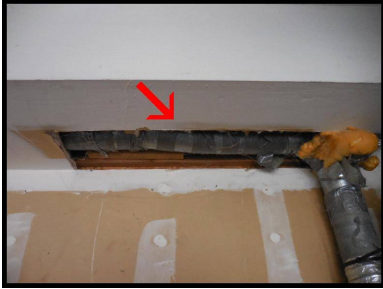
14.10 Fire Rated Ceiling:

39. Repairs in ceiling are necessary to maintain fire separation.
