Empire Home Inspection

Report: [Sample]

Confidential Inspection Report

Poway, CA 92064

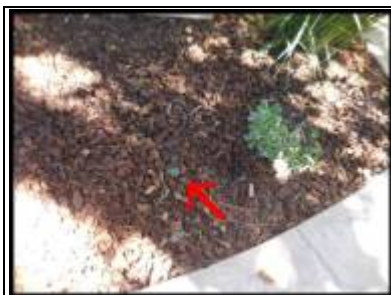
2.2 Site Drainage:

Functional - The lot appears to have adequate drainage to prevent water from ponding. House sits up on lot providing drainage away from structure. Area drains are present to remove surface water.

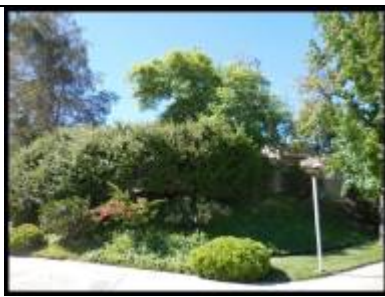
2.4 Trees Condition:

Mature Landscape is noted with aggressive root systems that may damage flatwork and structure.

Roots can cause expensive damage. Have tree specialist advise as to root pruning or tree removal.

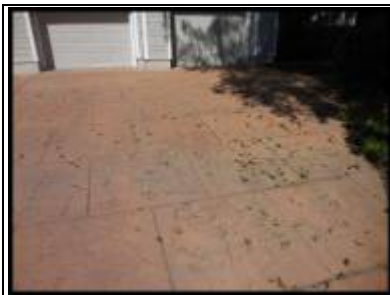
2.5 Driveway Paving Material:

Stamped and colored concrete.

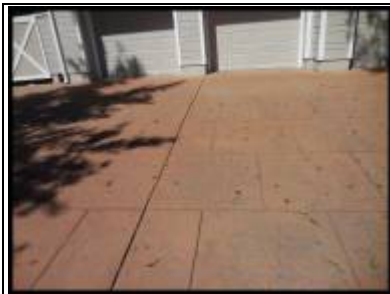
2.6 Driveway Condition:

The driveway surface material is in functional condition with only normal deterioration noted.

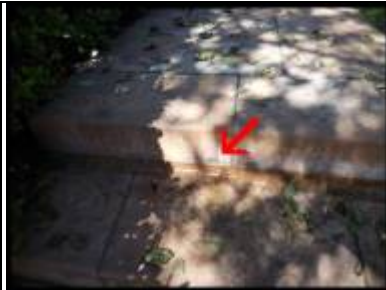
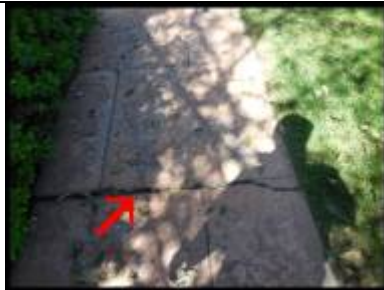
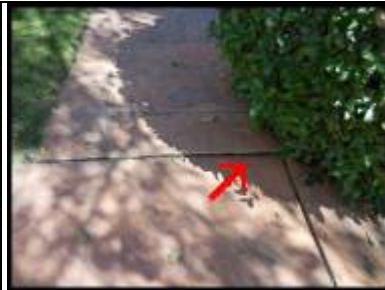
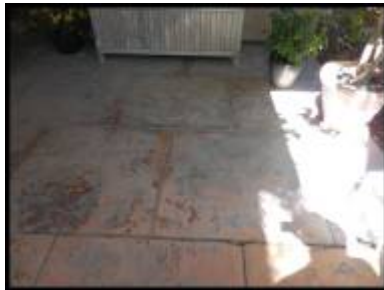
2.8 Walkway Condition:

Deterioration is noted at tread and riser. Crack is developing from lifting panel probably from root intrusion.

Lifting flatwork is causing a trip hazard noted by 1" vertical separation or more. Repair or replacement is needed.

Entrance flatwork is in functional condition. Stress relief cracking is noted in flatwork.

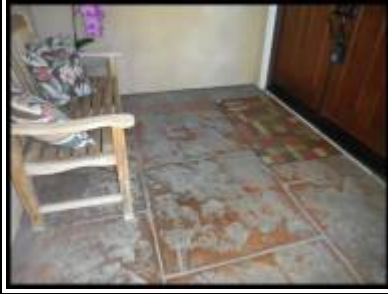
2.9 Entryway Stoop:

The entryway stoop is in functional condition.

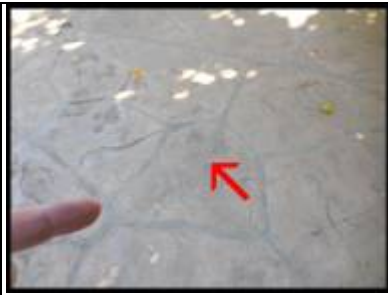
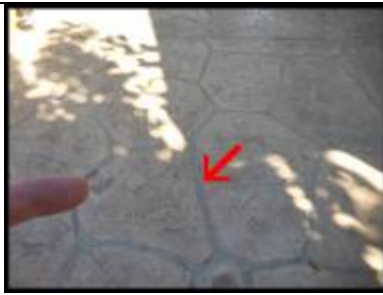
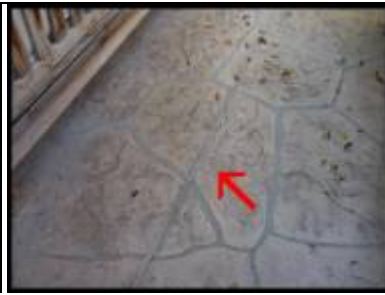
2.11 Slab Condition:

Stress relief cracking is noted.

Functional - The slab is in useable condition.

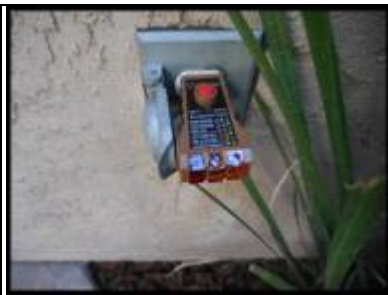
2.12 Electrical Service:

The outlet is Ground Fault Circuit Interrupt protected.

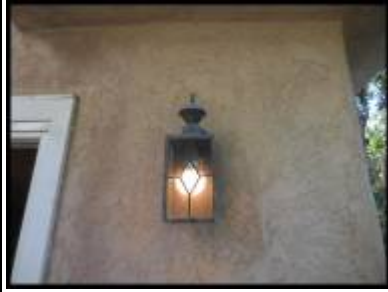
2.13 Patio Lighted:

Yes minimal light provide by fixture at rear door.

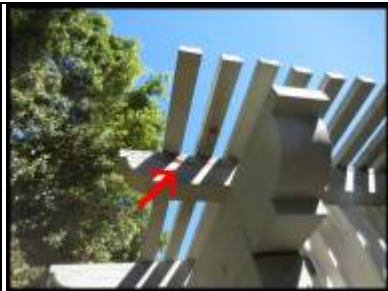
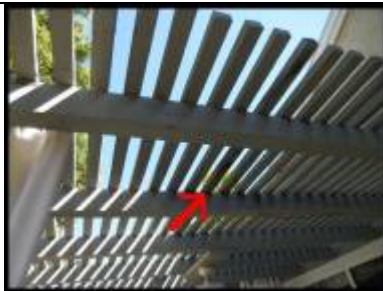
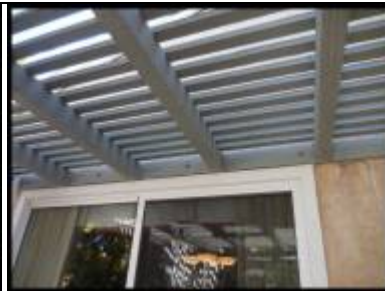
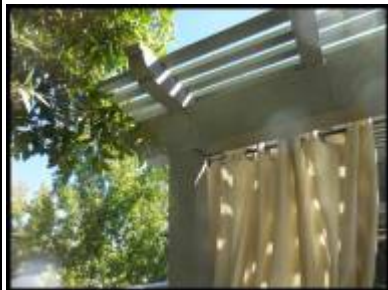
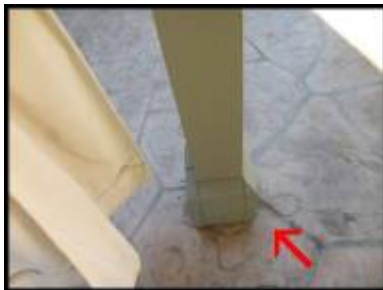
2.14 Patio Cover Condition:

Dry rot is noted on joist and sheeting. Repairs are needed.

Post to beam connection is correct using column cap.

Post are in acceptable condition, plinth blocks are concealing foundation attachment.

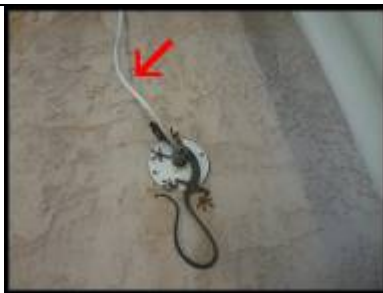
2.15 Patio Lighting:

Fan is exposed to water infiltration. Check to see if this fixture is exterior rated.

Electrical conductor exposed, should be enclosed in conduit.

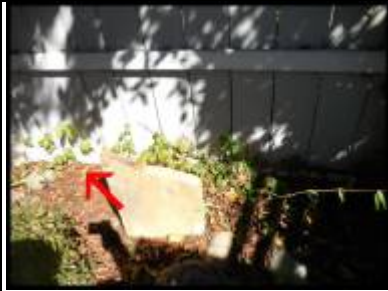
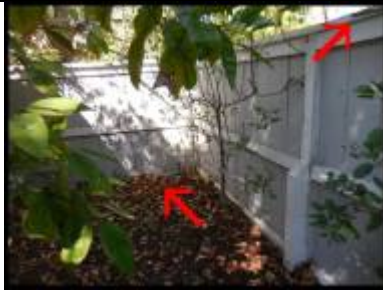
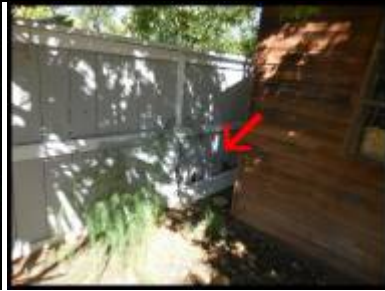
2.17 Fence Materials Condition:

Fencing is in contact with soil and is deteriorating.

Fencing needs to be clear from soil and repairs are needed at top cap and bottom rails where dry rot and deterioration have compromised structural integrity.

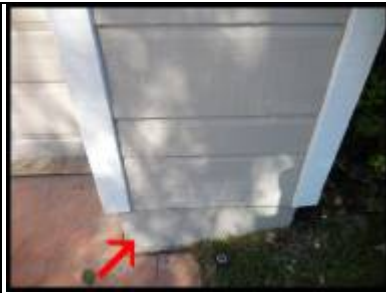
3.3 Visible Portions of Exterior Foundation Walls:

The exterior view of the foundation is limited to the portions visible above grade.

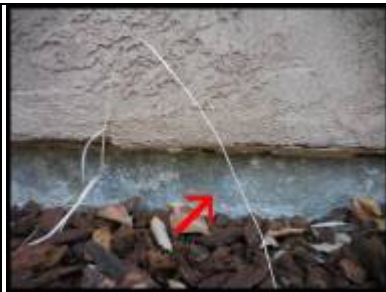
3.4 Visible Foundation Wall Cracks at Exterior:

No visible cracking in the vertical foundation walls was noted during the exterior examination.

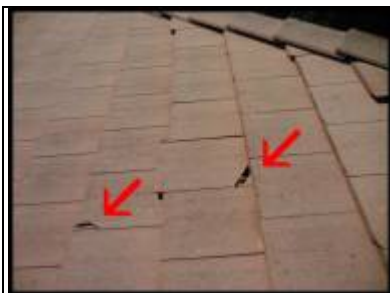
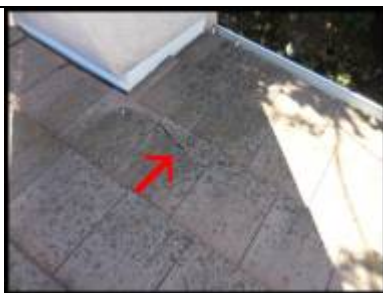
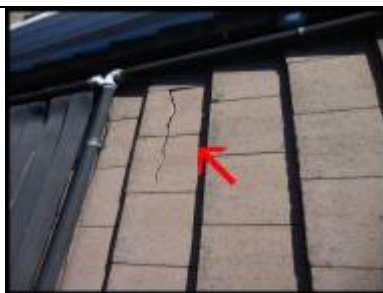
4.5 Condition of Roof Covering Material:

Broken roof tiles were observed and repairs are needed.

Slipping tiles are noted at roof to wall and hip cuts.

Have roof tune up to make repairs and prevent water intrusion.

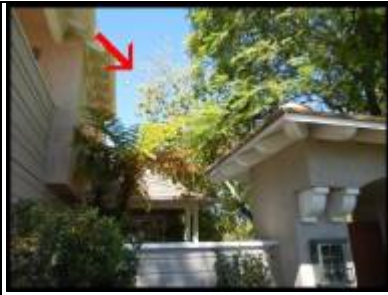
4.13 Roof Framing- Exterior Notes: Trees overhanging the structure need to be trimmed so that limbs, leaves, and rain will not drop off the tree onto the roof covering and clog the gutters, damage the roof, or promote moss growth. Trees that rub against the roof can cause severe damage and can drastically reduce the life of the roofing material.

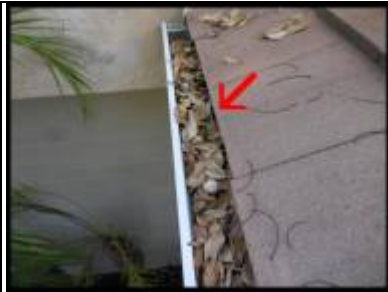
4.15 Roof Gutter System: Cleaning is necessary for proper function.

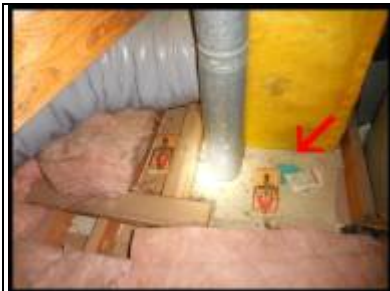
4.30 Pest Activity:

Traps are noted in attic cavity. Recommend pest control service be used to control intrusion.

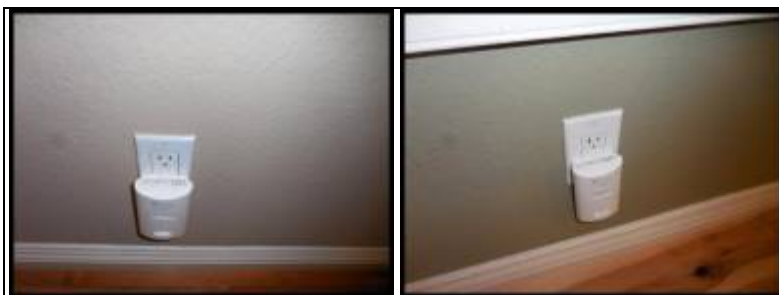
CO monitor is present in residence on both floor levels.

Recommend hardwired combination CO/ smoke detection monitors be installed in hallway on each floor of the living space with combustible gas appliances.

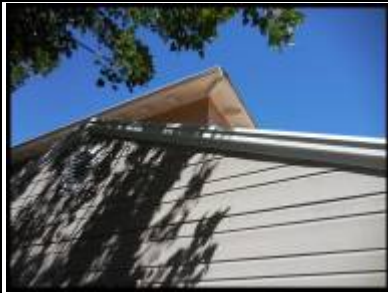
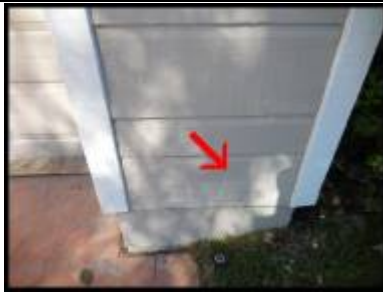
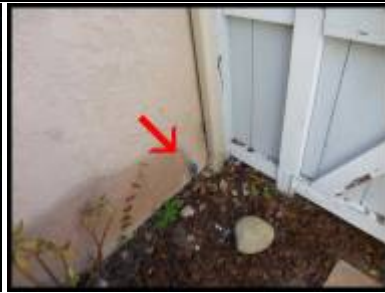
6.3 Siding Condition:

Some damage from irrigation is noted. Repairs are needed.

Keep irrigation water from structure and wood fencing.

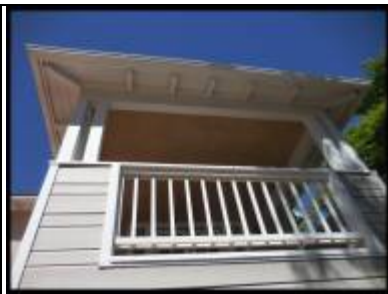
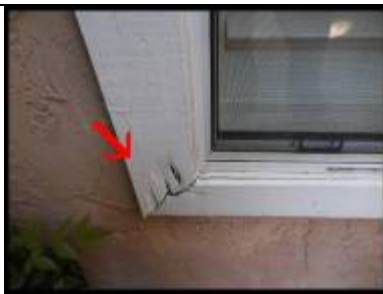
6.4 Trim Condition:

Deterioration on window surrounds is noted. Replace damaged pieces. Caulk and paint to prevent water intrusion as needed.

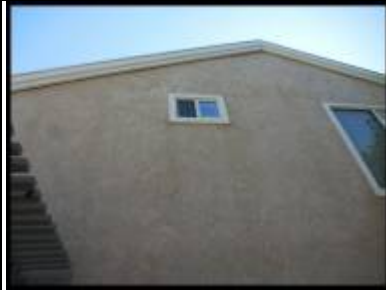
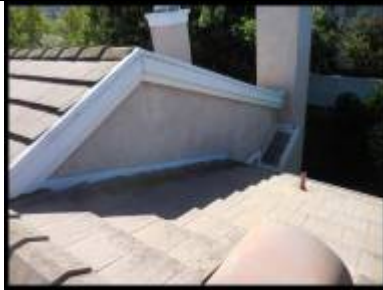
6.6 Fascia & Rake Boards:

The fascia and rake boards appear to be in adequate condition and show only signs of normal wear.

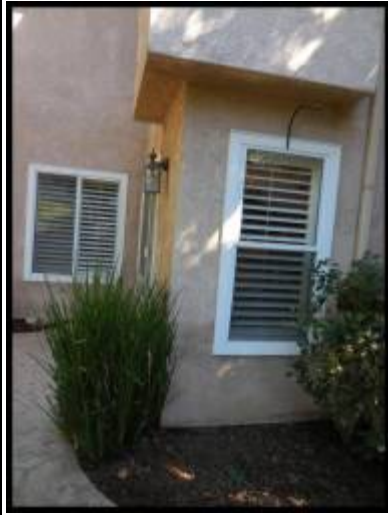
6.10 Window Condition:

The window framing and glass are functional, wear is consistent with age of structure.

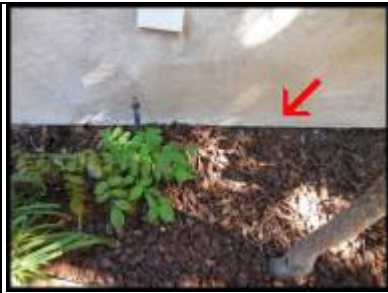
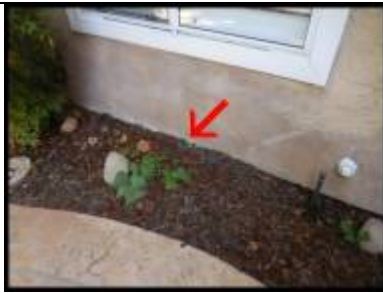
6.11 Earth-to-Wood Clearance:

There does not appear to be adequate clearance between the earth and the wood siding or framing members of the structure. It is suggested that there should be a minimum of a 6" clearance between the earth and any framing materials.

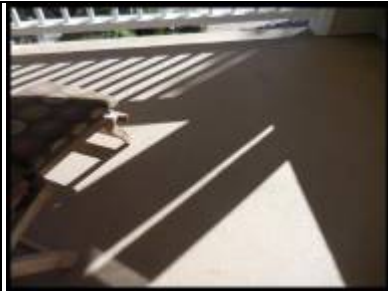
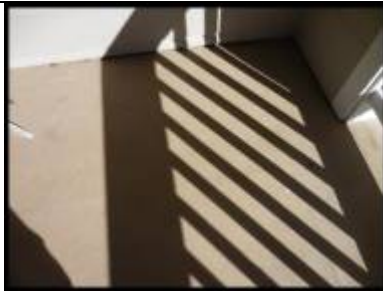
**6.19 Deck, Porch, or Balcony
Flooring Material:**

Cool Deck seamless deck coating. Seams are noted but weather proofing is acceptable and slope to drain.

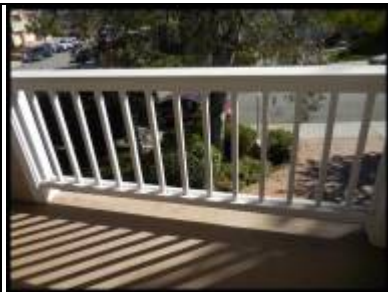
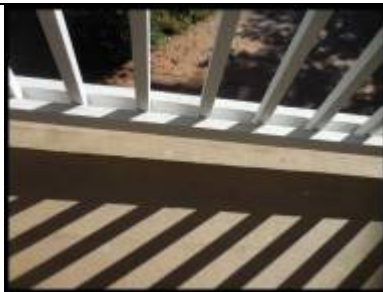
The railings as installed are functional.

The spacing between balusters is over 4". New construction allows only 4" spacing. This was instituted as a safety issue to prevent small children from getting caught between the balusters.

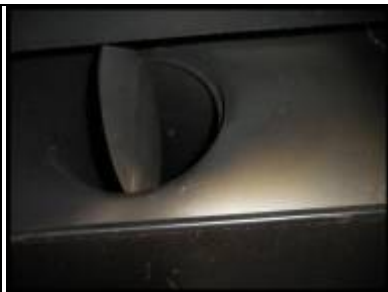
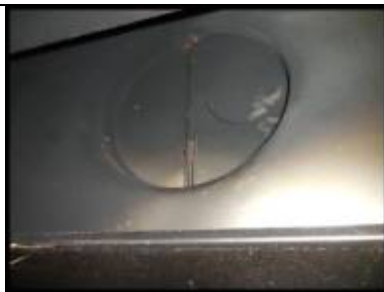
6.45 Damper Condition: The flue damper appears to be functional and fully adjustable.
There is no damper clip installed. All fireplaces with a gas connection should have a clip installed that will allow a small airflow up the chimney.

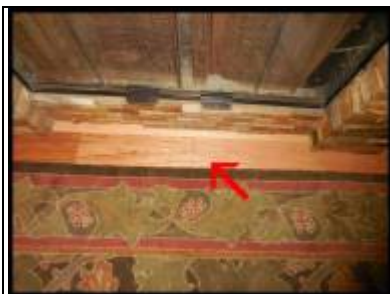
- 6.57 Source of Combustion Air:** Outside air is used for combustion. This is the most efficient system.
- 6.58 Hearth Condition:** Action Necessary - There is no hearth extending in front of the firebox. Gas appliance only is recommended with screens closed when operating.

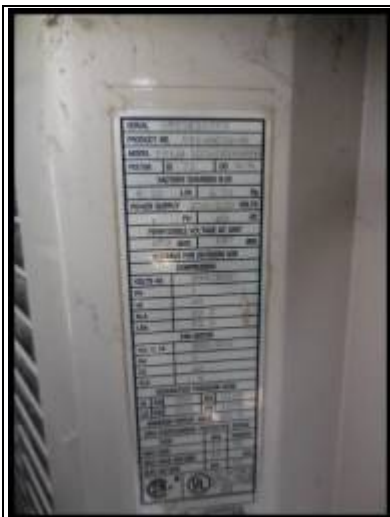
7.1 Model/ Serial Number/ Size:

System is Day & Night. Serial number is 0591E01993. MFG date February 1991. The typical service life for an AC unit is 12 - 15 years without major repairs.

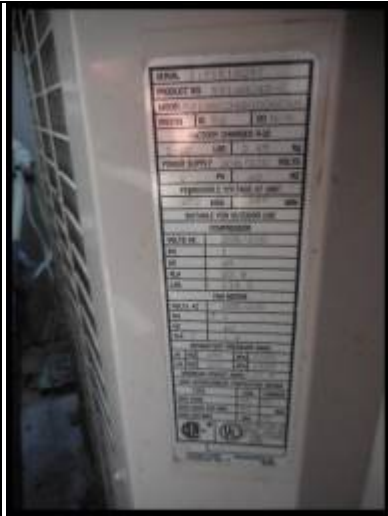
7.15 Type and Location: Refrigerator/Split System. Electricity-powered. Condenser unit Location- Left side of building.
7.16 Unit Tested: Yes.
7.17 Insulation Wrap on the Suction Line: **Attention Needed** - The insulation wrap on the suction line to the condenser/compressor is in need of attention due to deteriorated or missing insulation.

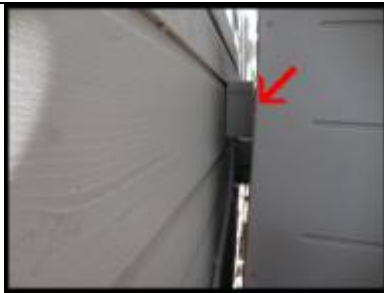
7.21 Service Disconnect:

Shut off is not accessible.

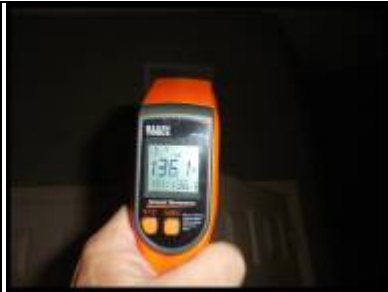
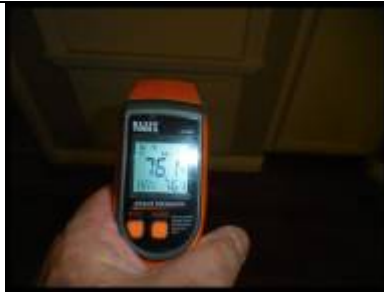
7.36 Burners / Heat Exchangers:

Burner igniter would not shut off after burners were lit. Service is needed. Burner Flame(s) appear typical.

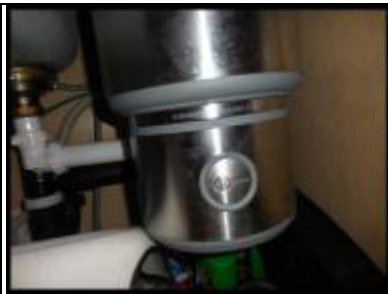
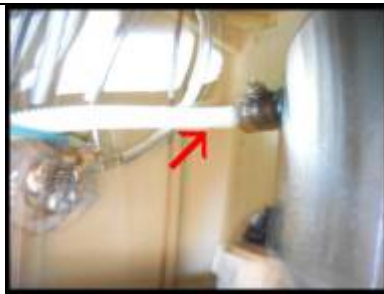
8.4 Food Waste Disposal:

System is Insinkerator. The food waste disposal appears to be functional. No food was ground up in this inspection. The inspector was unable to determine if the unit will grind food waste adequately. Air Gap not present. Dishwasher drains directly into garbage disposal.

No anti siphon protection is provided without air gap.

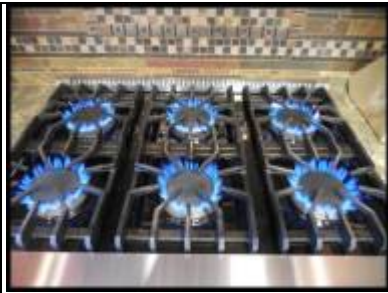
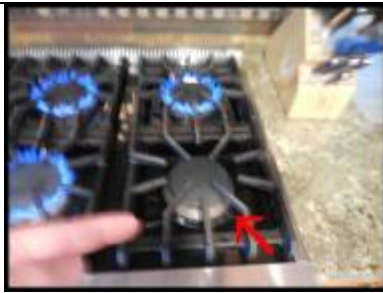
8.7 Cooktop:

Gas - There is a gas line installed for this cooktop, All Burners are functional set on high at the same time.

Igniter will not turn off after burner is on. Service is needed.

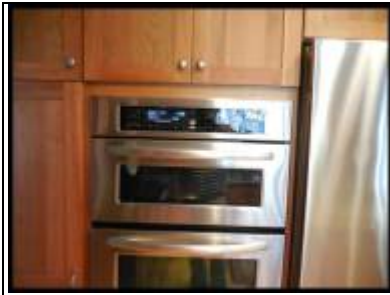
Built-in - There is a built-in microwave oven. The unit was tested by heating a cup of water. The unit functioned as intended.

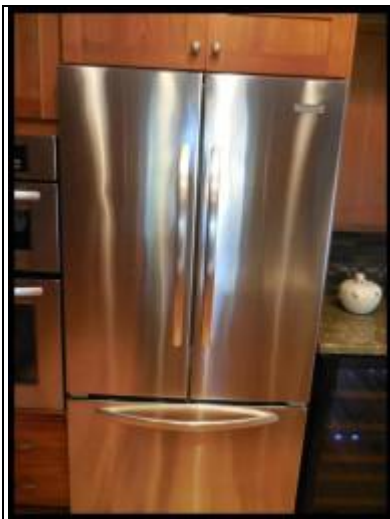
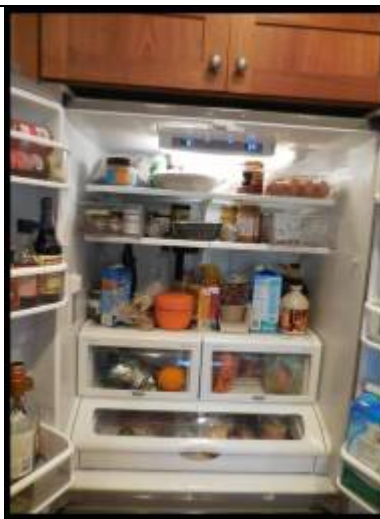
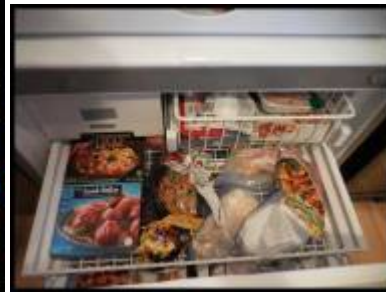
There is a refrigerator installed. This inspection determines only if the unit is currently keeping foodstuffs cold. The freezer portion of the refrigerator is required to freeze water. This refrigerator appears to pass this minimum inspection.

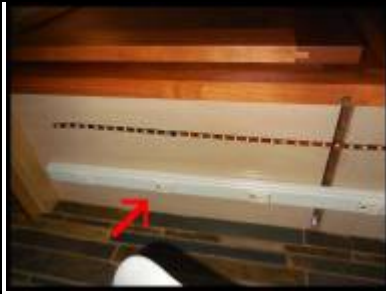
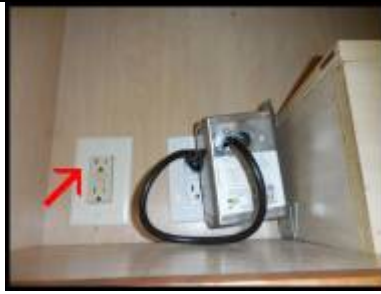
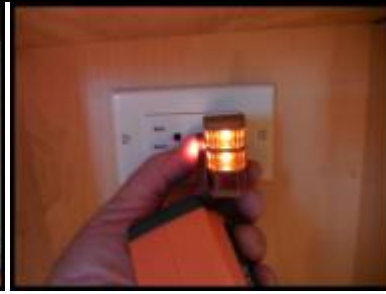
All outlets are located under kitchen cabinets and are GFCI protected.
Re-set is above cooktop in cabinet.
Island receptacle is not GFCI protected.

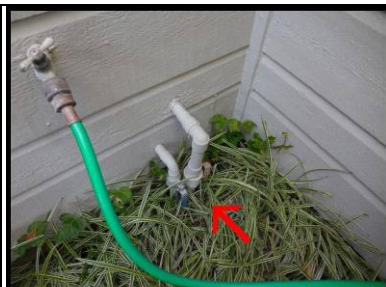
Service shut off

- 9.1 Water Source:** City/Municipal.
- 9.2 Plumbing Service Piping Size to Structure:** 1" water service line from the meter to the main cutoff.
- 9.3 Public Service Piping Material:** The visible main service line to the structure is copper.
- 9.4 Main Water Line Cutoff Location:** Front left of entry.

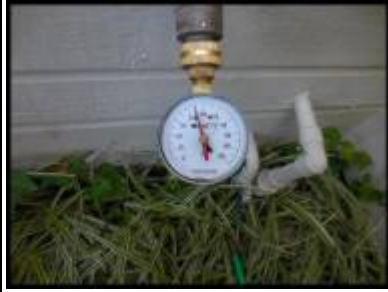
- 9.5 Visible Mineral Deposits or Encrustations:** No.
- 9.6 Interior Supply Piping Size:** The interior water supply piping is 1" in diameter then reduces to 3/4" and then steps down to 1/2" risers.
- 9.7 Interior Supply Piping Material:** The visible interior supply piping in the structure is predominantly copper.
- 9.8 Water Pressure:** Attention Needed - Water pressure was over 80 pounds per square inch and is considered excessive. 90 psi at time of inspection. Water pressure regulator valve correctly installed will allow adjustment of the incoming water pressure and over pressure protection. Garage was not accessible to this location. Service will need to be done to reduce pressure.

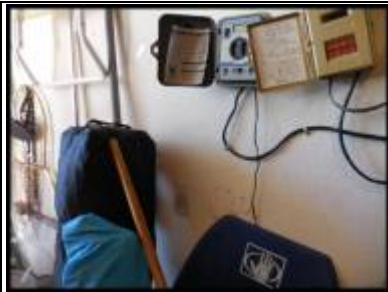
9.20 Lawn Sprinkler System:	There is a lawn sprinkler system installed. The inspection of the installed lawn sprinkler is beyond the scope of this inspection. Recommend further inspection by a licensed plumber or lawn sprinkler company.

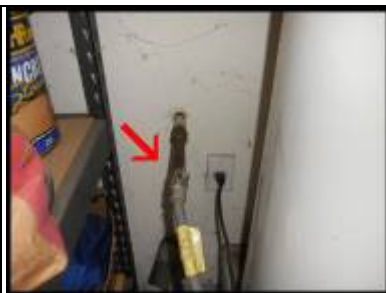
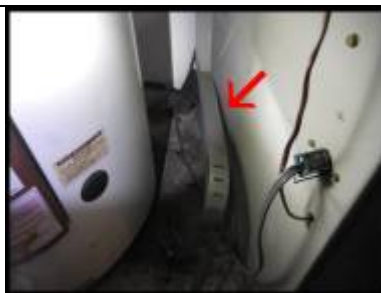
The water heater is gas-fired. **No earthquake straps are installed on water heater. Repairs are needed.**

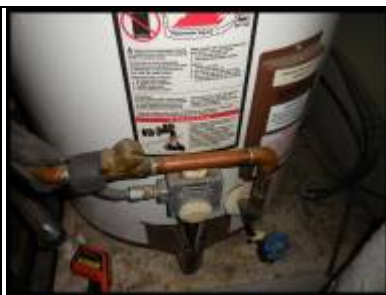
It shows some age, but it is not leaking at time of inspection.

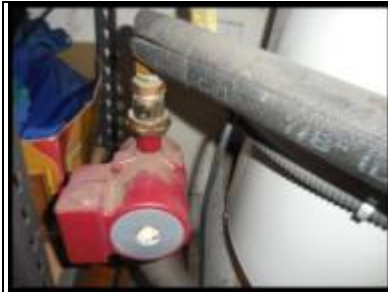
- 9.34 Safety Overflow Pipe:** The overflow pipe is correctly installed.
- 9.35 Water Heater Insulation Jacket:** No.
- 9.36 Insulated Hot Water Piping:** Good - The visible portions of the hot water supply piping are insulated. This will help deliver hot water to the faucets quicker with reduced heat loss.
- 9.37 Recirculation Pump:** Yes, condition is suspect with corrosion showing. Pump was very hot and may be continuously running.

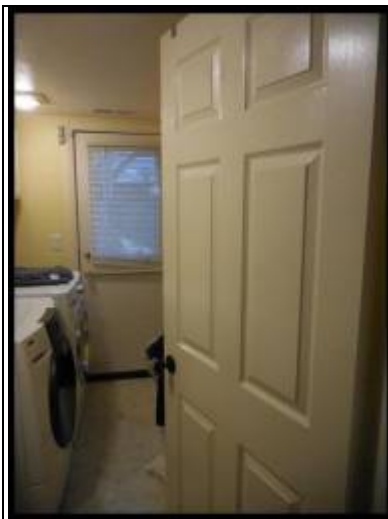
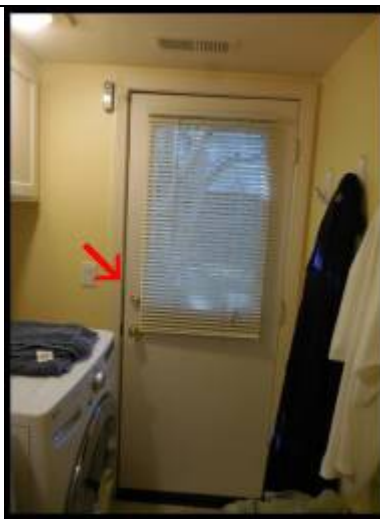
- 10.1 Location:** Off garage.
- 10.2 Entry Door:** The entry door to the laundry room is functional.
Thumb lock dead bolt needed for egress.

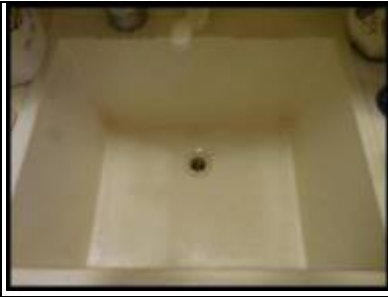
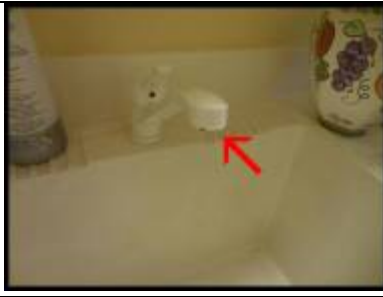
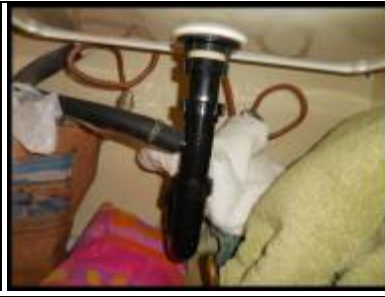
10.15 Laundry Basin:

Yes - There is a laundry basin installed.

Aerator is missing.

The unit is functional. No leaks were noted.

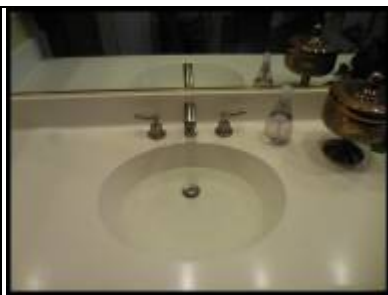
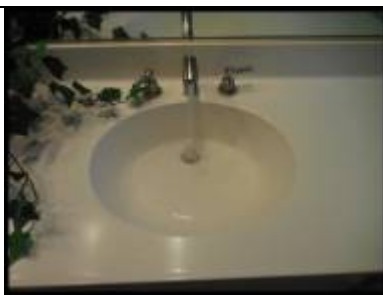
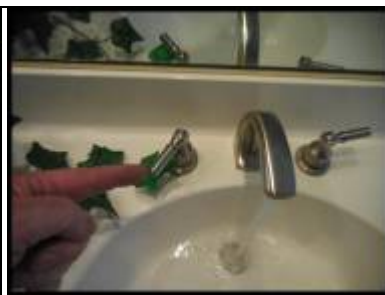
11.2 Faucet and Basin Fixture:

Hot valve on the right sink is stiff operating. Repair or replacement is needed.

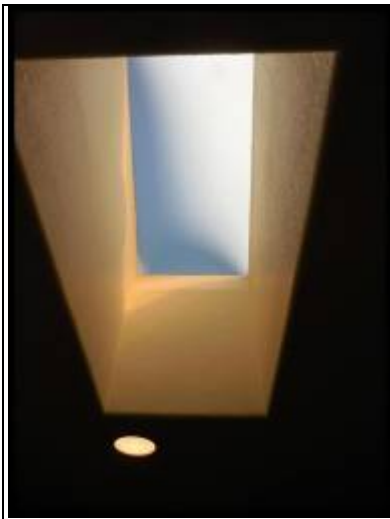
11.33 Windows:

Skylight is tight, no leaks were detected.

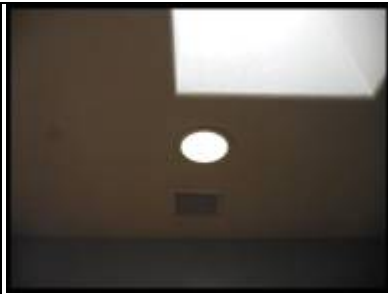
11.34 Ceiling: The ceiling in this bathroom is functional.

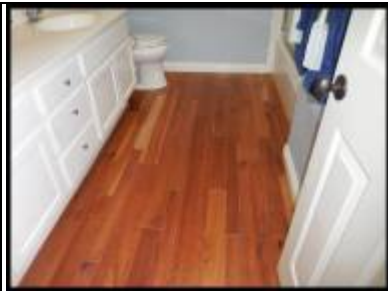
11.35 Floor: The flooring in this bathroom is functional. The floor covering material is hardwood.

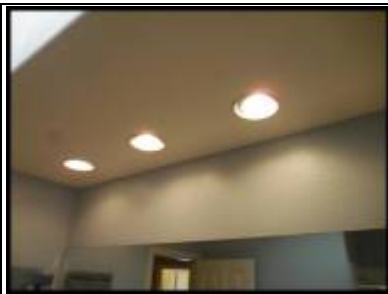
11.36 Lighting: The ceiling light and fixture in this bathroom are in functional condition.

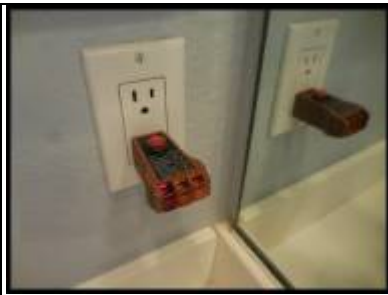
11.38 Ground Fault Interrupt Outlets: There is a functional Ground Fault Circuit Interrupt protected outlet installed in the area of the bathroom vanity.

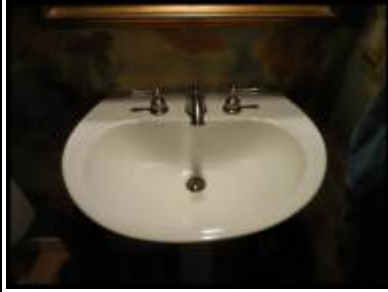
11.41 Faucet and Basin Fixture: The faucet and drainage fixture appear to be functional.

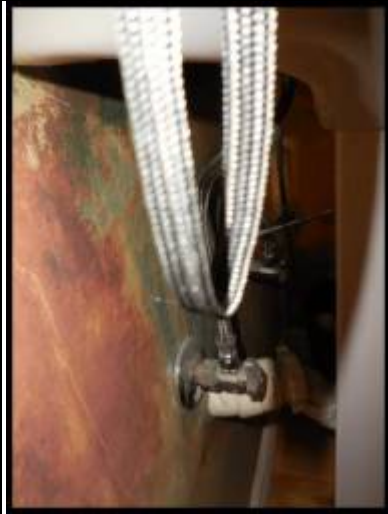
11.42 Supply and Drain Lines:

Faucets and supply lines are functional. No leaks were detected. There are shutoffs installed for both hot and cold water pipes under the basin.

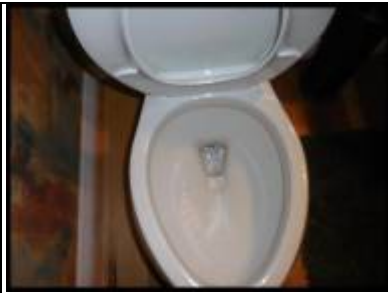
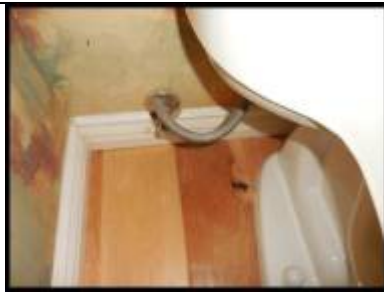
11.43 Toilet Condition

The toilet operates as designed no leaks were detected.

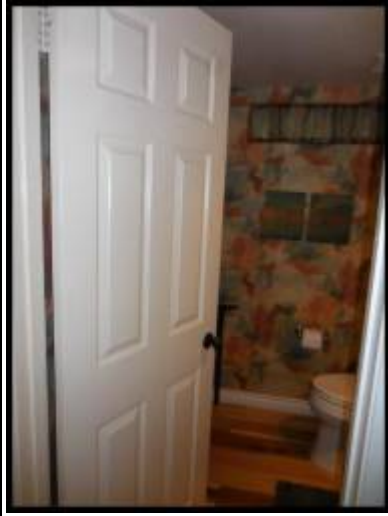
11.44 Entry Door:

The entry door to the bathroom is functional.

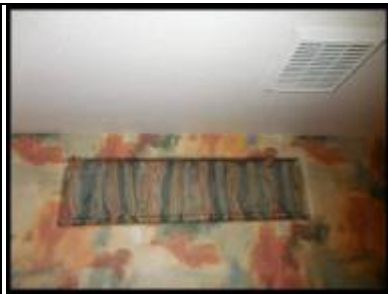
11.45 Walls:

The walls in this bathroom are functional.

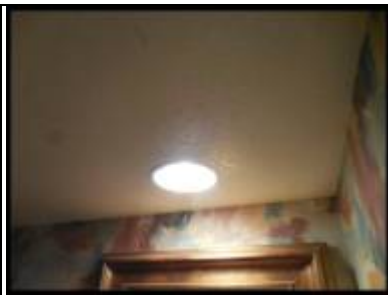
11.47 Ceiling:

The ceiling in this bathroom is functional.

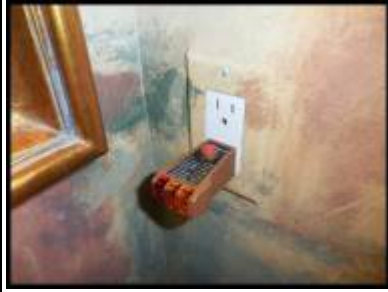
11.51 Ground Fault Interrupt Outlets: There is a functional Ground Fault Circuit Interrupt protected outlet installed in the area of the bathroom vanity.

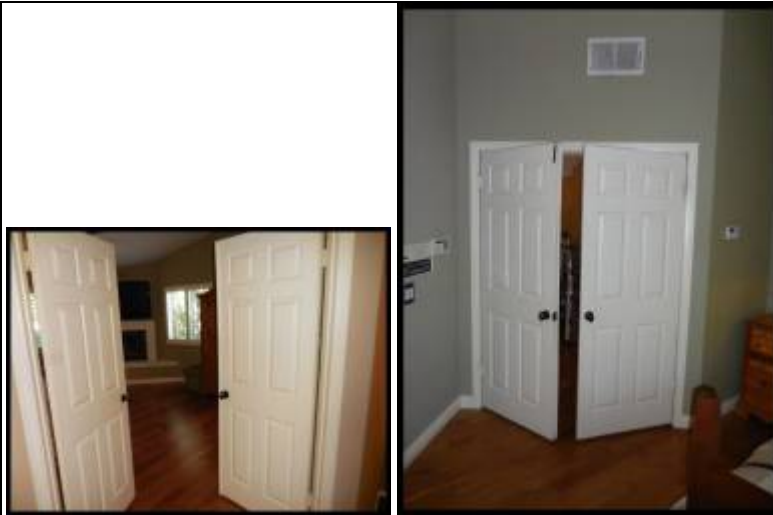
12.1 Entry Door: The entry door to this room is functional.

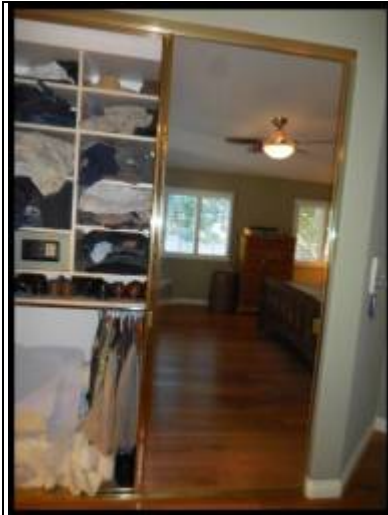
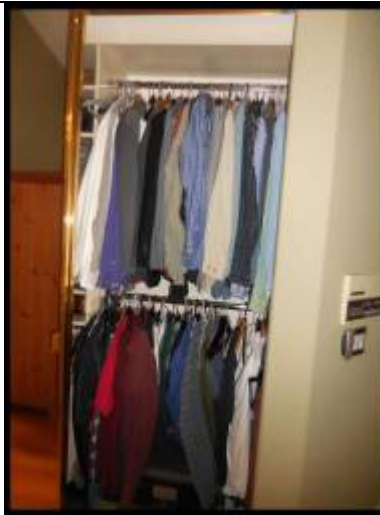
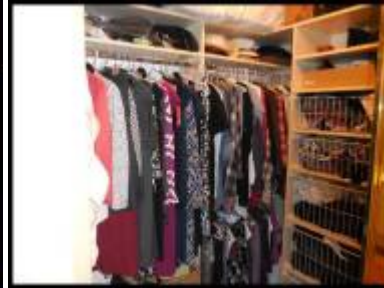
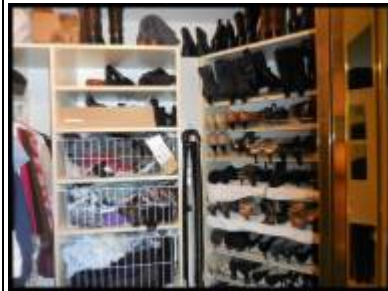
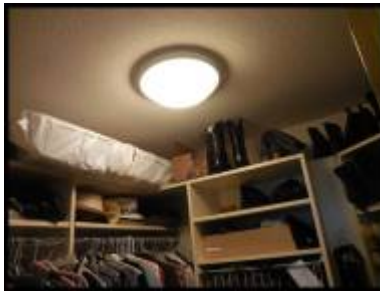
12.2 Closet: The closet is functional and of average size. Doors are functional.
Due to stored items in the closet, it is not possible to determine the condition of the walls and ceiling that are not visible.

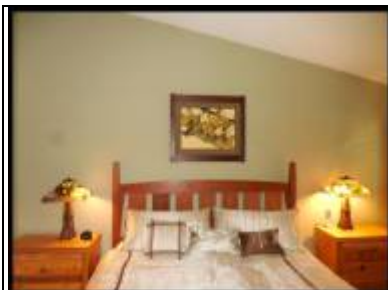
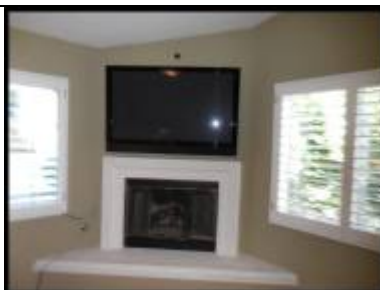
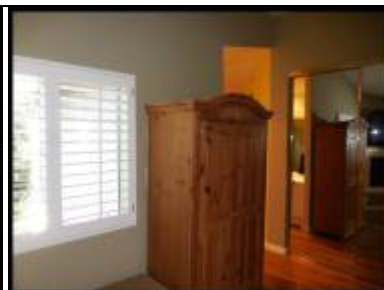
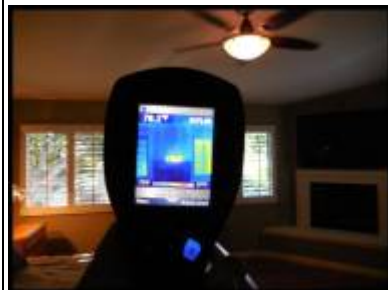
12.3 Walls:

The walls in the room appear to be functional.

Uniform insulation noted in exterior walls.

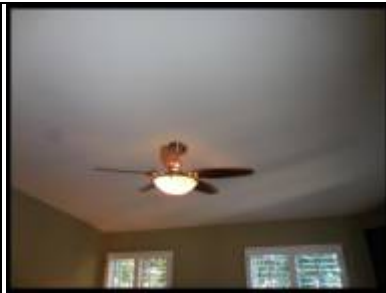
12.6 Light Fixture

There is a ceiling fan installed in this room. It appears to be functional.

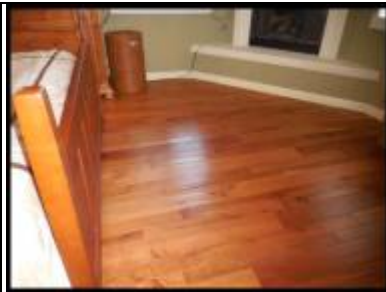
12.7 Floor:

The floors are in functional condition. The floor covering material is hardwood.

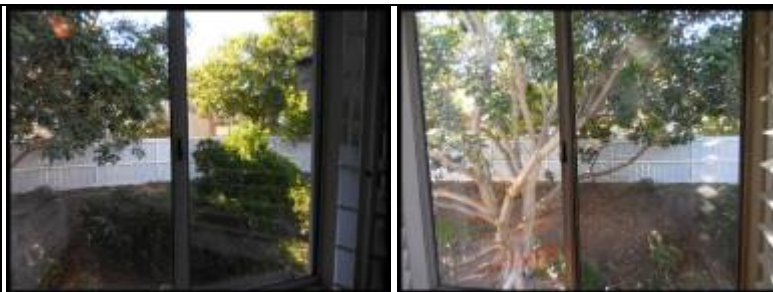
12.8 Windows:

Aged and worn aluminum slider is functional.

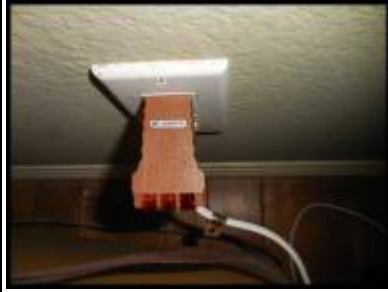
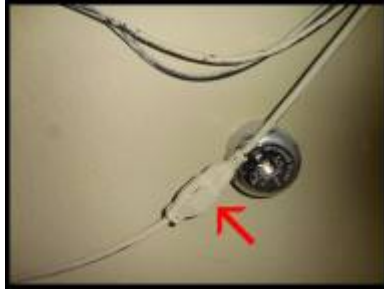
12.9 Electrical Outlets:

Functional - The outlets tested in this room are correctly wired and grounded. Suggest AFCI protected outlets be installed. This is a requirement in new construction but this safety upgrade is recommended for existing bedrooms. It is designed to prevent the plug from being loose enough to cause arcing which can result in a spark causing a fire. Extension cord exposed for television over fireplace. Permanent power is required for permanent fixture.

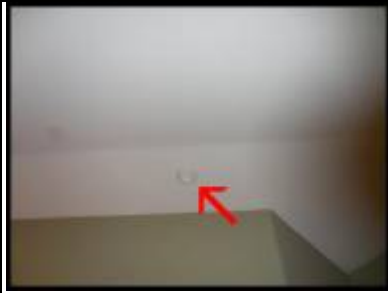
12.11 Smoke Detector:

Smoke & Carbon Monoxide Detectors are required to be present in rooms with a fireplace.

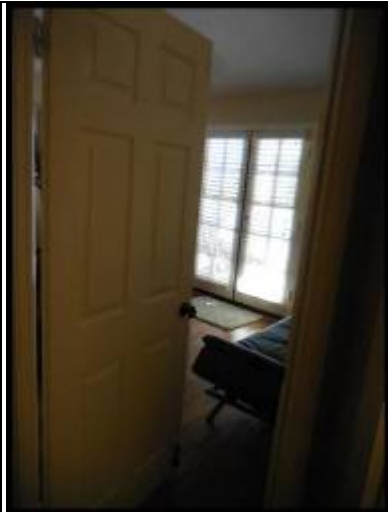
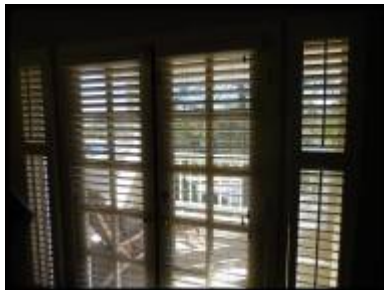
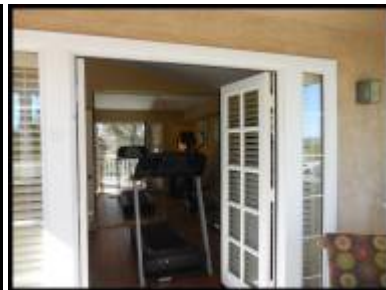
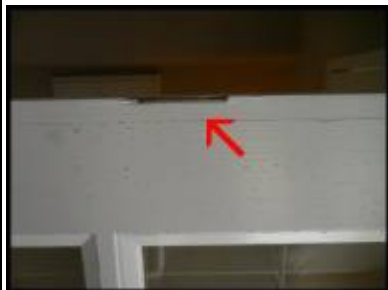
12.12 Entry Door:

The entry door to this room is functional.
Exterior door is fully functional.
Wear is noted at top of door.

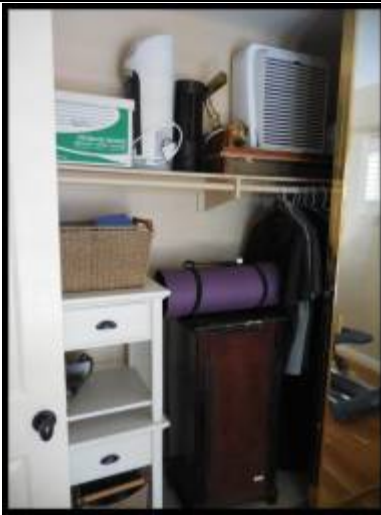
12.13 Closet:

The closet is functional and of average size.
Doors are functional.

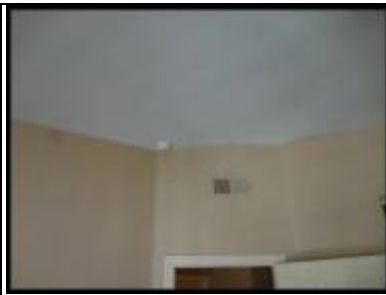
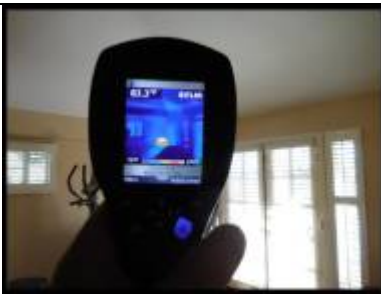
12.14 Walls:

The walls in the room appear to be functional.
Uniform insulation noted in exterior walls.

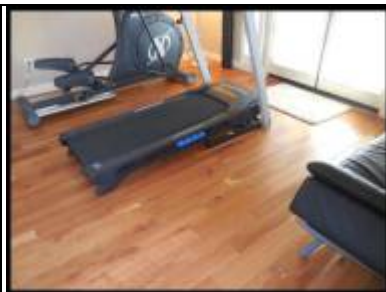
12.17 Floor:

The floors are in functional condition. The floor covering material is hardwood.

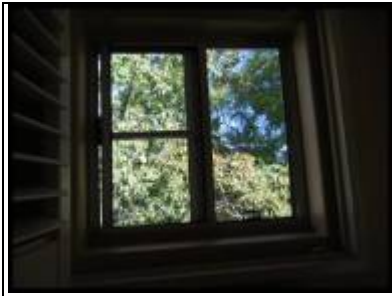
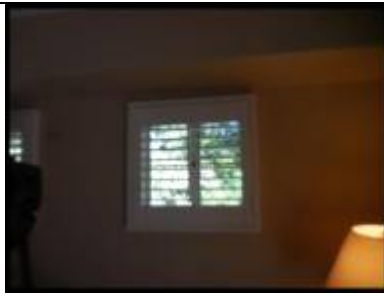
12.18 Windows:

The windows and associated hardware in this room are all functional.

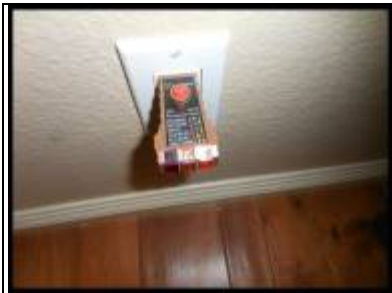
12.19 Electrical Outlets:

Functional - The outlets tested in this room are correctly wired and grounded. Suggest AFCI protected outlets be installed. This is a requirement in new construction but this safety upgrade is recommended for existing bedrooms. It is designed to prevent the plug from being loose enough to cause arcing which can result in a spark causing a fire.

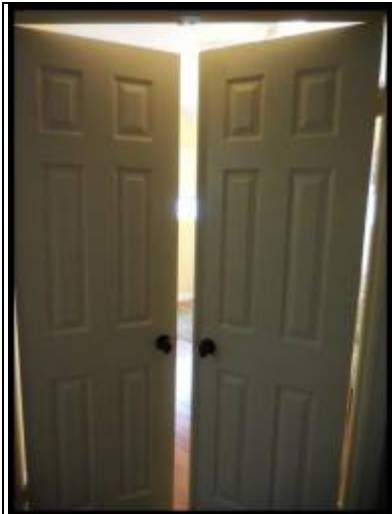
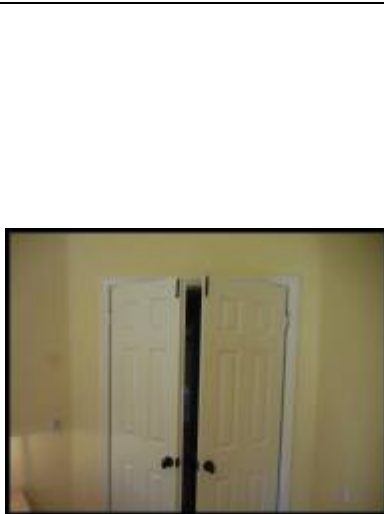
12.22 Entry Door:

The entry door to this room is functional.

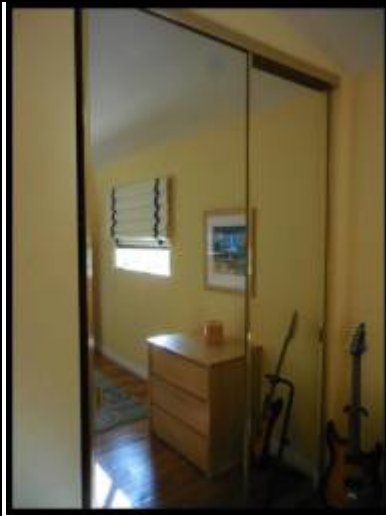
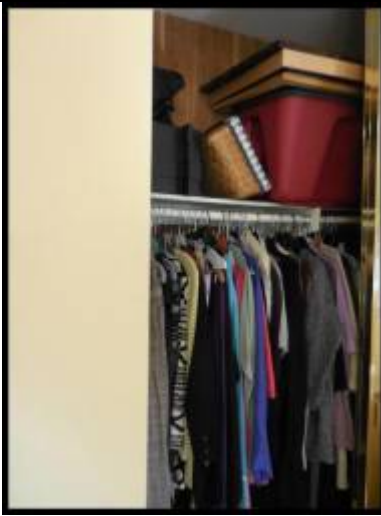
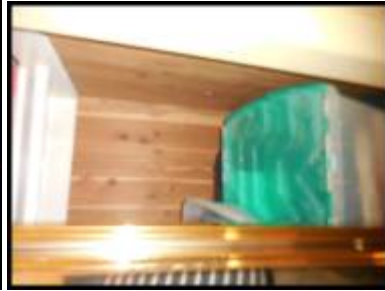
12.23 Closet:

The closet is functional and of average size.
Doors are functional.

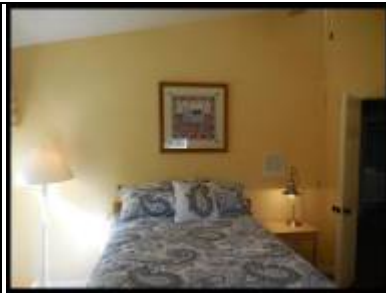
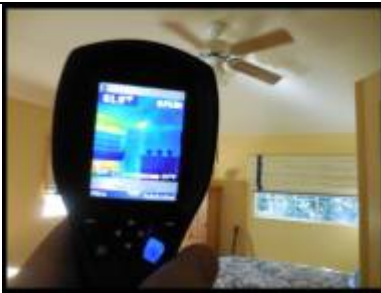
12.24 Walls:

The walls in the room appear to be functional.
Consistent insulation noted in exterior walls.

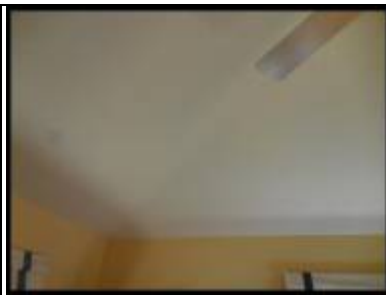
12.25 Ceiling:

The ceiling is functional.

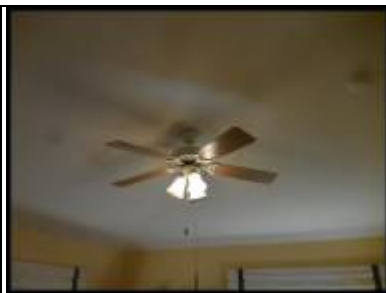
12.27 Light Fixture

There is a ceiling fan installed in this room. It appears to be functional.

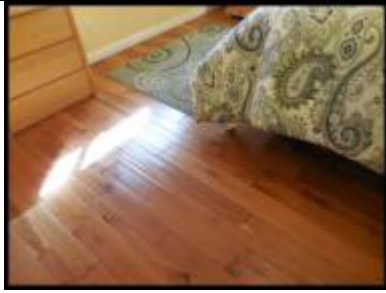
12.28 Floor:

The floors are in functional condition. The floor covering material is hardwood.

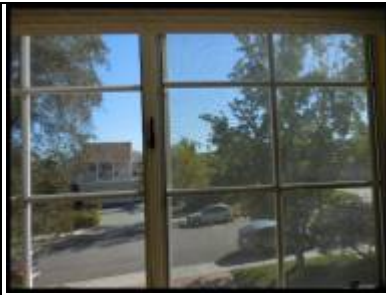
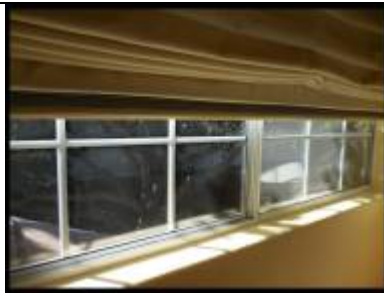
12.29 Windows:

The windows and associated hardware in this room are all functional.
Aged and worn aluminum slider.

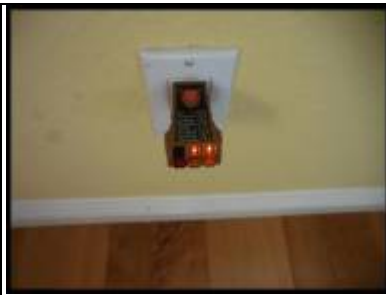
12.30 Electrical Outlets:

Functional - The outlets tested in this room are correctly wired and grounded. Suggest AFCI protected outlets be installed. This is a requirement in new construction but this safety upgrade is recommended for existing bedrooms. It is designed to prevent the plug from being loose enough to cause arcing which can result in a spark causing a fire.

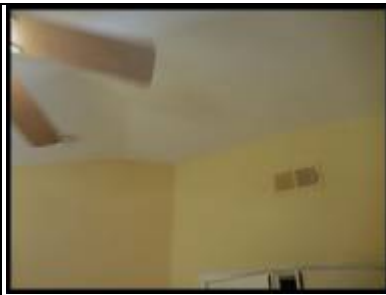
12.31 Heat Source Noted:

There is a heat source to this room. There is no comment as to the amount of air or temperature coming from the supply vent.

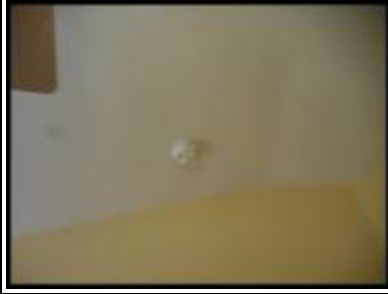
12.32 Smoke Detector:

There is a smoke detector installed in the room. It is undetermined if the unit is hardwired or is battery operated.

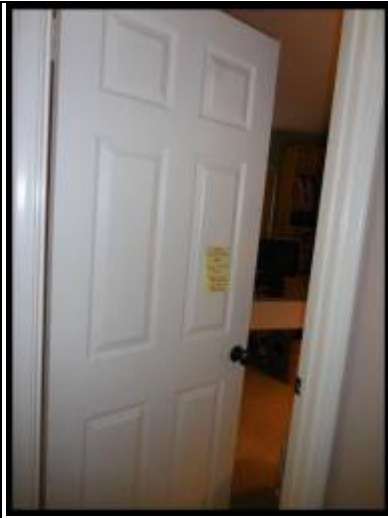
12.33 Entry Door:

The entry door to this room is functional.

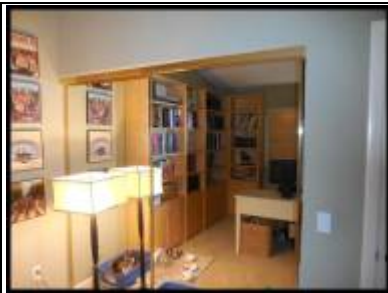
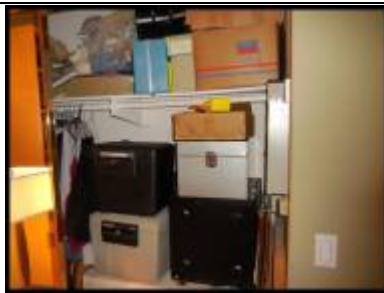
12.34 Closet:

The closet is functional and of average size. Due to stored items in the closet, it is not possible to determine the condition of the walls and ceiling that are not visible.

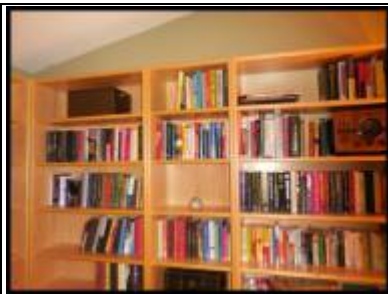
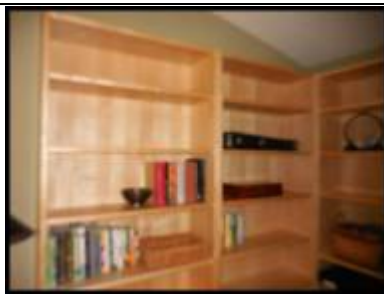
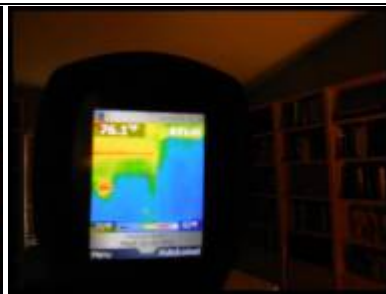
12.35 Walls:

The walls in the room appear to be functional.

Uniform insulation noted in exterior walls.

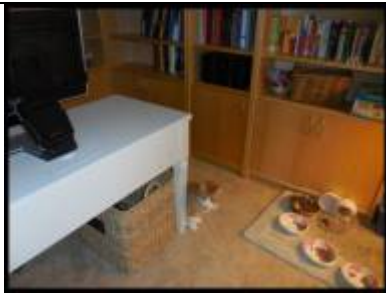
12.38 Floor:

The floors are in functional condition. The floor covering material is carpet.

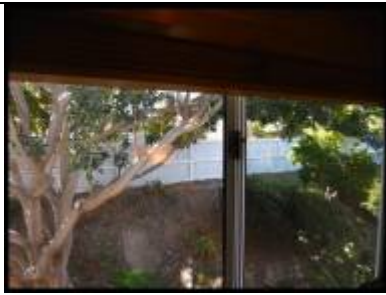
12.39 Windows:

The windows and associated hardware in this room are all functional.

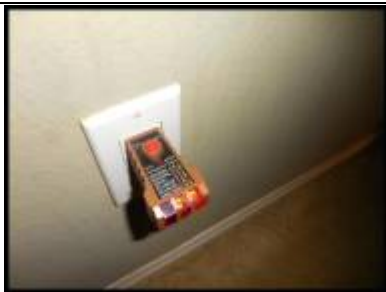
12.40 Electrical Outlets:

Functional - The outlets tested in this room are correctly wired and grounded. Suggest AFCI protected outlets be installed. This is a requirement in new construction but this safety upgrade is recommended for existing bedrooms. It is designed to prevent the plug from being loose enough to cause arcing which can result in a spark causing a fire.

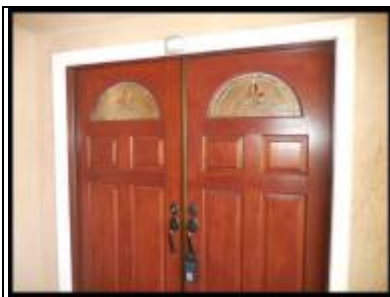
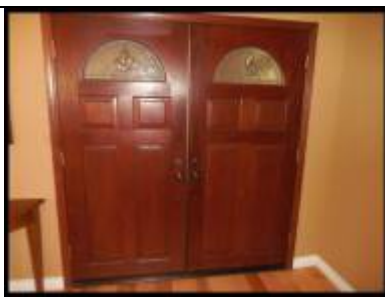
13.2 Front Entry Door:

The main entry door to the structure is in functional condition.

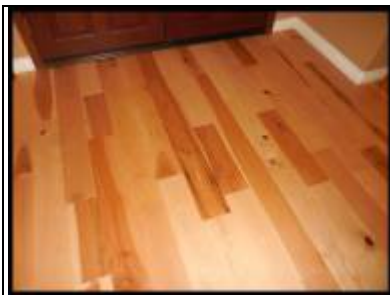
13.3 Entry Floor:

The entry floor material appearance is good and material is functional. The floor covering material is wood.
