Empire Home Inspection

Report: [Sample]

Confidential Inspection Report

Poway, CA 92064

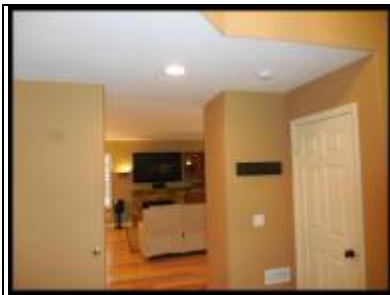
13.4 Main Hallway:

The main hallway walls and floor are without significant issues.

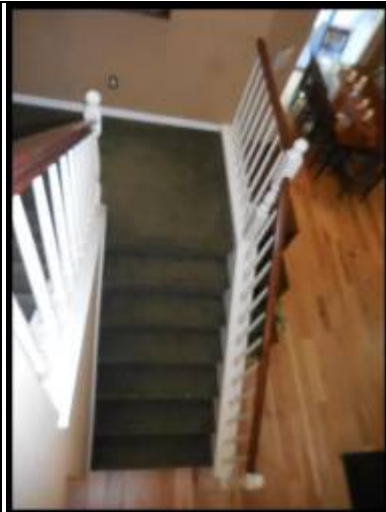
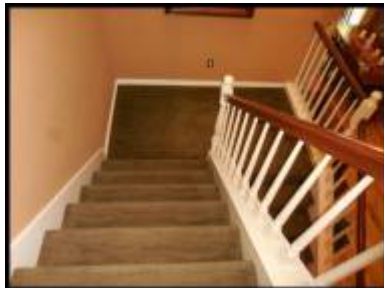
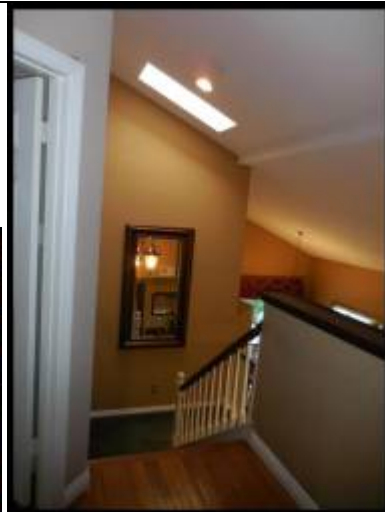
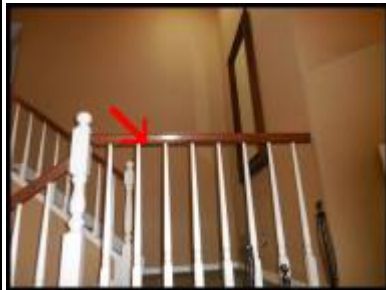
13.7 Main Staircase:

The main staircase is appropriately installed. There is a handrail installed at proper height.
The staircase has a landing.
The staircase is adequately lighted.
Baluster spacing exceeds current code spacing of 4" maximum, it was in compliance when it passed final inspection at time of construction.

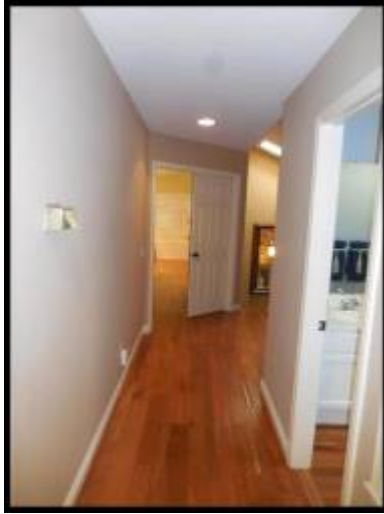
13.8 Upper Level Hallway:

The upper level hallway walls and floor are without significant issues.

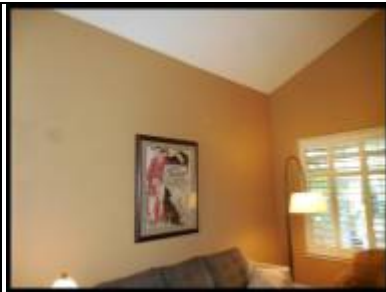
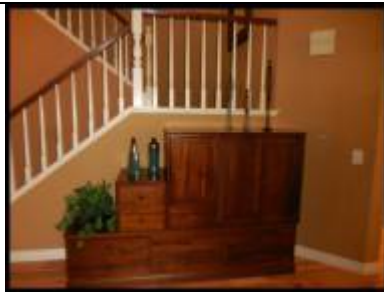
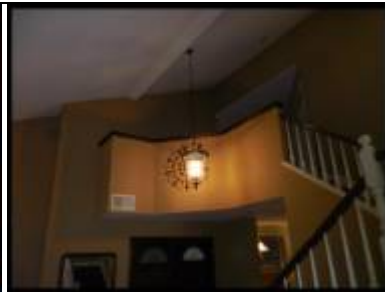
13.10 Walls:

The walls in the room appear to be functional.

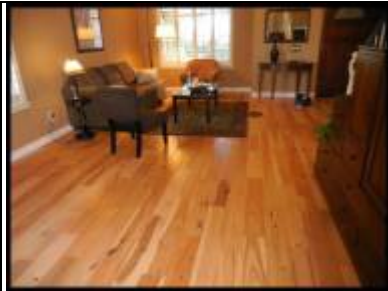
13.13 Floor:

The floors are in functional condition. The floor covering material is hardwood.

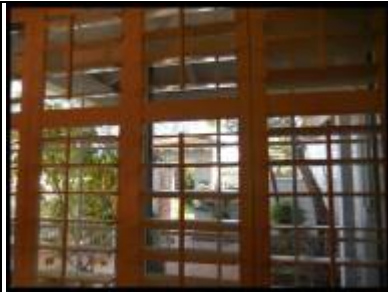
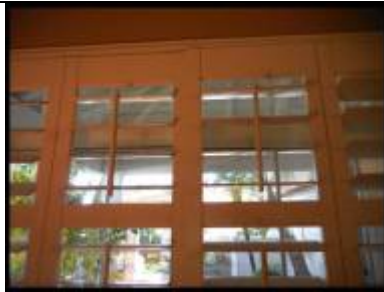
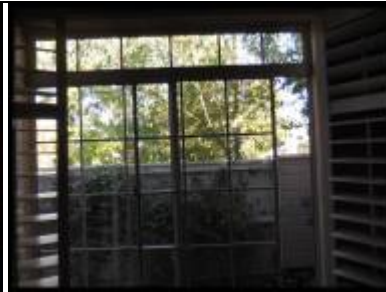
13.14 Windows:

The windows and associated hardware in this room are all functional.
Aged and worn aluminum slider.

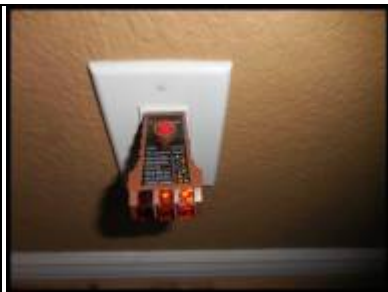
13.15 Electrical Outlets:

Functional - The outlets tested in this room are correctly wired and grounded.

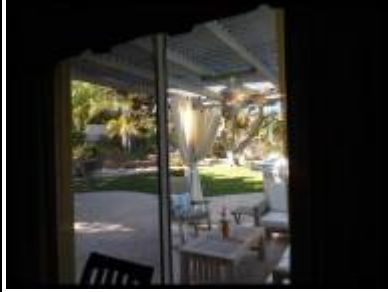
13.17 Entry Door:

The entry door to this room is functional.

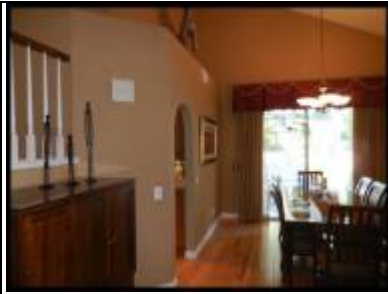
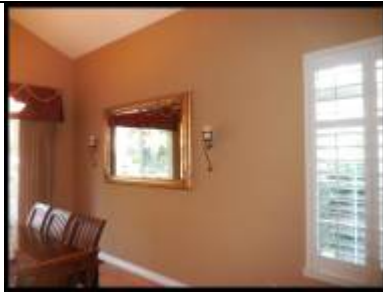
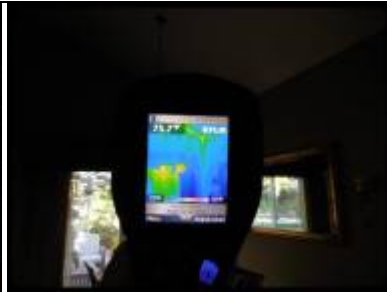
13.18 Walls:

The walls in the room appear to be functional.
Uniform insulation noted in exterior walls.

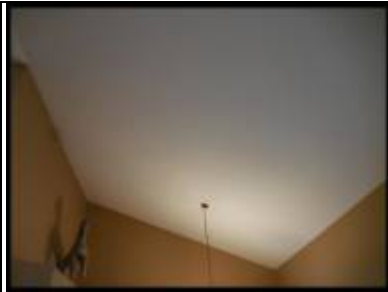
13.19 Ceiling:

The ceiling is functional.

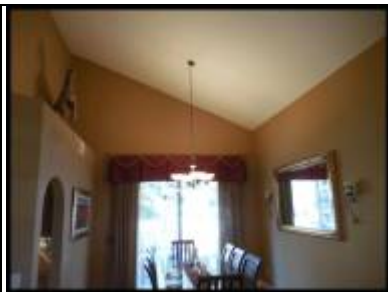
13.21 Light Fixture

Dining Room Light fixture is operational at time of inspection.

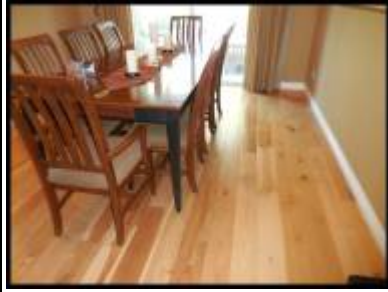
13.22 Floor:

The floors are in functional condition. The floor covering material is hardwood.

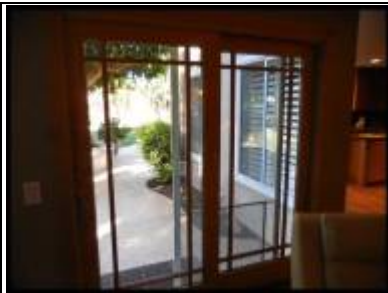
13.25 Entry Door:

The entry door to this room is functional and in good condition.

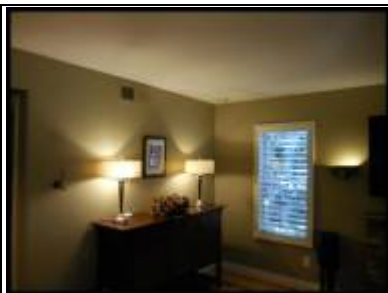
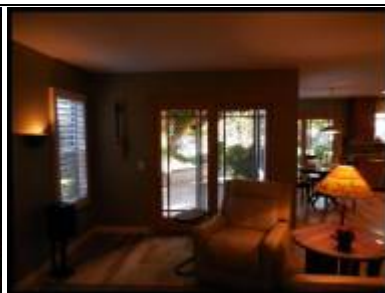
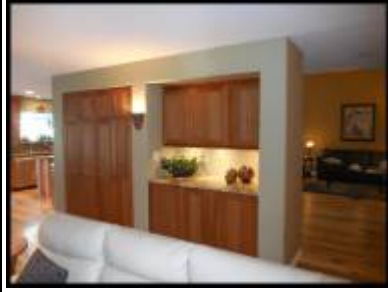
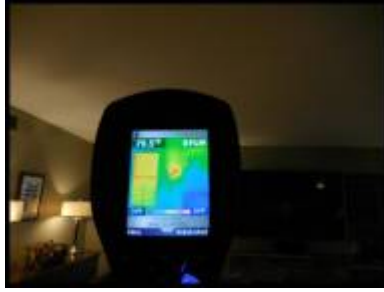
13.26 Walls:

The walls in the room appear to be functional.
Uniform insulation noted in exterior walls.

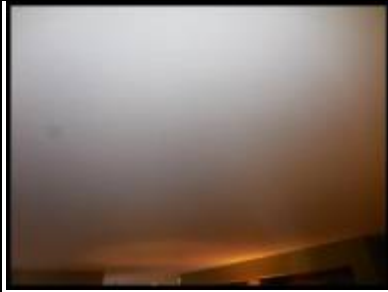
13.27 Ceiling:

The ceiling is functional.

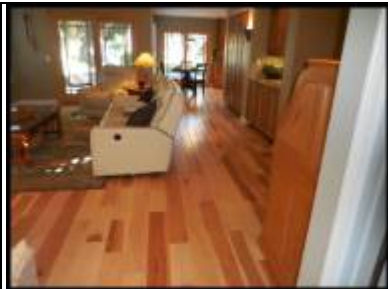
13.29 Floor:

The floors are in functional condition. The floor covering material is hardwood.

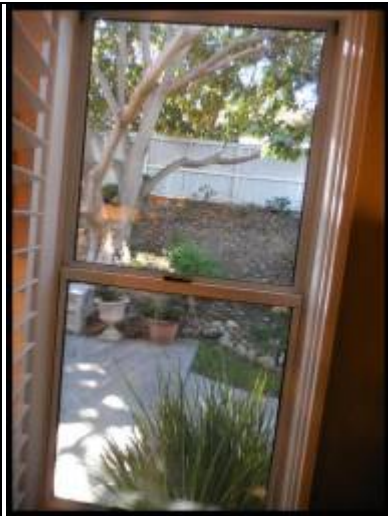
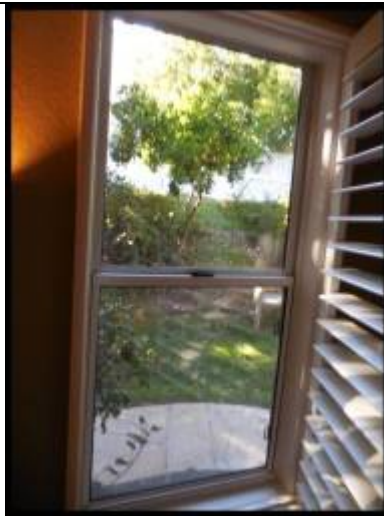
13.30 Windows:

The windows and associated hardware in this room are all functional.

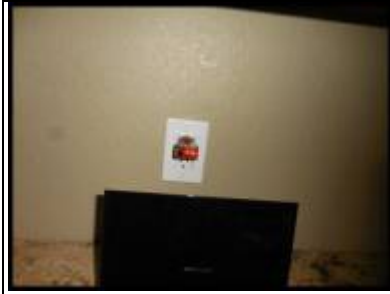
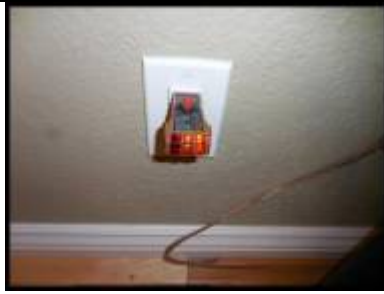
13.31 Electrical Outlets:

Functional - The outlets tested in this room are correctly wired and grounded.

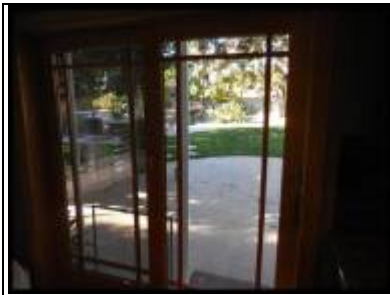
13.35 Entry Door:

The entry door to this room is functional.

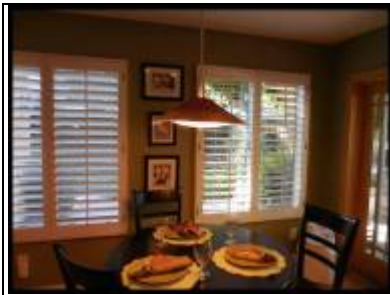
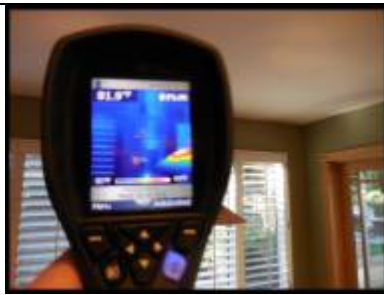
13.36 Walls:

The walls in the room appear to be functional.
Consistent insulation noted in exterior walls.

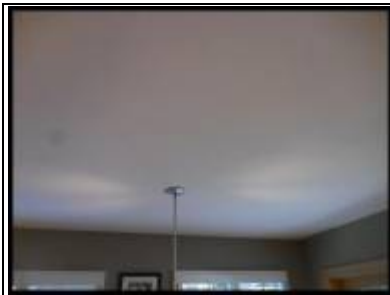
13.37 Ceiling:

The ceiling is functional.

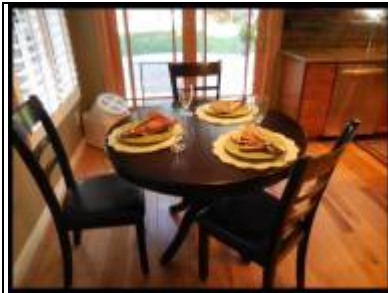
13.40 Floor:

The floors are in functional condition. The floor covering material is hardwood.

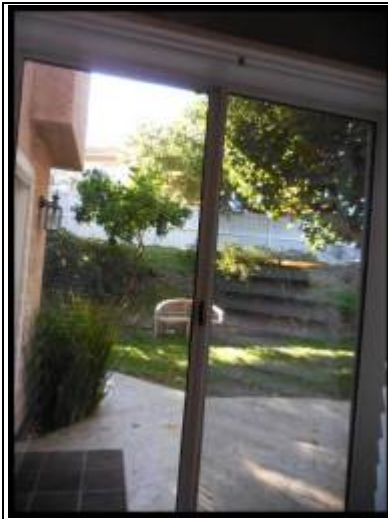
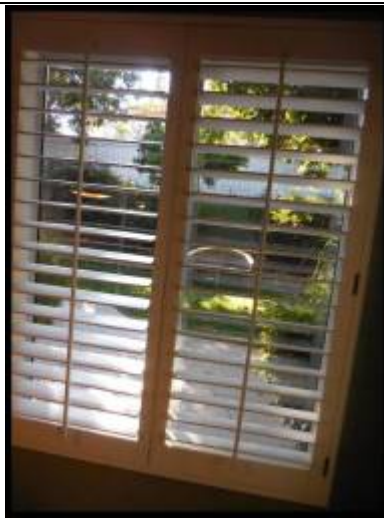
13.41 Windows:

The windows and associated hardware in this room are all functional.

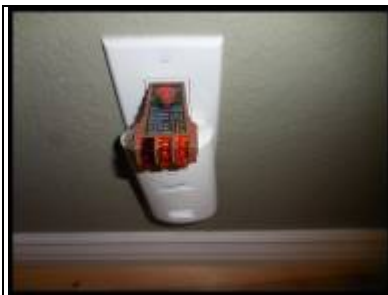
13.42 Electrical Outlets:

Functional - The outlets tested in this room are correctly wired and grounded.

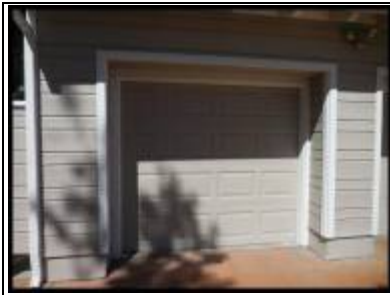
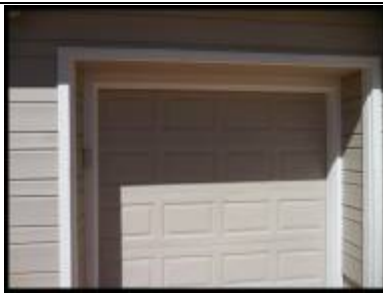
14.2 Size of Garage: Three car garage.
14.3 Number of Overhead Doors There are three overhead doors.

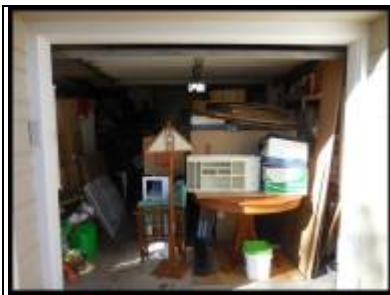
14.4 Left Overhead Door and Hardware Condition: Door and opener for door #1(closest to the left looking from front) is operable. No electronic reversing sensor is present but pressure sensitive switch is reversing door at proper resistance.

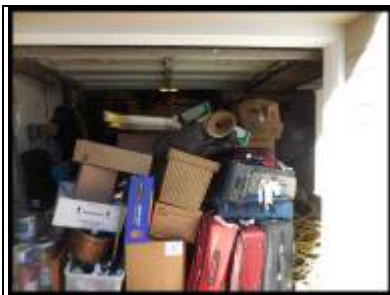
14.5 Middle Overhead Door and Hardware Condition: Door and opener for door #2(middle door) is operable. Electronic reversing sensor is operable and pressure sensitive switch is reversing door at proper resistance.

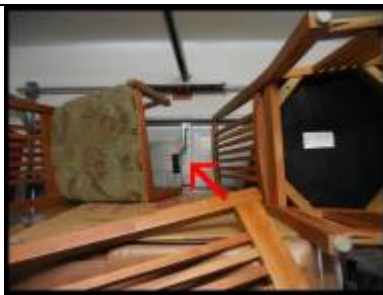
14.6 Right Overhead Door and Hardware Condition: Door opener is operable but door is disconnected.

Service is needed to repair or replace necessary parts and make adjustments to safety systems for all doors to operate properly.

30. Service is needed to repair or replace necessary parts and make adjustments to safety systems for all doors to operate properly.

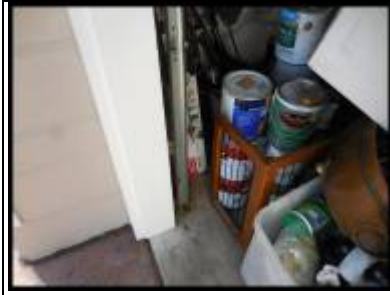
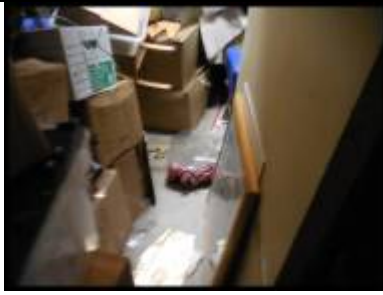
Due to stored items on the garage floor, I was unable to determine the condition of the portions of the floor that are not visible.

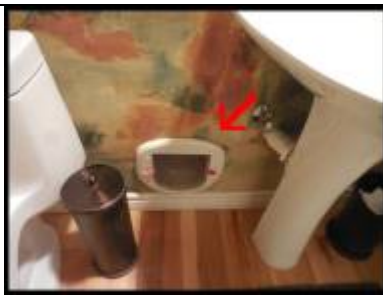
The wall covering appears to meet the minimum fire separation standards. However, it is not possible to verify after the sheetrock is finished.

Cat door through fire wall is violation of separation garage and living area. Repairs are needed.

31. Cat door through fire wall is violation of separation garage and living area. Repairs are needed.

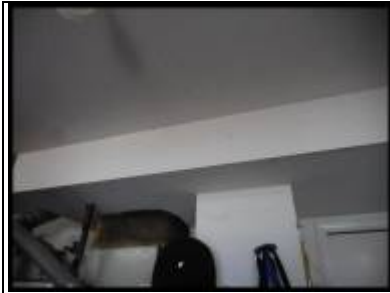
Yes - There appears to be a fire rated separation between the garage ceiling and the adjacent living areas.

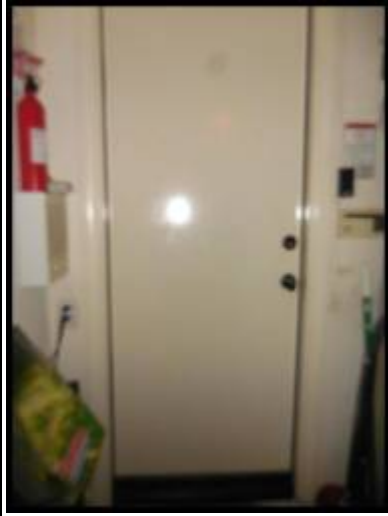
Yes - There is a solid core door separating the garage from the living areas of the house. Self Closing door devise is operable.

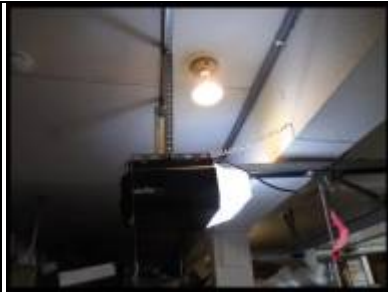
There is a post supporting an overhead beam in the garage. It appears to be adequately installed.

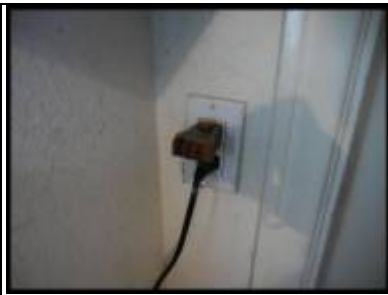
The garage electrical outlets, except for dedicated circuits, are protected with Ground Fault Circuit Interrupt protection as required by current standards.

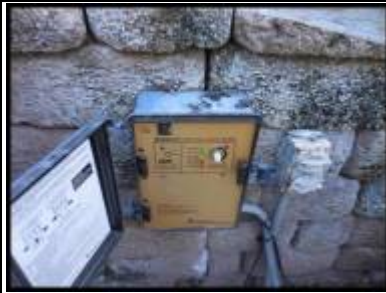
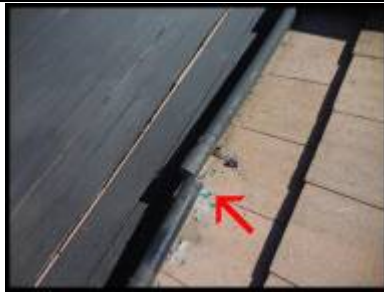
Solar controller is not functioning to provide solar heated water from roof.

Ask seller about condition and operation of this system.

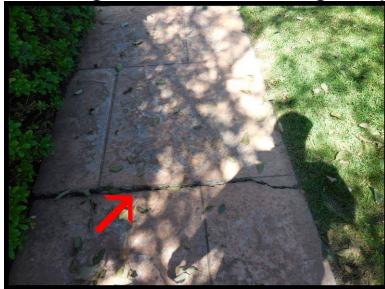
3. Lifting flatwork is causing a trip hazard noted by 1" vertical separation or more. Repair or replacement is needed.

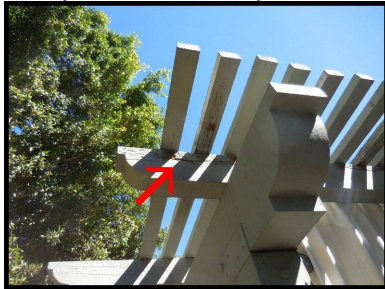
4. Dry rot is noted on joist and sheeting. Repairs are needed.

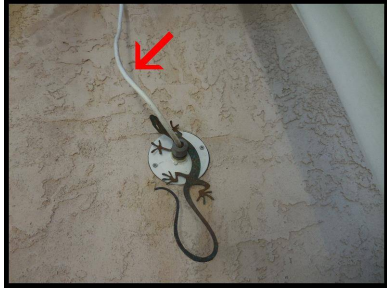
6. Electrical conductor exposed, should be enclosed in conduit.

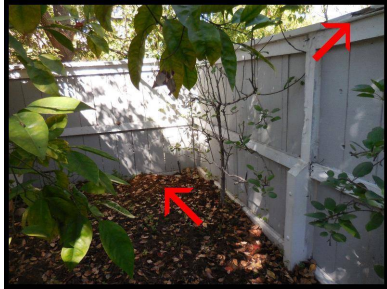
2.17 Fence Materials Condition:

7. Fencing needs to be clear from soil and repairs are needed at top cap and bottom rails where dry rot and deterioration have compromised structural integrity.

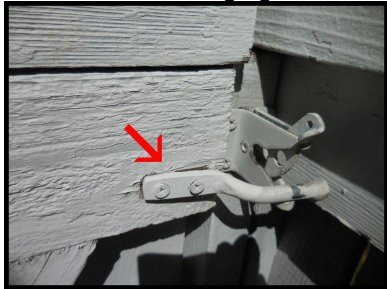
2.18 Gates and Latches:

8. Gate is out swinging but latch is not operating properly to secure gate to access pool area.

9. The gate or latch hardware needs repair to function as intended.

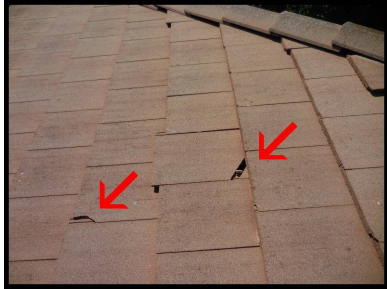
4.5 Condition of Roof Covering Material:

11. Broken roof tiles were observed and repairs are needed.

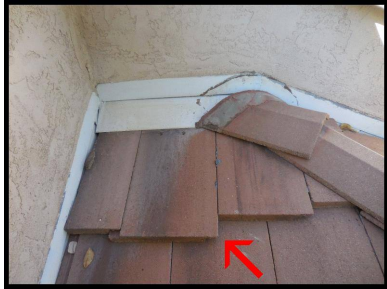
12. Slipping tiles are noted at roof to wall and hip cuts.

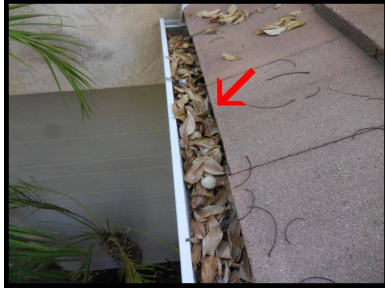
4.15 Roof Gutter System:

15. Cleaning is necessary for proper function.

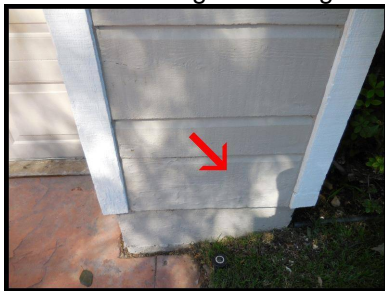
6.3 Siding Condition:

17. Some damage from irrigation is noted. Repairs are needed.

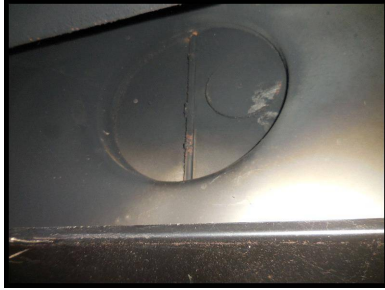
6.45 Damper Condition:

19. There is no damper clip installed. All fireplaces with a gas connection should have a clip installed that will allow a small airflow up the chimney.

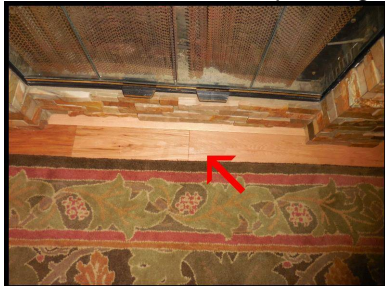
6.58 *Hearth Condition:*

20. Action Necessary - There is no hearth extending in front of the firebox. Gas appliance only is recommended with screens closed when operating.

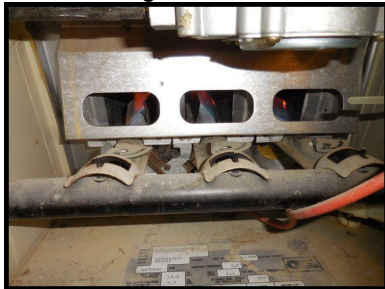
7.36 Burners / Heat Exchangers:

21. Burner igniter would not shut off after burners were lit. Service is needed.

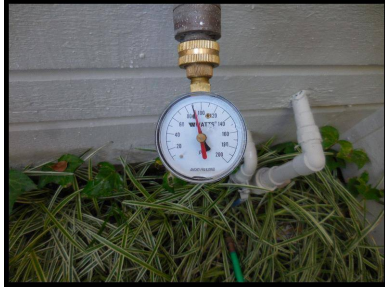
23. Attention Needed - Water pressure was over 80 pounds per square inch and is considered excessive. 90 psi at time of inspection. Water pressure regulator valve correctly installed will allow adjustment of the incoming water pressure and over pressure protection. Garage was not accessible to this location. Service will need to be done to

reduce pressure.

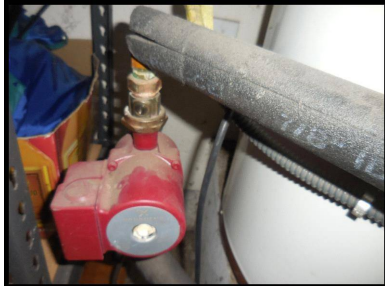
9.37 Recirculation Pump:

26. Yes, condition is suspect with corrosion showing. Pump was very hot and may be continuously running.

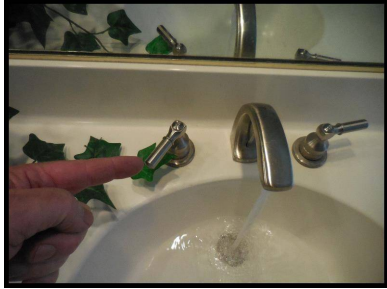
11.2 Faucet and Basin Fixture:

27. Hot valve on the right sink is stiff operating. Repair or replacement is needed.

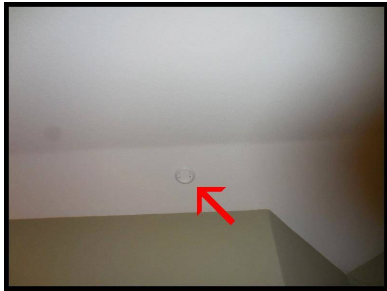
12.11 Smoke Detector:

28. Smoke & Carbon Monoxide Detectors are required to be present in rooms with a fireplace.
